CITY OF DUNWOODY

Subject: **Stormwater Inventory Update**

Stormwater Inventory Update

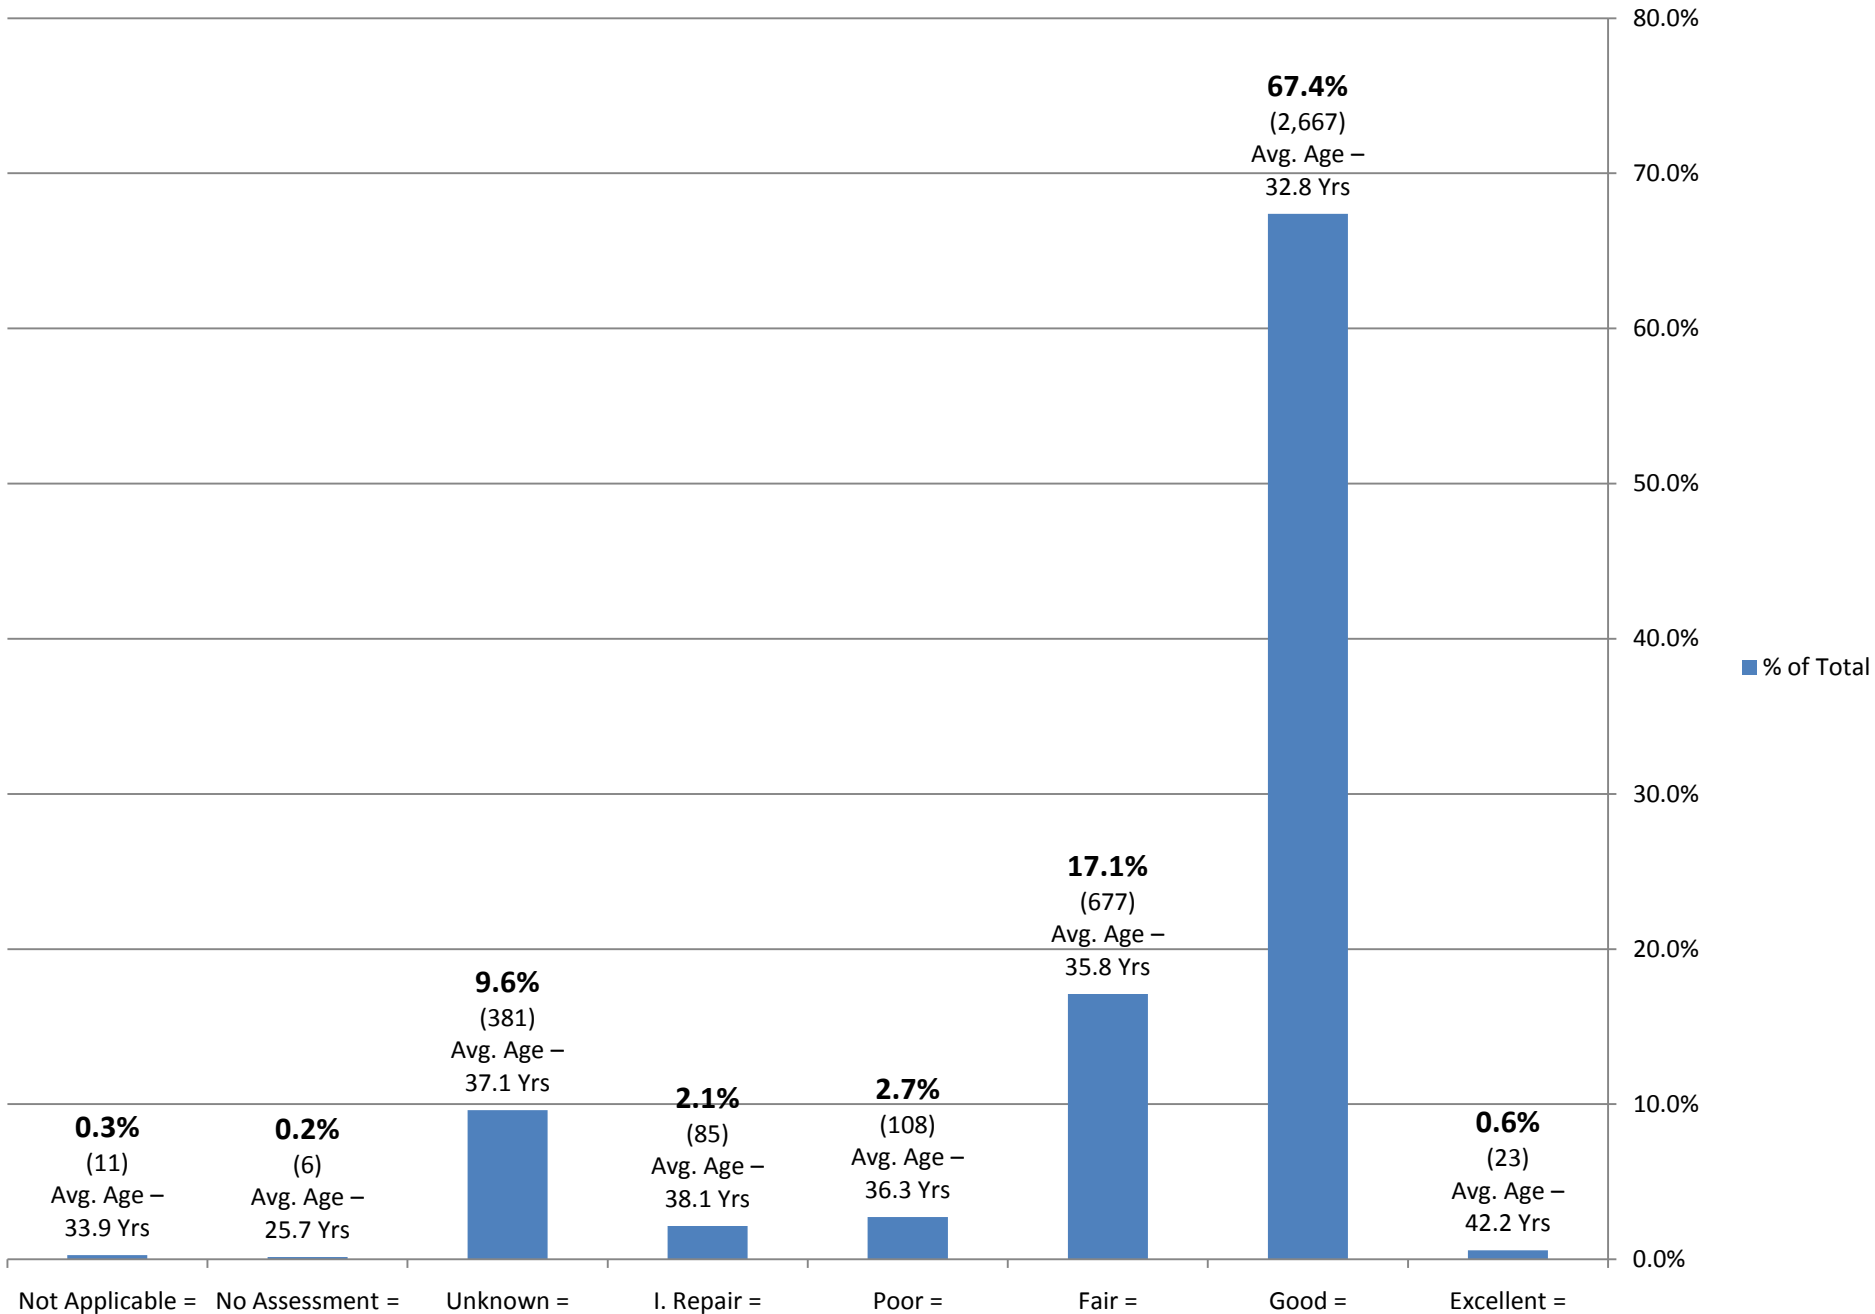
Structure Summary

1. Total area inventoried is 3,640 acres, (42.8% of the City). A total of 3,958 structures and 2,975 conveyances were mapped with a replacement value of \$17.1 million.
2. Although 85% of structures and 90% of conveyances were rated in Fair or better condition the average age of the system is just under 34 years old, based on the recorded plats, the system will begin to deteriorate at an increased rate due to the age and the lack of maintenance.
