**The Brook Run Theater
Feasibility Study**

**Report of Findings and Recommendations
Regarding Rehabilitation, Adaptive Re-Use and Operations**

January 2016

City of Dunwoody
Brook Run Park Theater

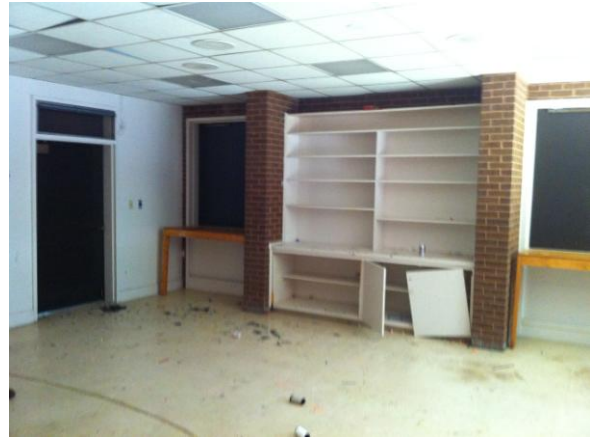
Damaged Flooring & Millwork

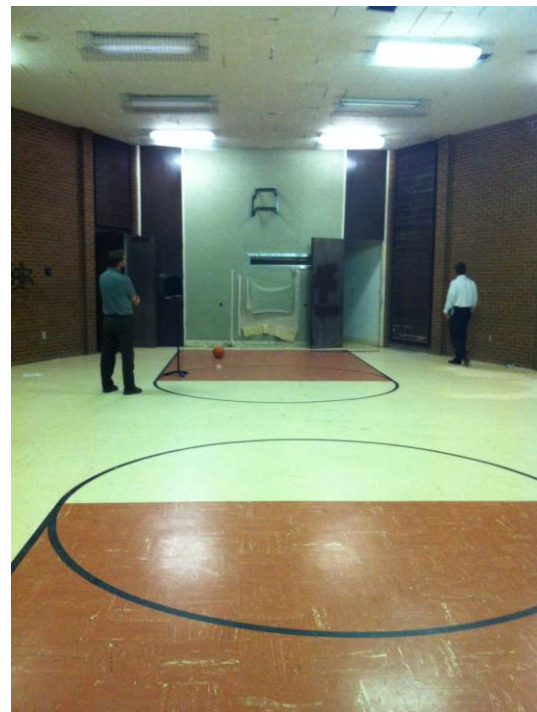
Damaged Walls at Recreation Room

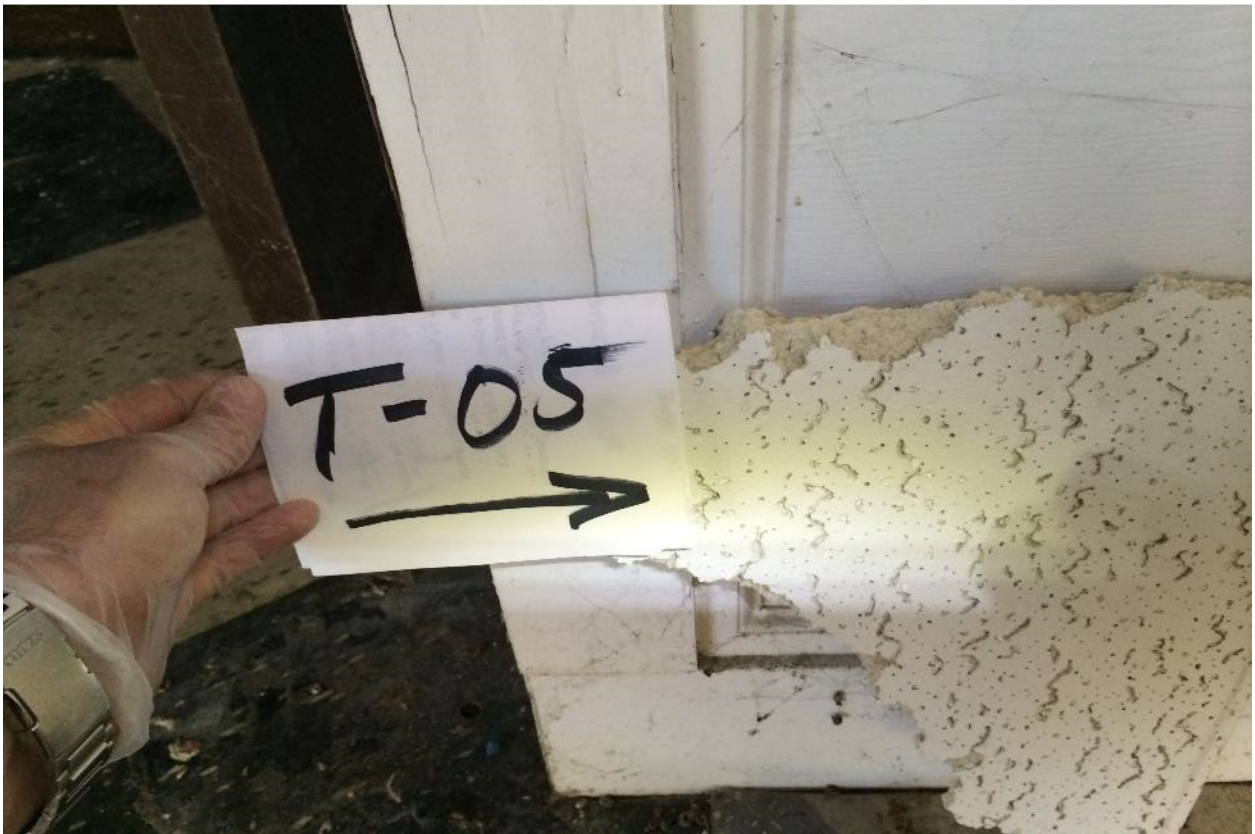
Plate 56: Laboratory analyses detected 2% chrysotile asbestos within suspended ceiling tile sample TS-05 collected from the Theatre Building lobby area.

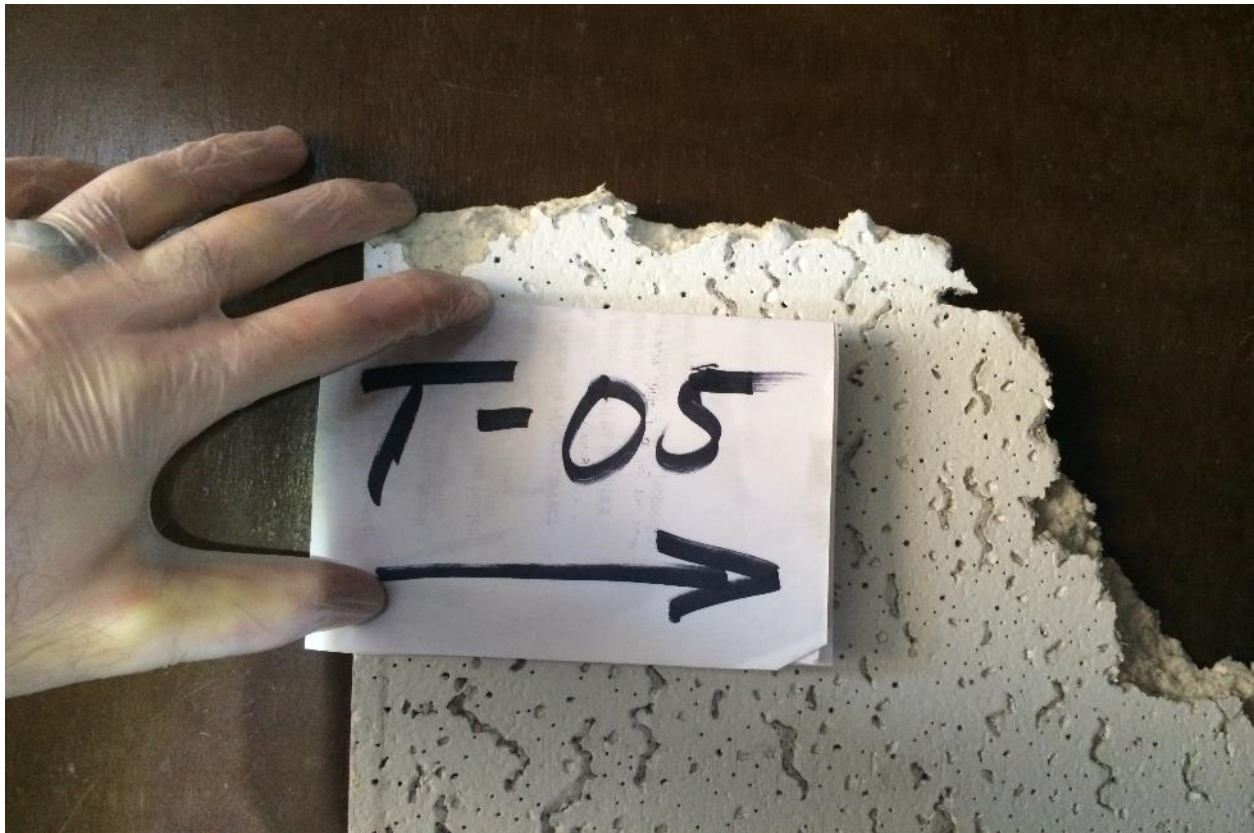
Plate 57: Laboratory analyses detected 2% chrysotile asbestos within suspended ceiling tile sample TS-06 collected from the Theatre Building hallway (sample should be labeled TS-06).

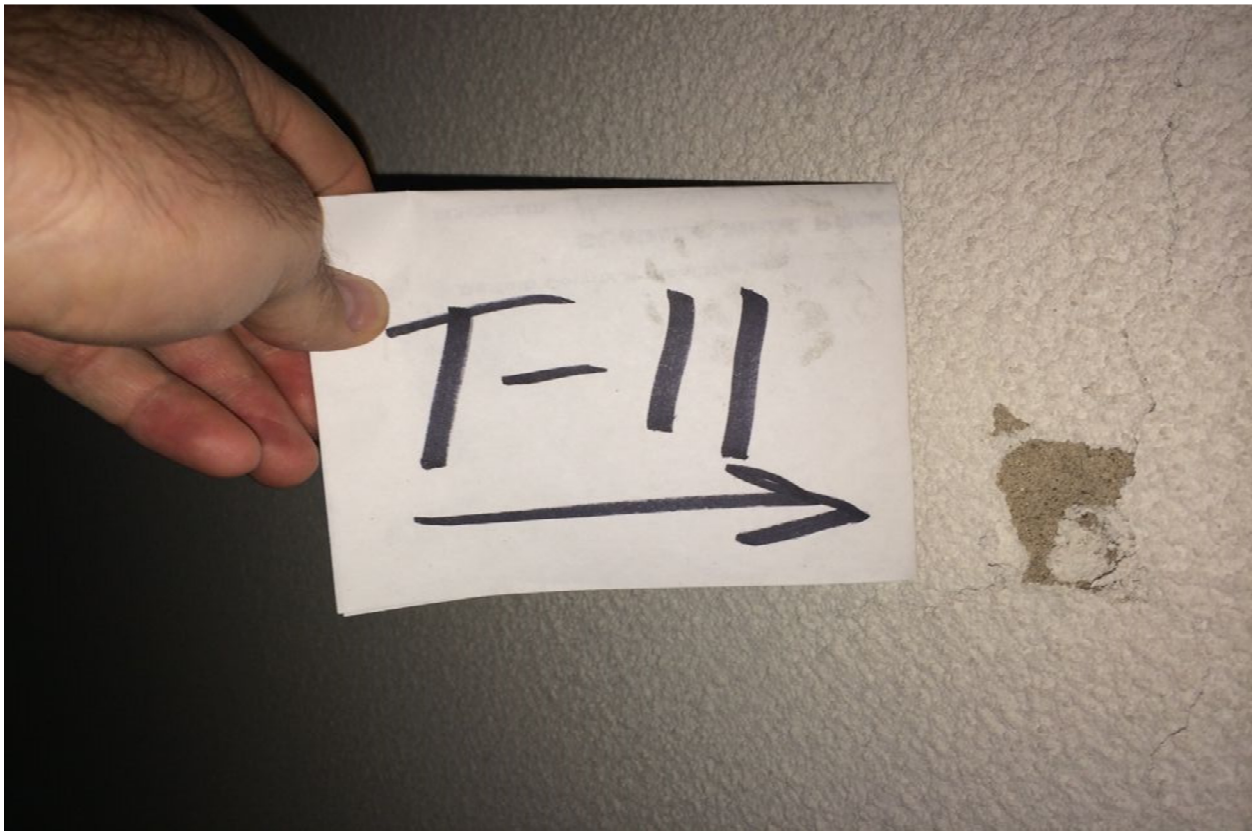
Plate 62: Laboratory analyses detected 20% chrysotile asbestos within spray on surfacing material sample TS-11 collected from the Theatre Building upstairs projection room ceiling.

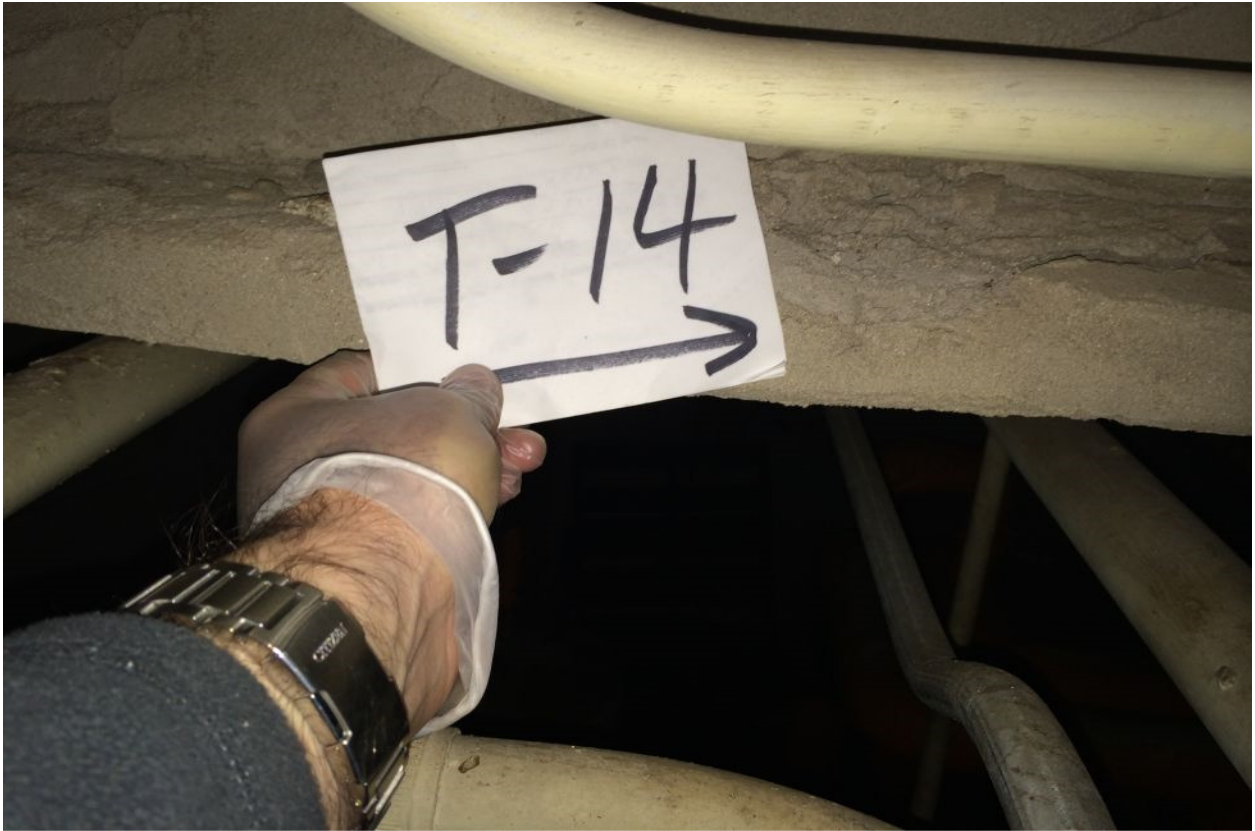
Plate 65: Laboratory analyses detected 20% chrysotile asbestos within spray on surfacing material sample TS-14 collected from the Theatre Building basement structural steel.

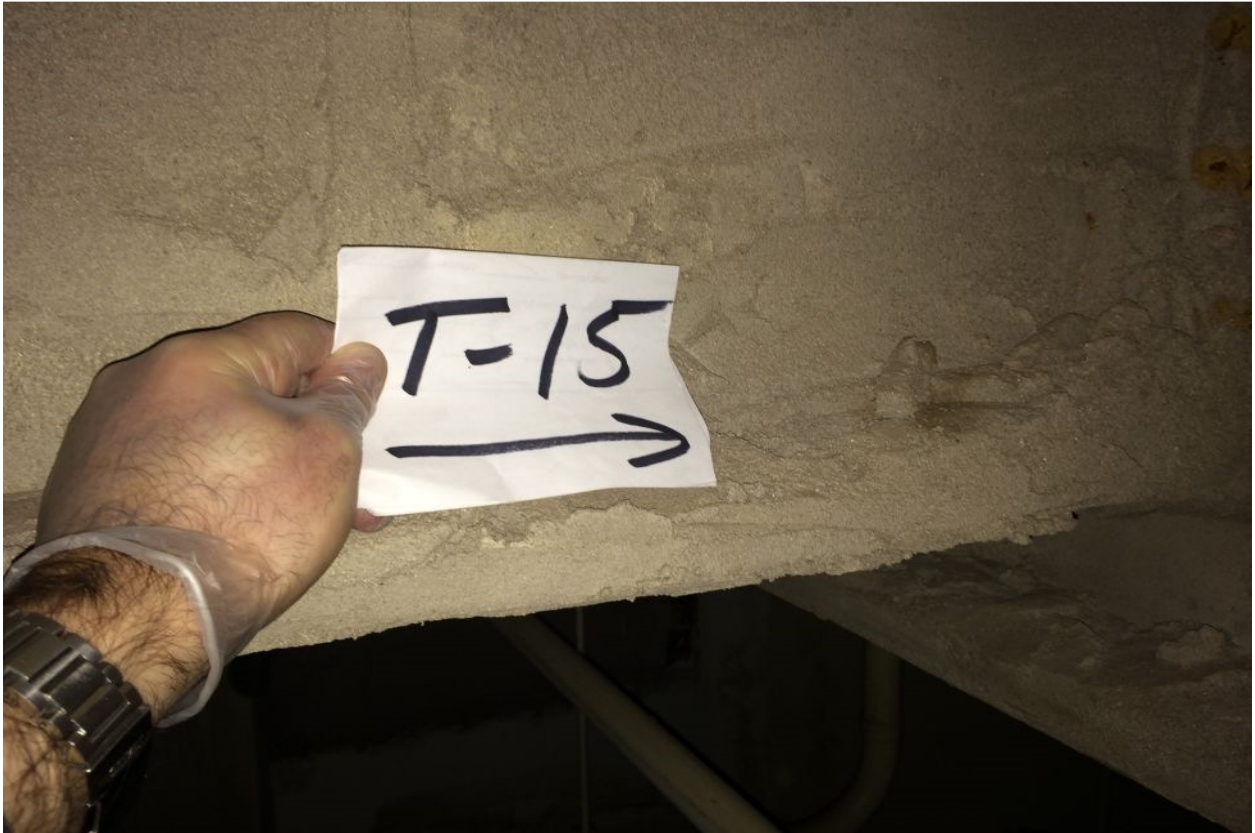
Plate 66: Laboratory analyses detected 20% chrysotile asbestos within spray on surfacing material sample TS-15 collected from the Theatre Building basement structural steel.
