# City of Dunwoody

## 4800 Ashford Dunwoody Building Condition Assessment & Space Needs Analysis

July 2016

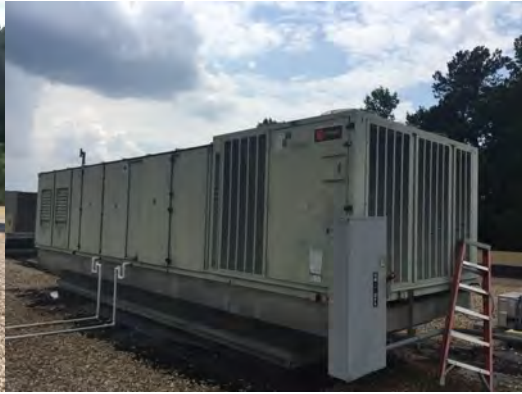
Trane 70T

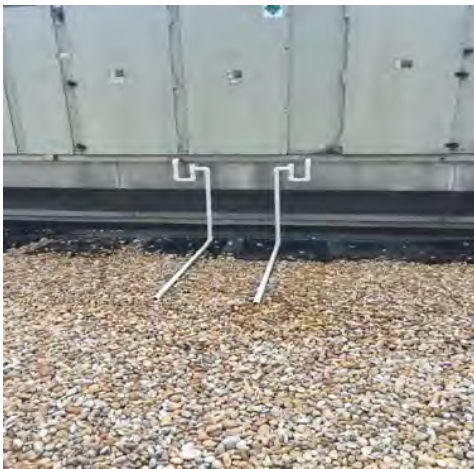
RTU Condensate Piping

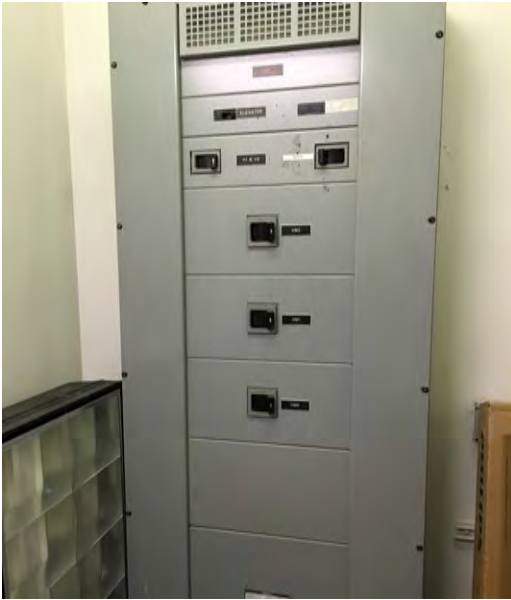
The facility is fed underground from a power utility transformer located on site with one power meter for the building. Incoming power was distributed through a 1200 ampere, 480y/277 VAC, three phase main distribution panel with no main breaker. The electrical distribution system appeared to be in good condition although panel does not contain a main circuit breaker so there is a limit to a maximum of (6) circuit breakers in this panel. The panel contains the maximum allowed by code and cannot accept additional circuit breakers.

Full main distribution panel

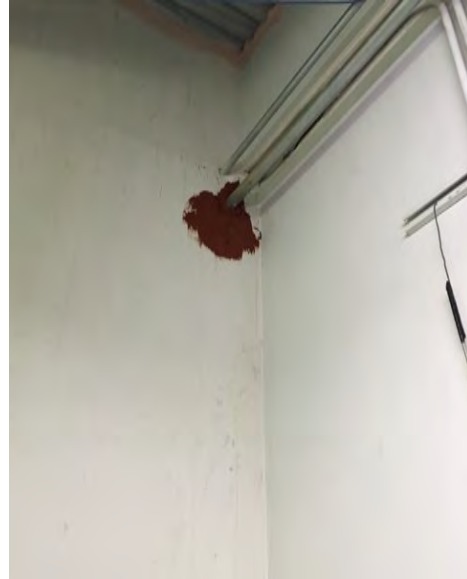
Several electrical code violations existed in the facility. Some subpanels throughout the building are lacking circuit index cards or do not appear to be fully updated to indicate loads served. Most firewall penetrations within the electrical rooms appear to be fire sealed, but some are not.

Fire sealing missing

We recommend a complete analysis of the electrical system to assure loads, life safety systems, and connections are in good condition and also tightening/inspecting all wiring terminations. We also recommend all fire penetrations be fire sealed and the ground location on the water pipe be relocated per code.

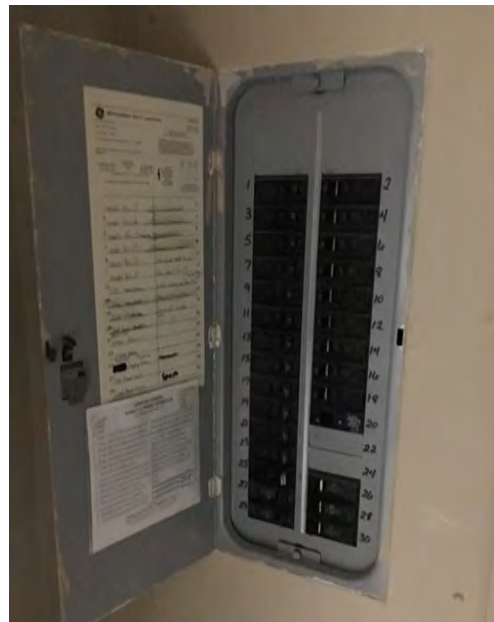
Most facility electrical panels appeared to be located in the 1<sup>st</sup> and 2<sup>nd</sup> floor stacked electrical rooms. We did identify a sub-panel located in a vacant tenant space. Access to occupied spaces was limited, but the facilities represented stated that there were not sub-panels within the tenant spaces.

Tenant sub-panel

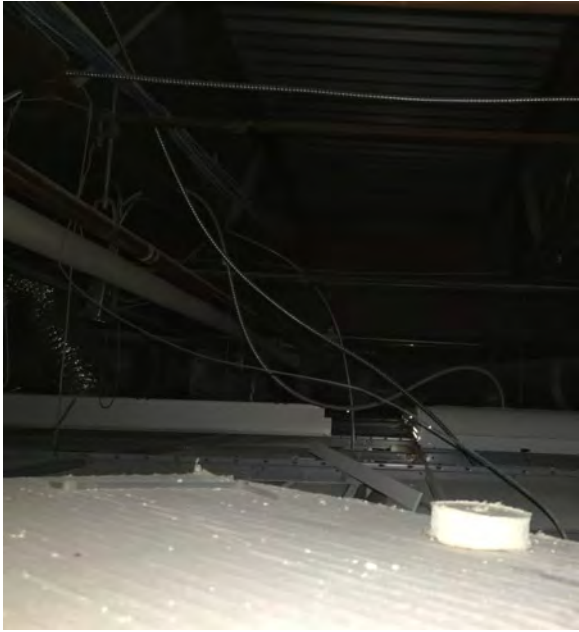
The circuit homeruns appeared to be contained within conduit, but most of the branch circuiting was comprised of MC cable.

MC Cable above ceiling

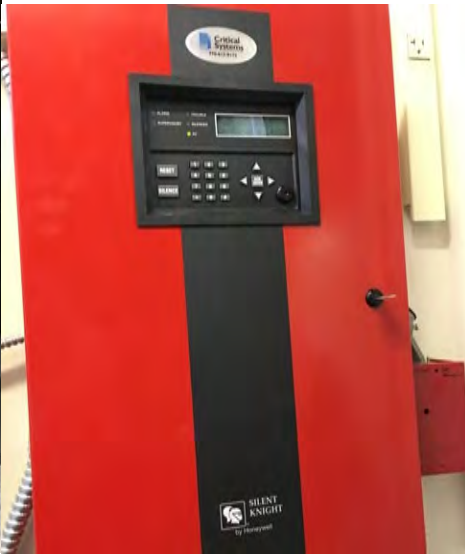
The main fire alarm panel was located in the main electrical room. It appeared to be an addressable Silent Knight panel. The fire alarm indicating device layout did not appear to comply with current codes. The locations indicating devices did not comply with the current codes. The smoke detector in the lobby did not appear to be close enough to the elevator to control the elevator recall function properly. There was a duct smoke detector currently under repair within the vacant tenant space.

Fire Alarm Panel

We recommend the fire alarm system be updated to comply with current codes. It is possible the existing panel could be re-used and expanded as required.

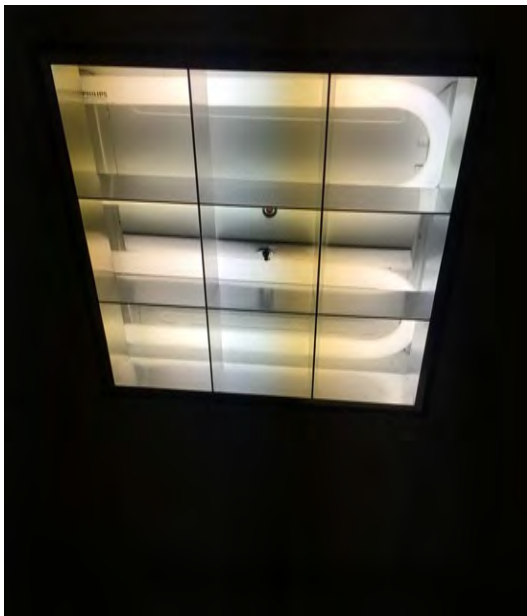
Most of the interior light was 2x2 2 lamp parabolics with T12-U fluorescent lamps in common areas. We identified 2x4 parabolics with fluorescent lamps in the tenant space as well as incandescent downlights. There were downlights with retrofit LED lamps in the lobby area with fluorescent cove lighting (some not operational).

Common area light

We recommend replacement of all lighting with either fluorescent or led sourced fixtures with replacement of all T12 lamped fixtures with higher efficiency T8 fixtures with electronic ballasts. We recommend the recessed emergency lighting be tested/repaired.

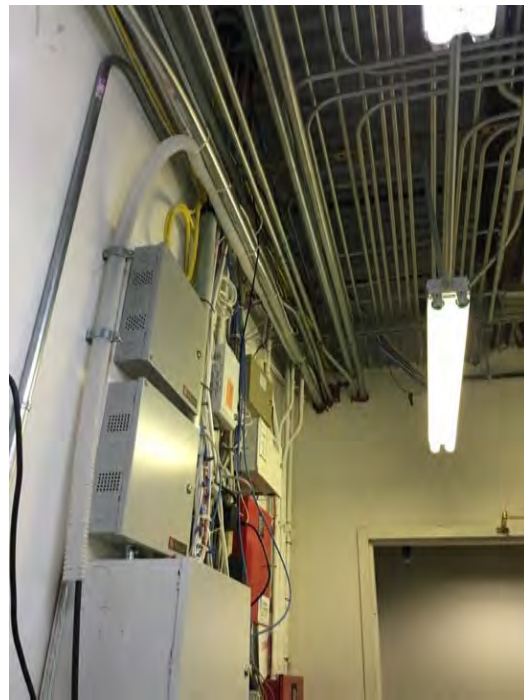
The original telephone service appeared to enter through the slab. Fiber optic cabling was routed overhead to the telephone backboard, but we could not determine if this was a new service into the building.

Overhead fiber optic cabling

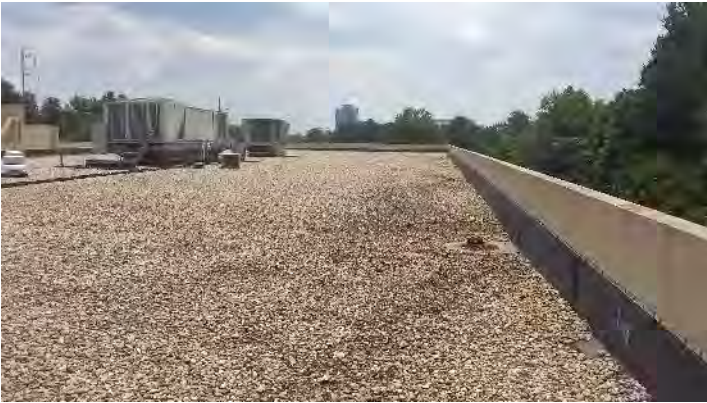
Loose Laid Ballast EDPM Membrane at Perimeter:  
- or open at base flashings.

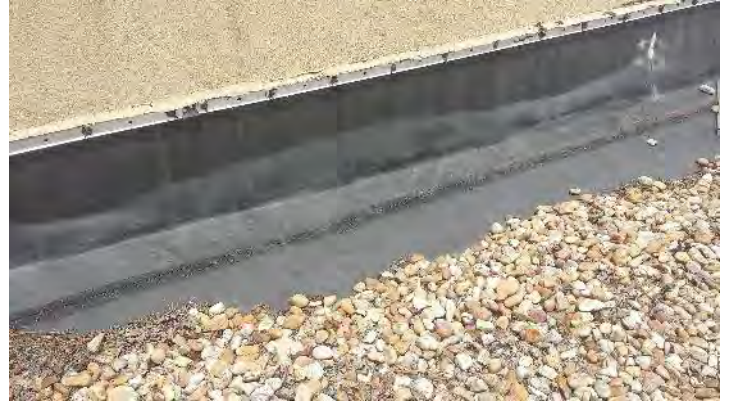
Perimeter base flashing display bridging or shrinkage  
at most of the assembly.

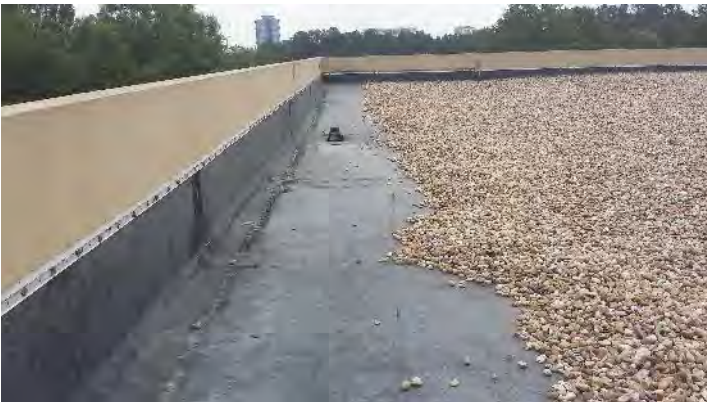
Insufficient ballast was observed in localized  
locations.

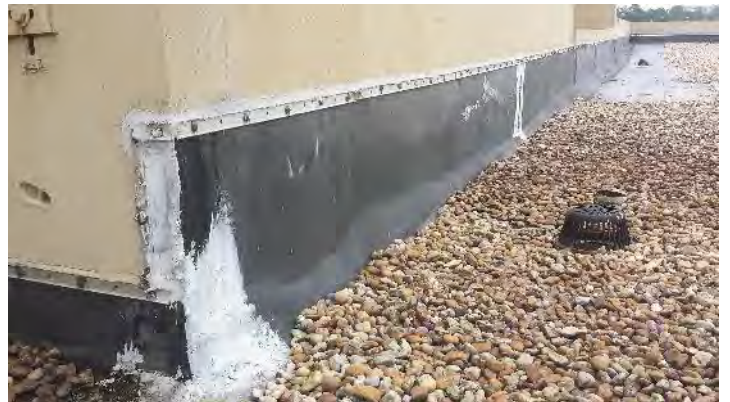
Termination bar was observed to have multiple  
inconsistent types of sealants.

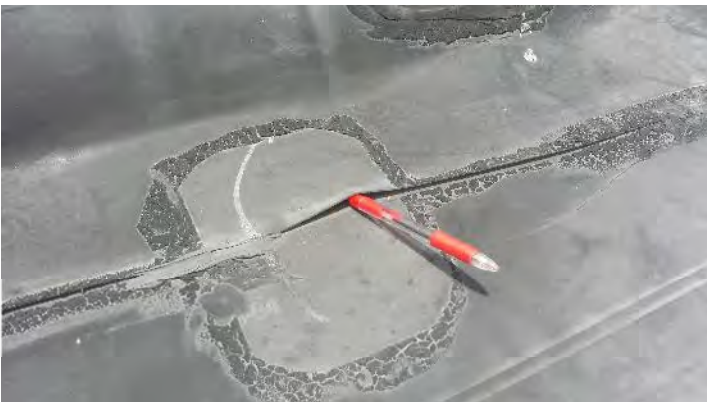
Membrane seam lap sealant is deteriorated or open  
at base flashings.

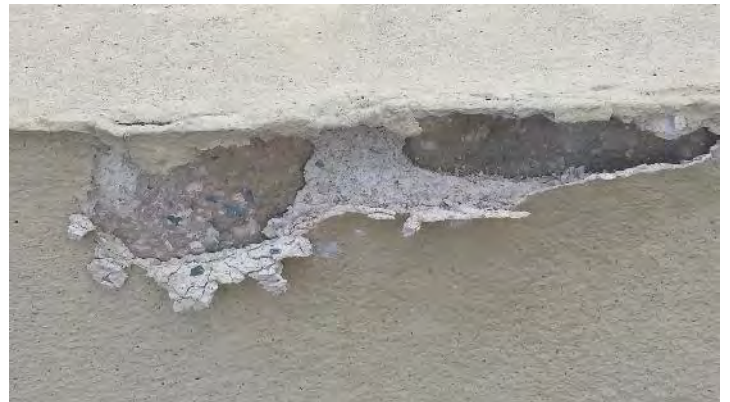
Moisture intrusion was observed between cast  
parapet wall and cementitious coating on south  
elevation.

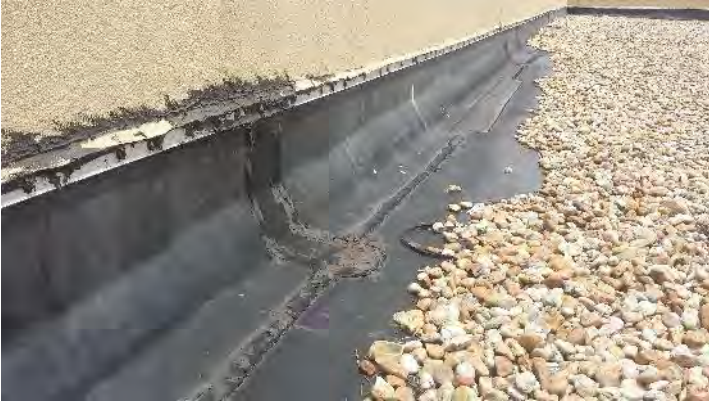
Many repairs observed were done with improper material. As a result, these repairs are failing.

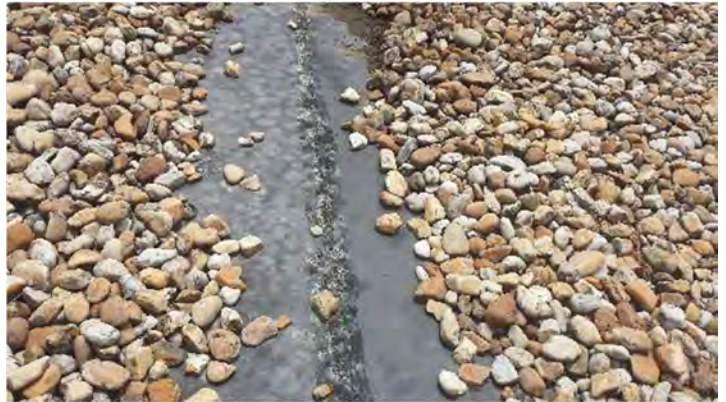
Field lap sealants and adhesives are deteriorating.

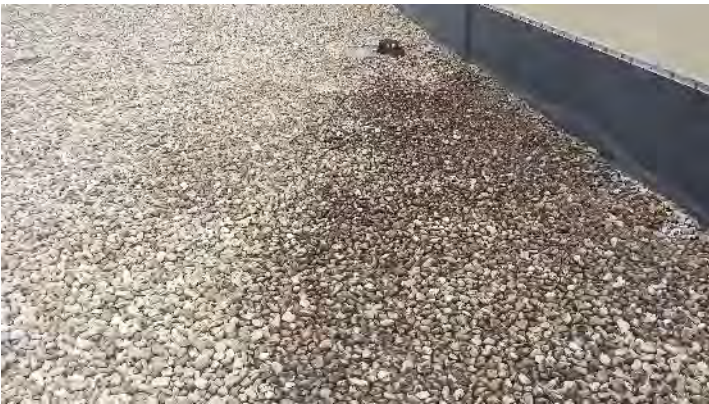
Evidence of red algae growth, in the ballast, at some locations. This may be a result of the roof drain not set low enough to function properly.

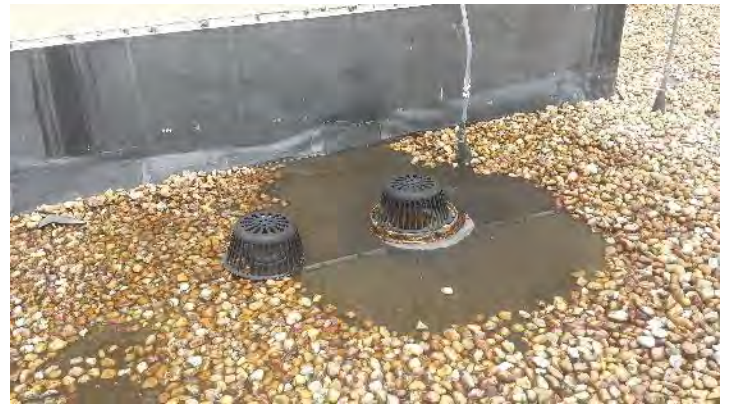
Standing water was observed in many locations.

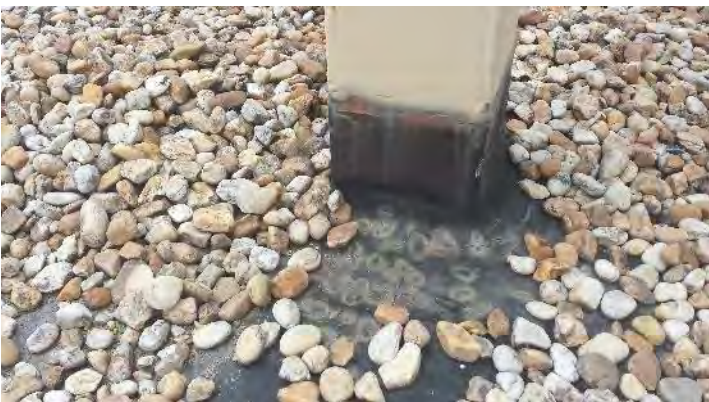
Structural supports on east elevation lacks appropriate membrane joint.

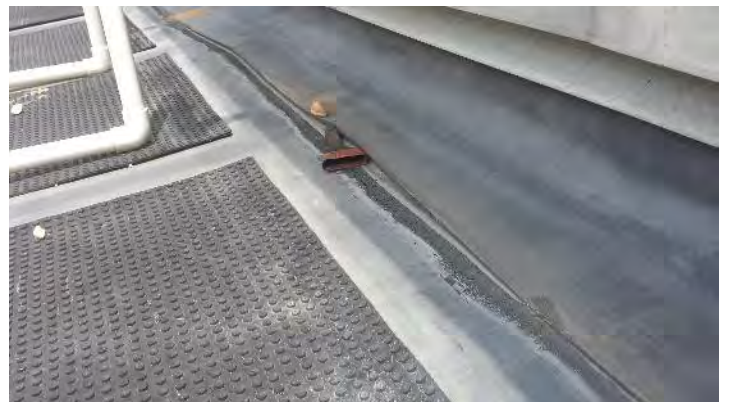
Base flashing membrane seams, at curb penetrations, exhibit deterioration. A curb base flashing was observed deteriorated with active water intrusion observed.

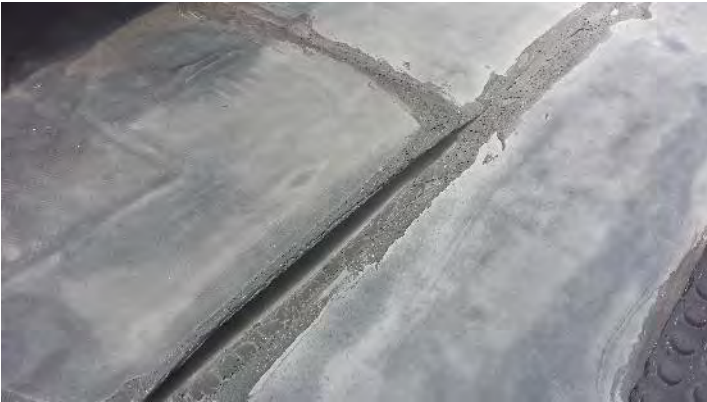
Repairs at base flashing done with improper materials

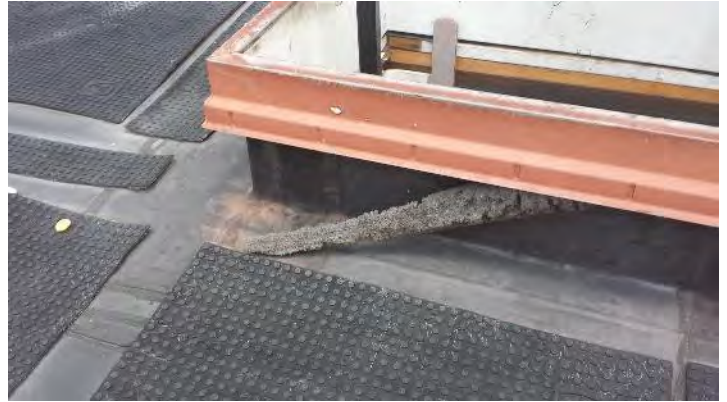
Foam material termination at roof hatch is loose and deteriorated.

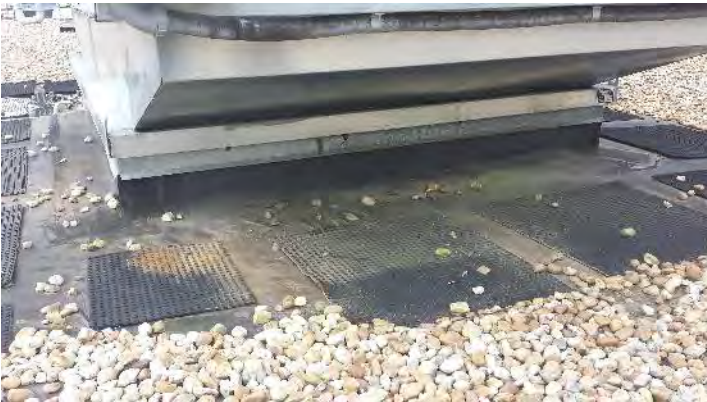
Deterioration of membrane integrity, likely caused by petroleum based fluid spill, was observed at an HVAC

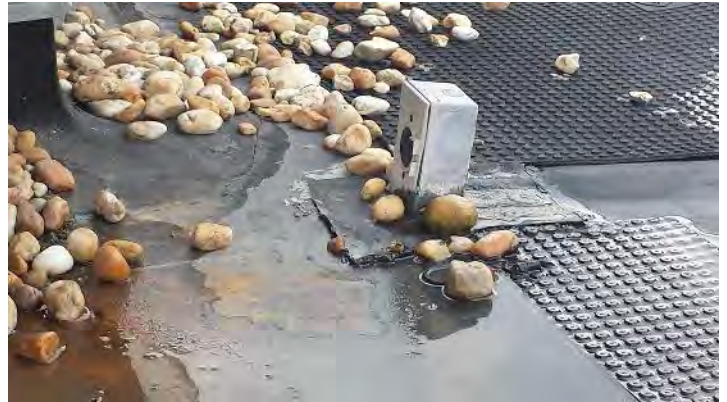
Standing water was present at various locations at HVAC flashing.
