Addendum Report of Comprehensive Asbestos Survey

Theatre Building

Brook Run Park

Geo-Hydro Project Number 150114.30

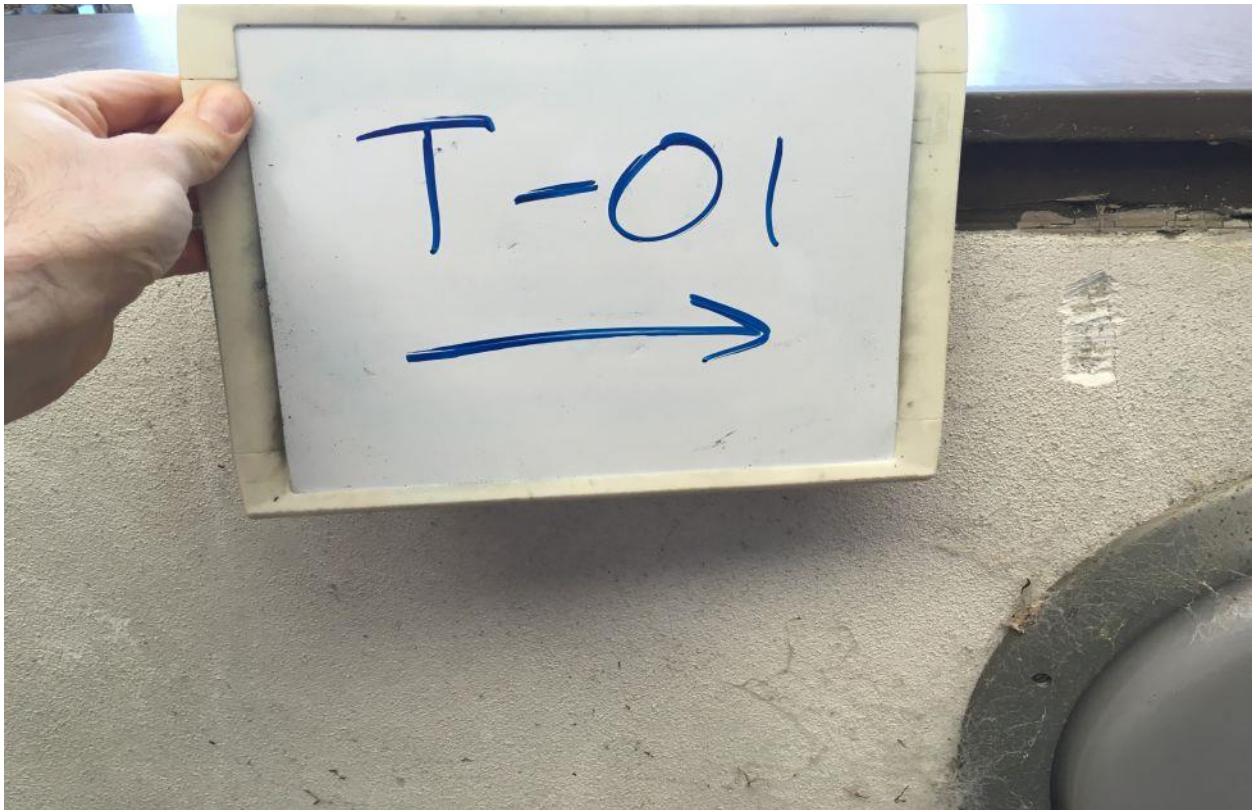
Plate 1: Laboratory analyses did not detect asbestos minerals within the skim coat T-01 sample collected from the north side lobby entrance overhang of the Theatre Building.

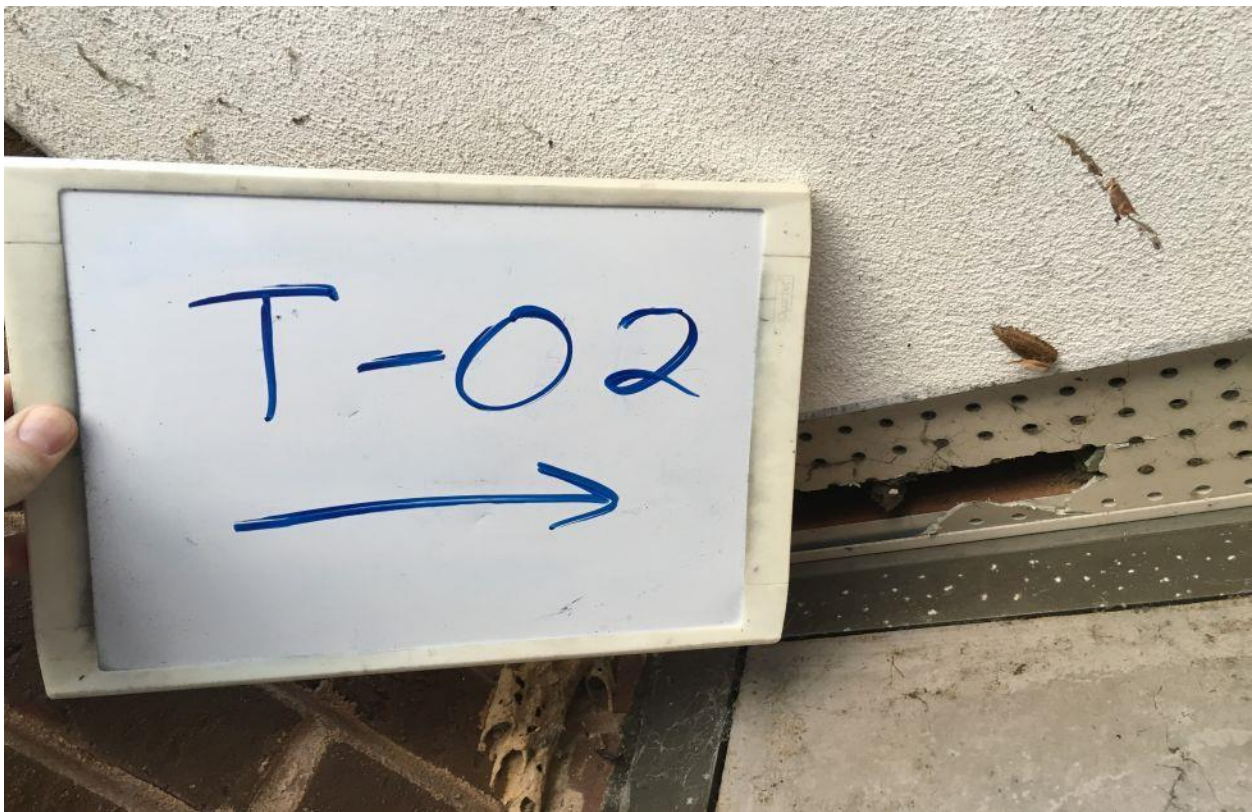
Transite Ceiling Tiles: Laboratory analysis detected 20% chrysotile asbestos in samples T-02 and T-04, of the grey, perforated transite ceiling tiles located on the entrance and window overhangs around the outside of the theatre building. The transite ceiling tiles are a Category I non-friable ACM as long as the transite ceiling tiles are removed using methods that will not cause the transite ceiling tiles to become friable. Approximately 400 square feet of transite ceiling tiles were observed on the entrance and window overhangs around the outside of the theatre building

Plate 2: Laboratory analyses detected 20% chrysotile asbestos within transite ceiling tile sample T-02 collected from the north side lobby entrance overhang of the Theatre Building.

Prior to renovation or demolition, a licensed asbestos abatement contractor should remove and dispose of the asbestos-containing materials identified by this report. Georgia EPD requires notifications for demolition of ACMs encompassing 10 or more square feet. Additionally, ACMs encompassing at least 10 square feet are regulated by the U.S. Environmental Protection Agency (USEPA) under the National Emission Standards for Hazardous Air Pollutants (NESHAP) and also by the Occupational Safety and Health Administration (OSHA) under its worker protection regulations. These regulations require special handling and disposal procedures when asbestos containing materials are disturbed.

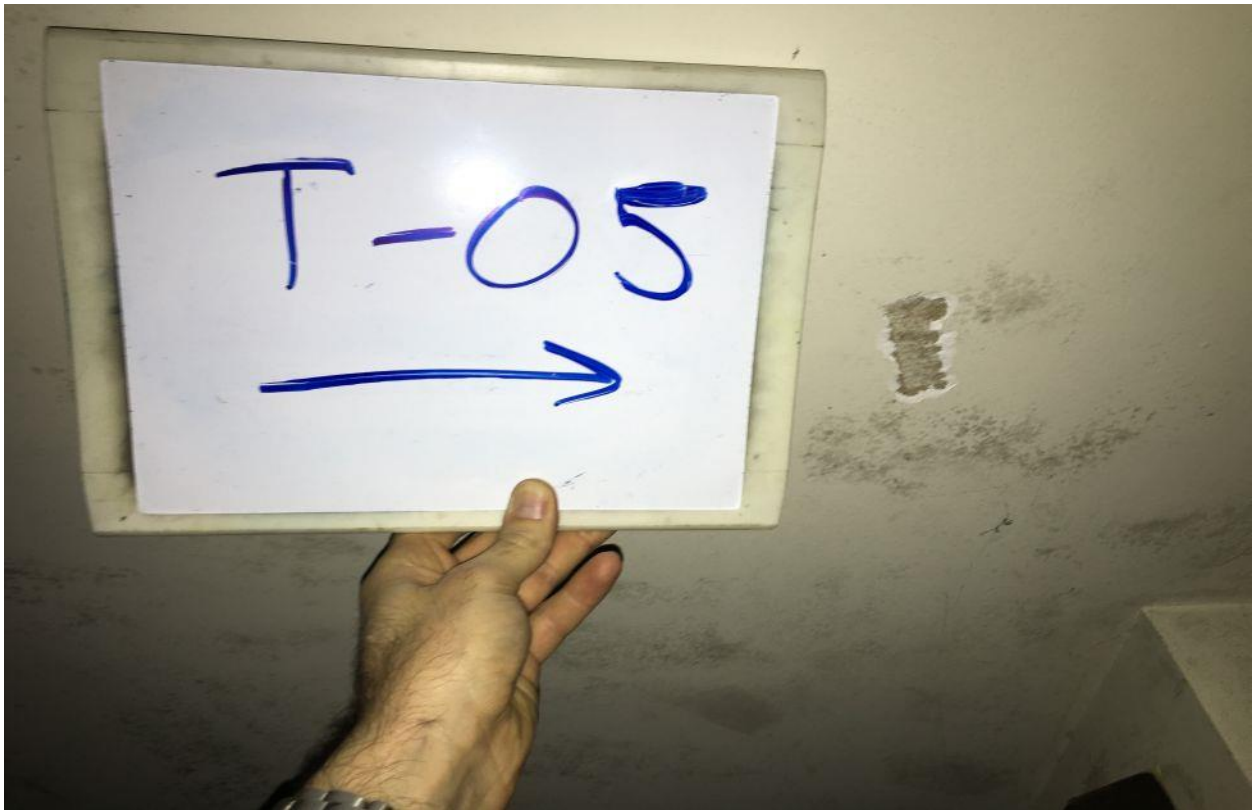
Plate 5: Laboratory analyses did not detect asbestos minerals within the skim coat T-05 sample collected from the auditorium ceiling of the Theatre Building.

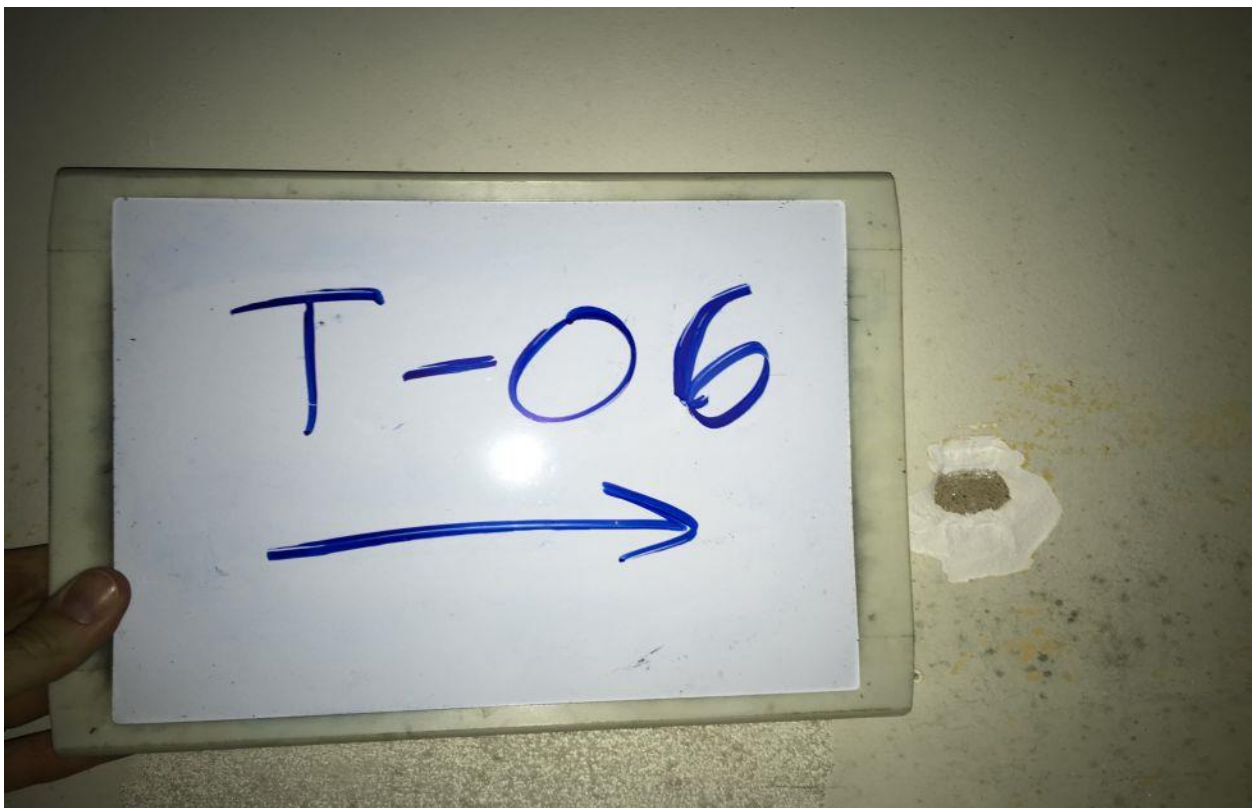
Plate 6: Laboratory analyses did not detect asbestos minerals within the skim coat T-06 sample collected from the auditorium wall of the Theatre Building.

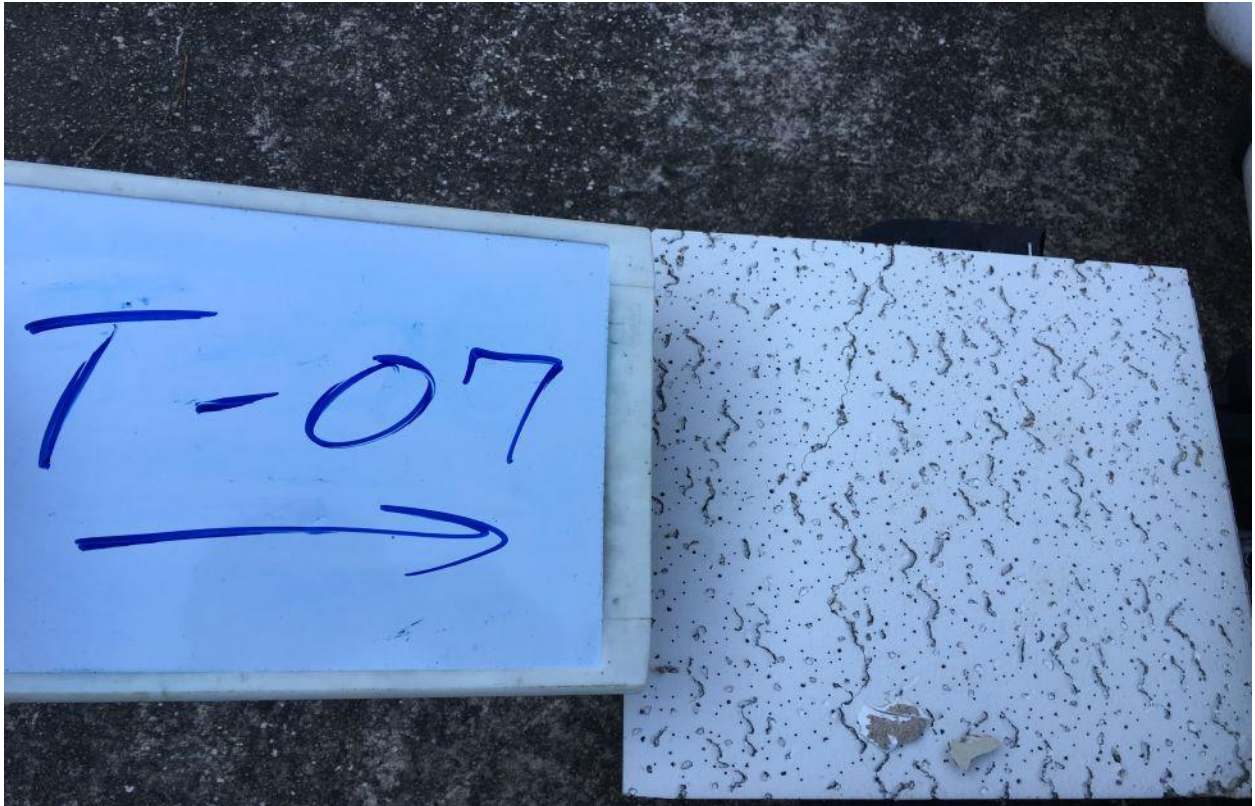
White (12-Inch Square) Ceiling Tile: Laboratory analysis detected 3% amosite asbestos in samples T-07 and T-08 of the white, 12-inch square ceiling tile. The white, 12-inch square ceiling tile are a Category I non-friable ACM as long as the white, 12-inch square ceiling tile are removed using methods that will not cause the white, 12-inch square ceiling tile to become friable. Approximately 2,700 square feet of white, 12-inch square ceiling tile was observed in the chapel room and gym room of the theatre building.

Plate 7: Laboratory analyses detected 3% chrysotile asbestos within 12"x12" ceiling tile sample T-07 collected from the chapel room of the Theatre Building.

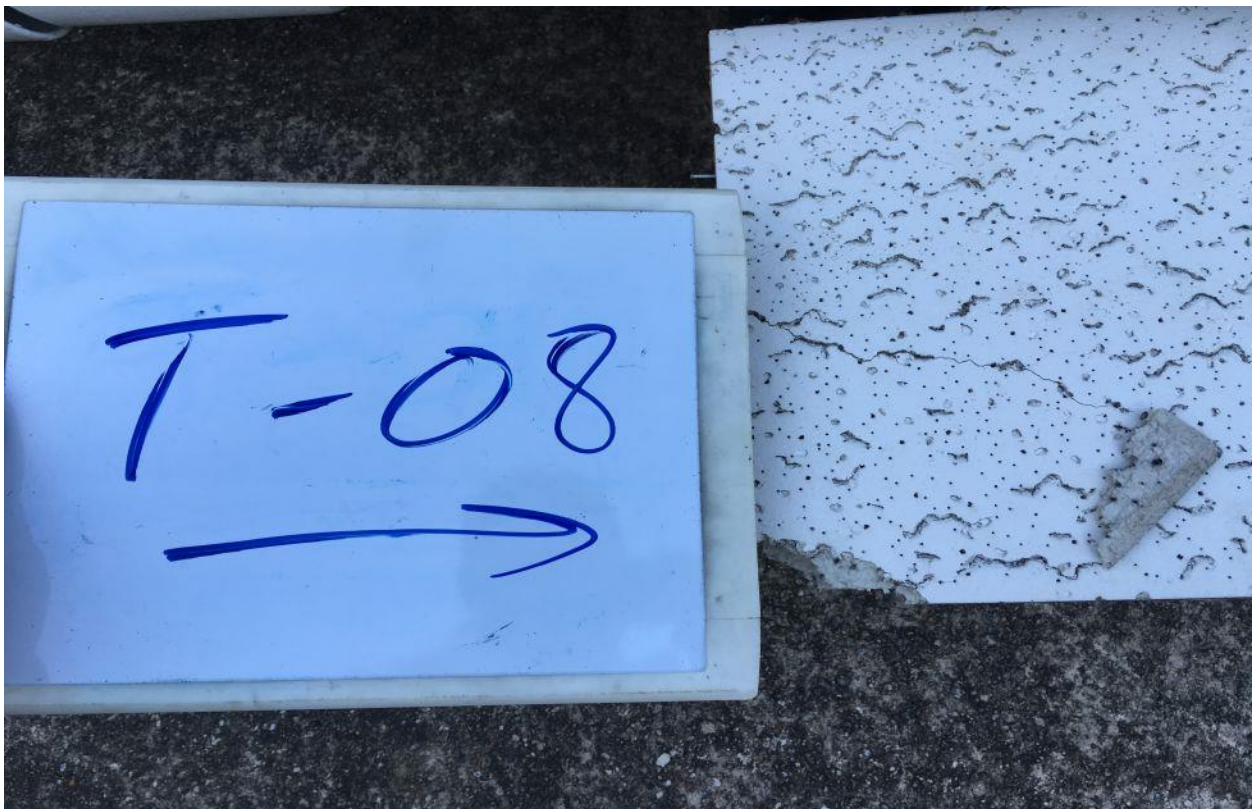
Plate 8: Laboratory analyses detected 3% chrysotile asbestos within 12"x12" ceiling tile sample T-08 collected from the gym room of the Theatre Building.

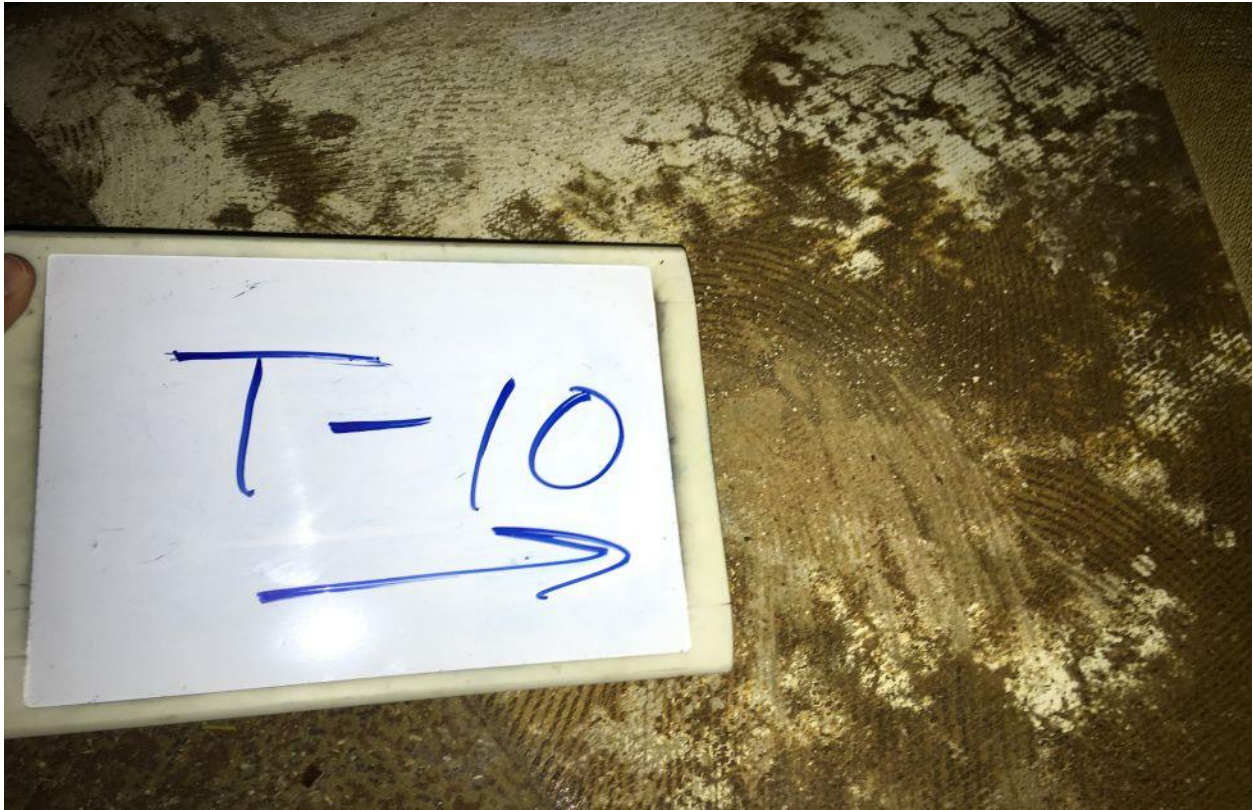
Glue Under Carpet: Laboratory analysis detected 2% chrysotile asbestos in samples T-10 and T-11 and of the glue under the carpet located auditorium and the chapel room of the theatre building. The glue system is a Regulated Asbestos Containing Material (RACM). Approximately 8,000 square feet of carpet with this glue underneath was observed in the auditorium and chapel room.

Plate 10: Laboratory analyses detected 2% chrysotile asbestos within the glue T-10 sample collected from the underneath the carpet in the auditorium of the Theatre Building.

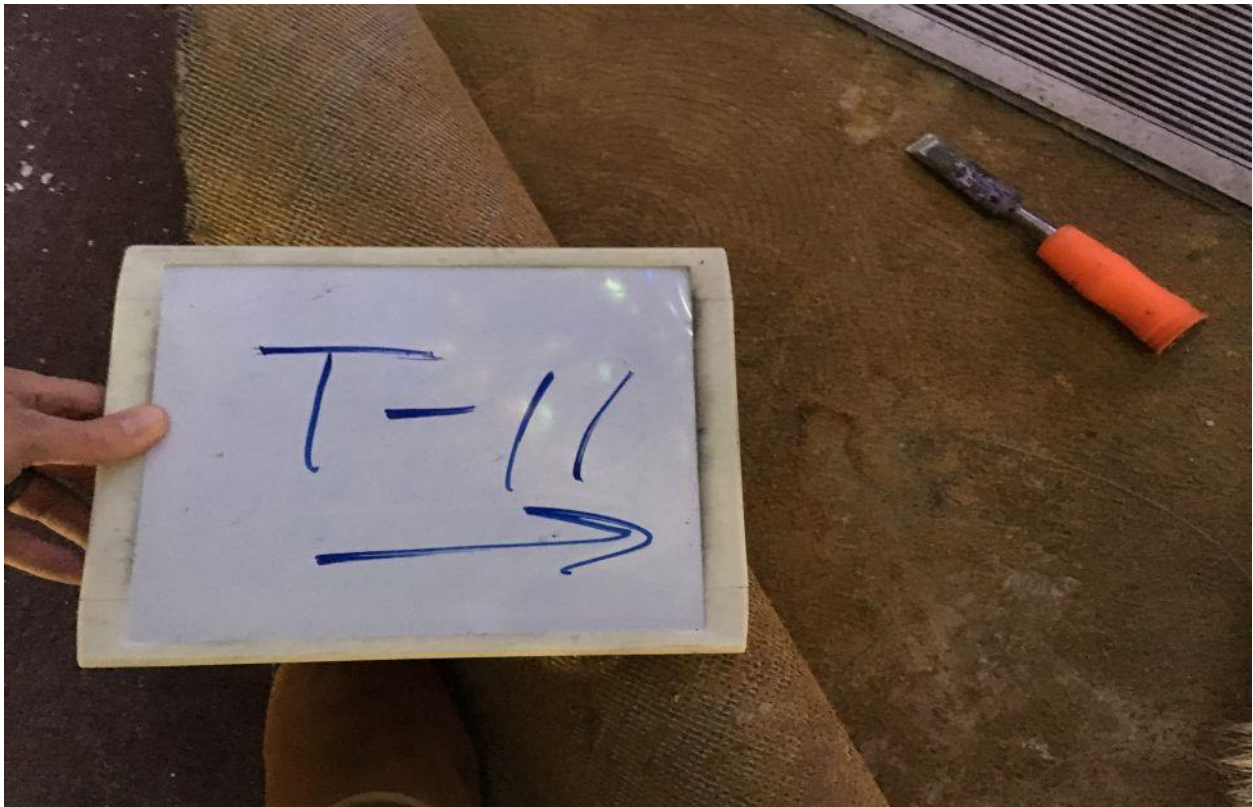
Plate 11: Laboratory analyses detected 2% chrysotile asbestos within the glue T-11 sample collected from the underneath the carpet in the chapel room of the Theatre Building.

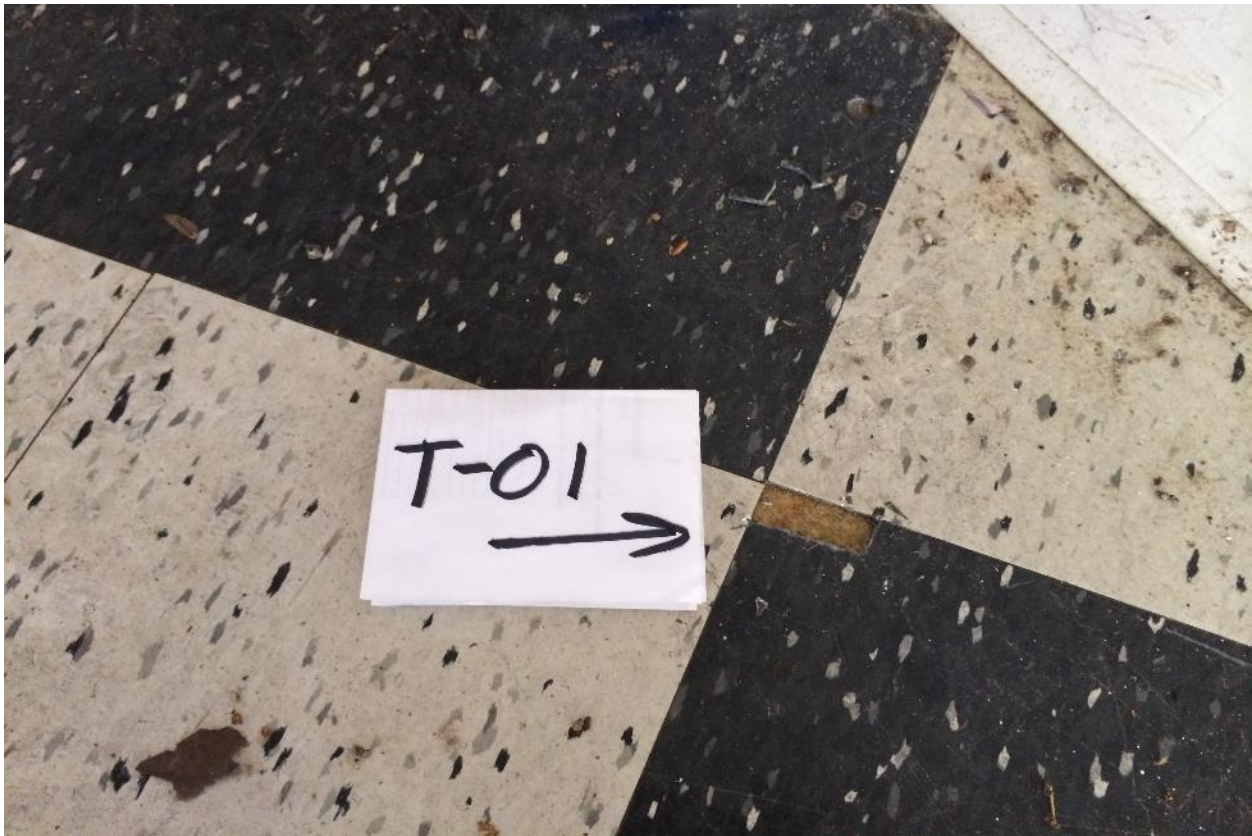
Mastic Under Black and White (12-Inch Square) Floor Tile: Laboratory analysis detected 5%, 3%, 2%, and 2% chrysotile asbestos in samples TS-01 through TS-04, respectively, of the black and white, 12-inch square floor tile mastic. The floor tile system is a Category I non-friable ACM as long as the floor tile system is removed using methods that will not cause the floor tile system to be friable. Approximately 1,300 square feet of black and white, 12-inch square floor tile were observed in the front lobby area of the theatre building.

Plate 52: Laboratory analyses did not detect asbestos minerals within the black floor tile from sample TS-01 but did detect 5% chrysotile asbestos in the mastic from sample TS-01 collected from the Theatre Building lobby area.

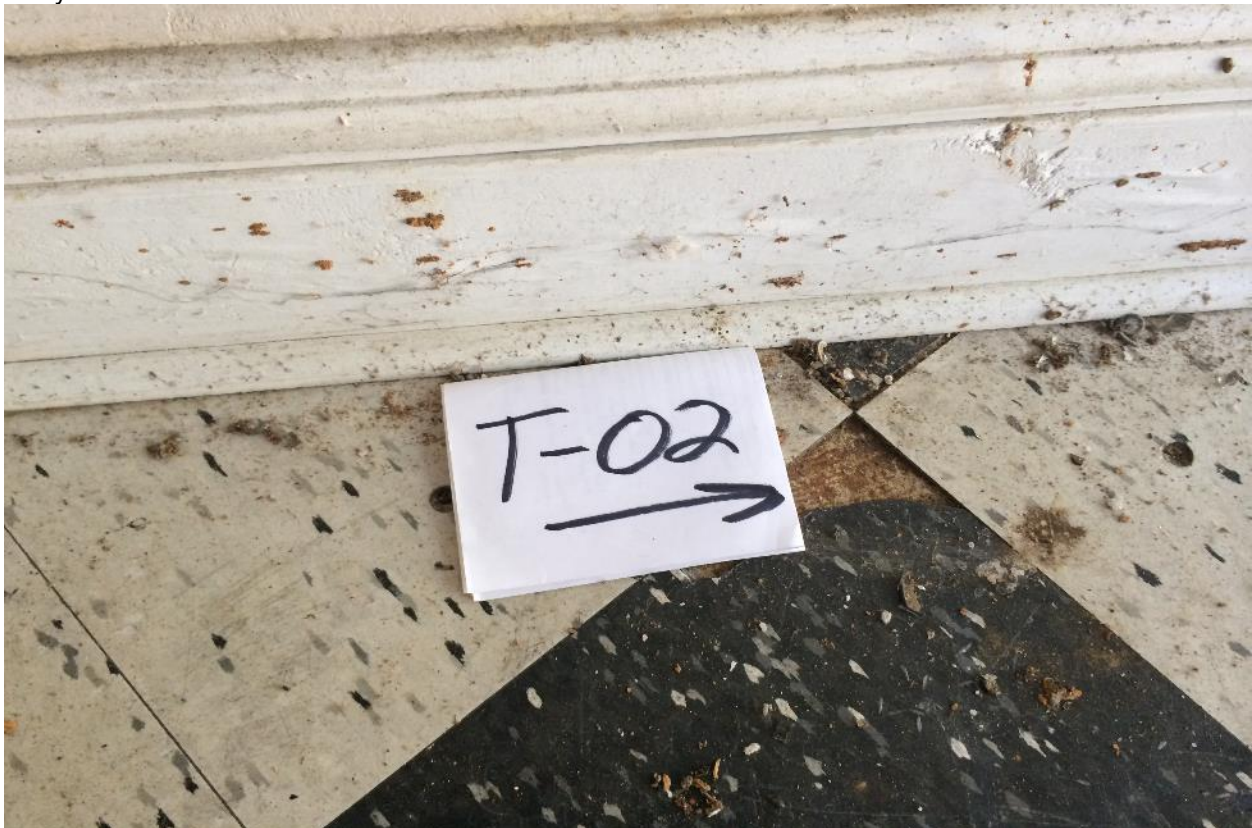
Plate 53: Laboratory analyses did not detect asbestos minerals within the black floor tile from sample TS-02 but did detect 5% chrysotile asbestos in the mastic from sample TS-02 collected from the Theatre Building lobby area.

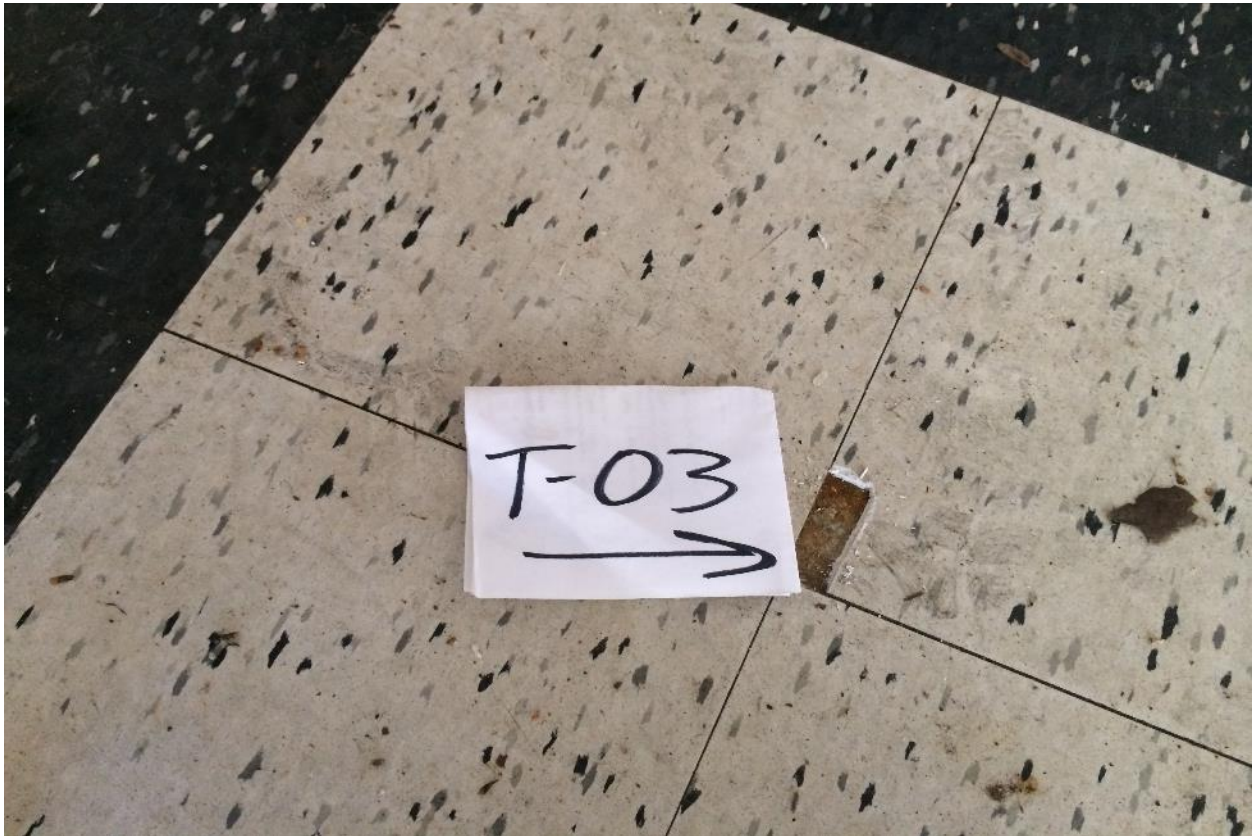
Plate 54: Laboratory analyses did not detect asbestos minerals within the white floor tile from sample TS-03 but did detect 5% chrysotile asbestos in the mastic from sample TS-03 collected from the Theatre Building lobby area.

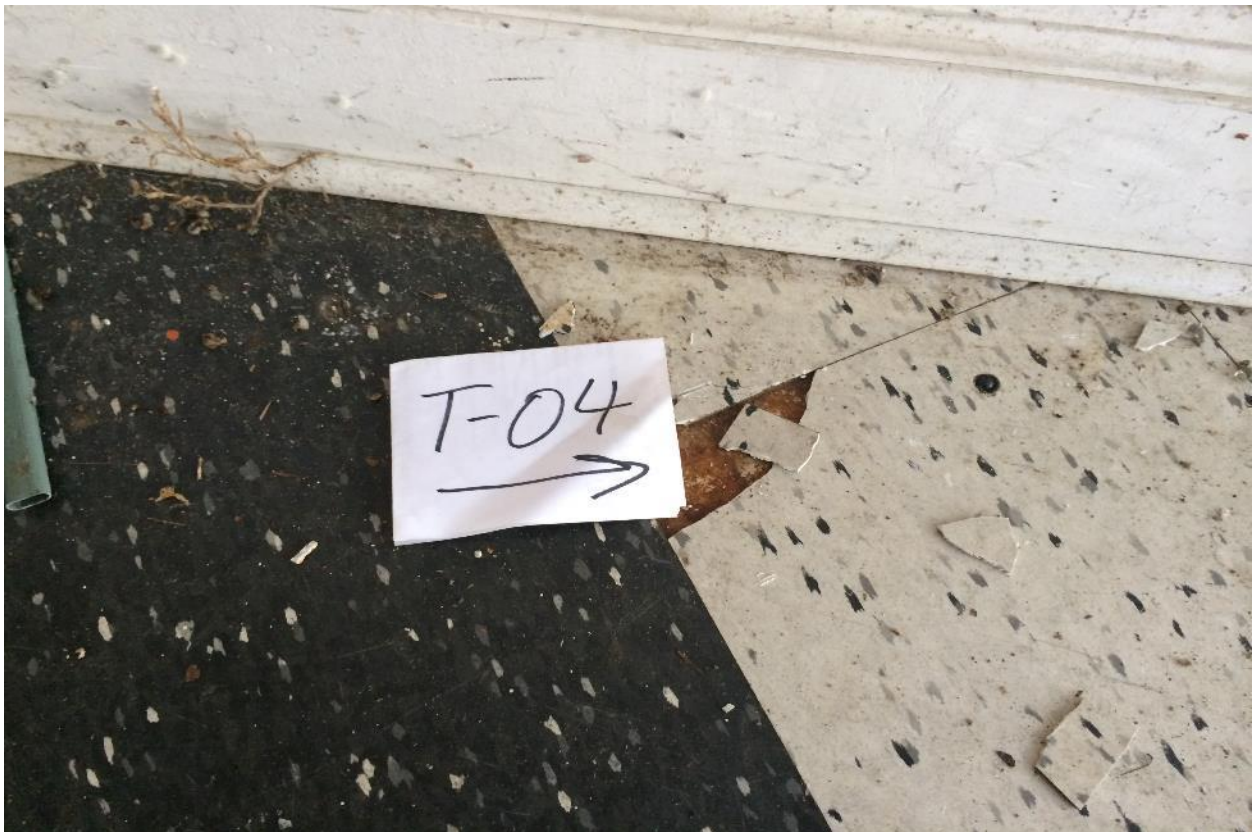
Plate 55: Laboratory analyses did not detect asbestos minerals within the white floor tile from sample TS-04 but did detect 5% chrysotile asbestos in the mastic from sample TS-04 collected from the Theatre Building lobby area.

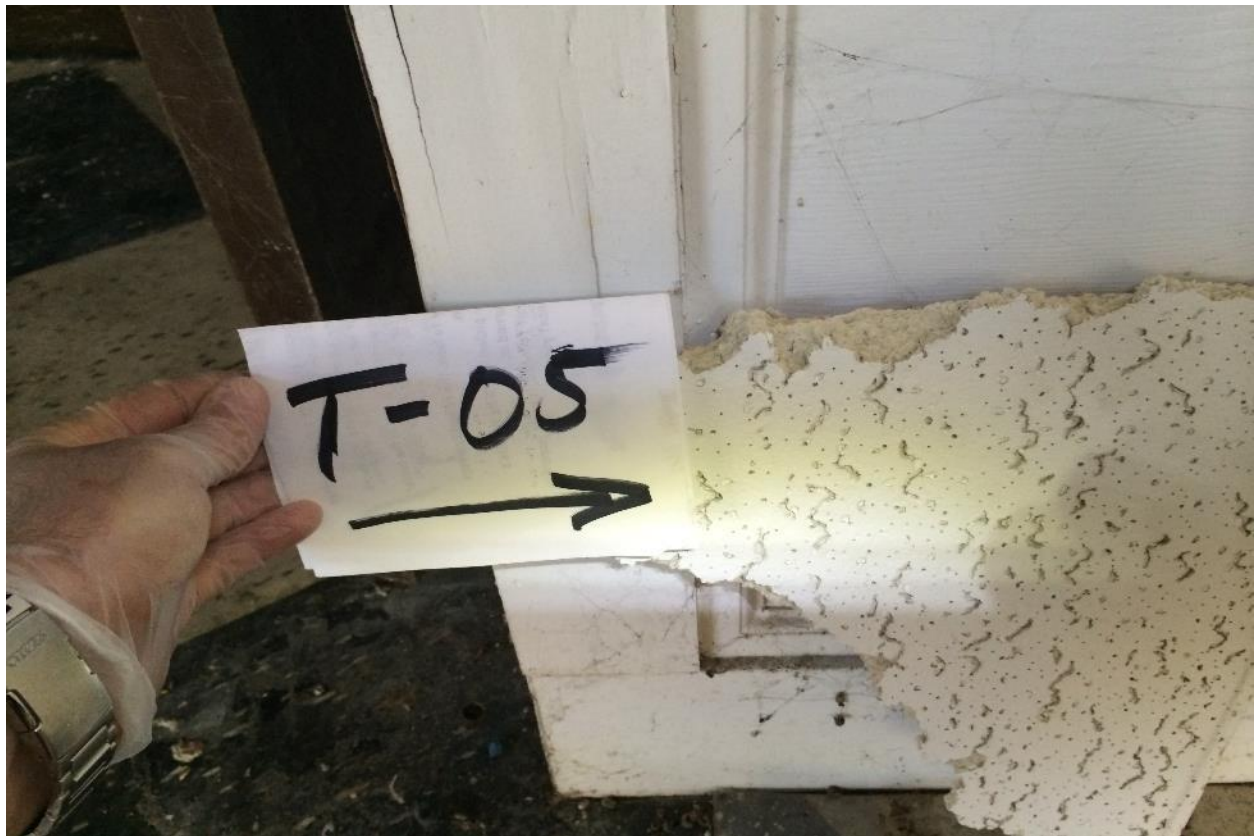
White (24-Inch Square) Ceiling Tile: Laboratory analysis detected 2% amosite asbestos in samples TS-05 and TS-06 of the ceiling tile. The ceiling tile system is a Category I non-friable ACM as long as the ceiling tile system is removed using methods that will not cause the ceiling tile system to be friable. Approximately 5,000 square feet of 24-inch square ceiling tile were observed throughout the main floor of the theatre building. An additional 2,700 square feet of 12-inch square ceiling tile were observed in the chapel room and gym room of the theatre building. Although a sample of this 12-inch square ceiling tile was not collected, it is the same 12-inch square ceiling tile that was observed in the administrative buildings and found to contain 2% chrysotile asbestos and 2% amosite asbestos. It is the opinion of Geo-Hydro that all 12-inch square ceiling tile in the Theatre Building be treated as an ACM.

Plate 56: Laboratory analyses detected 2% chrysotile asbestos within suspended ceiling tile sample TS-05 collected from the Theatre Building lobby area.

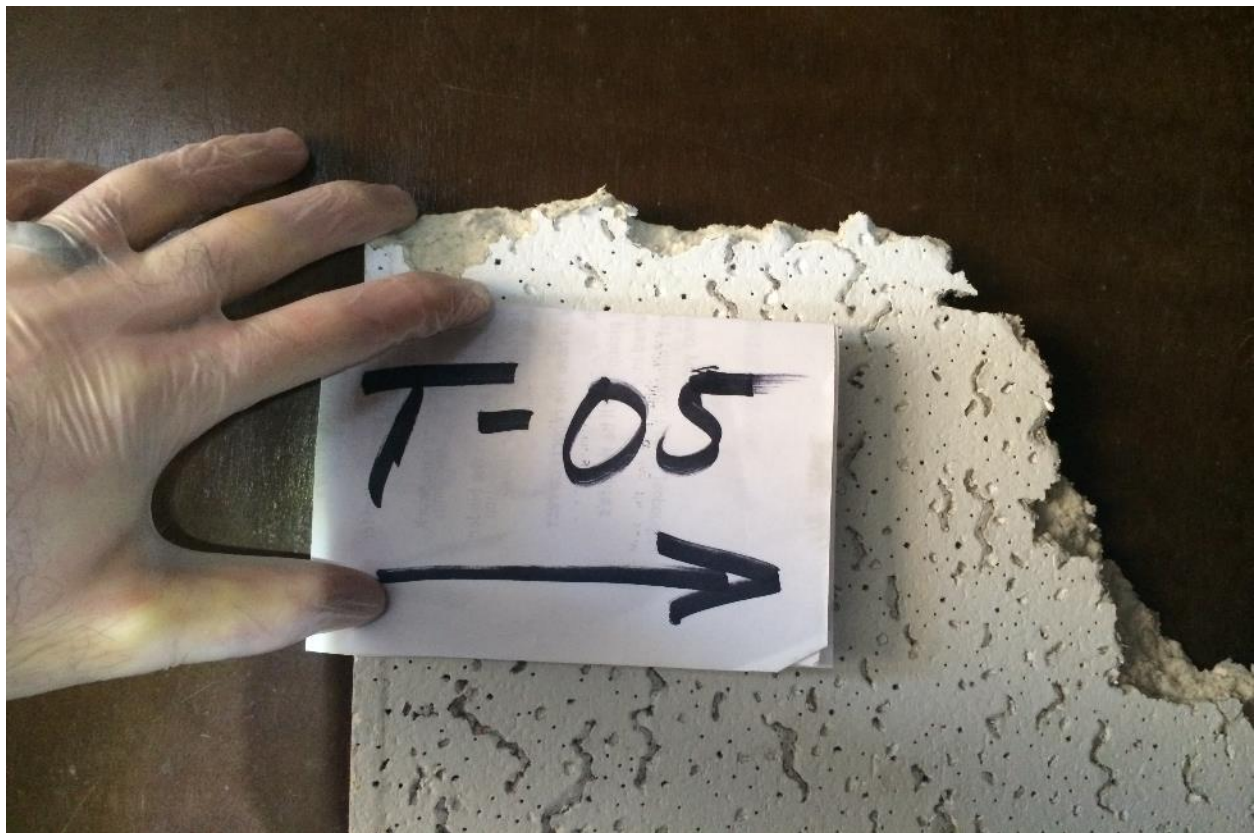
Plate 57: Laboratory analyses detected 2% chrysotile asbestos within suspended ceiling tile sample TS-06 collected from the Theatre Building hallway (sample should be labeled TS-06).

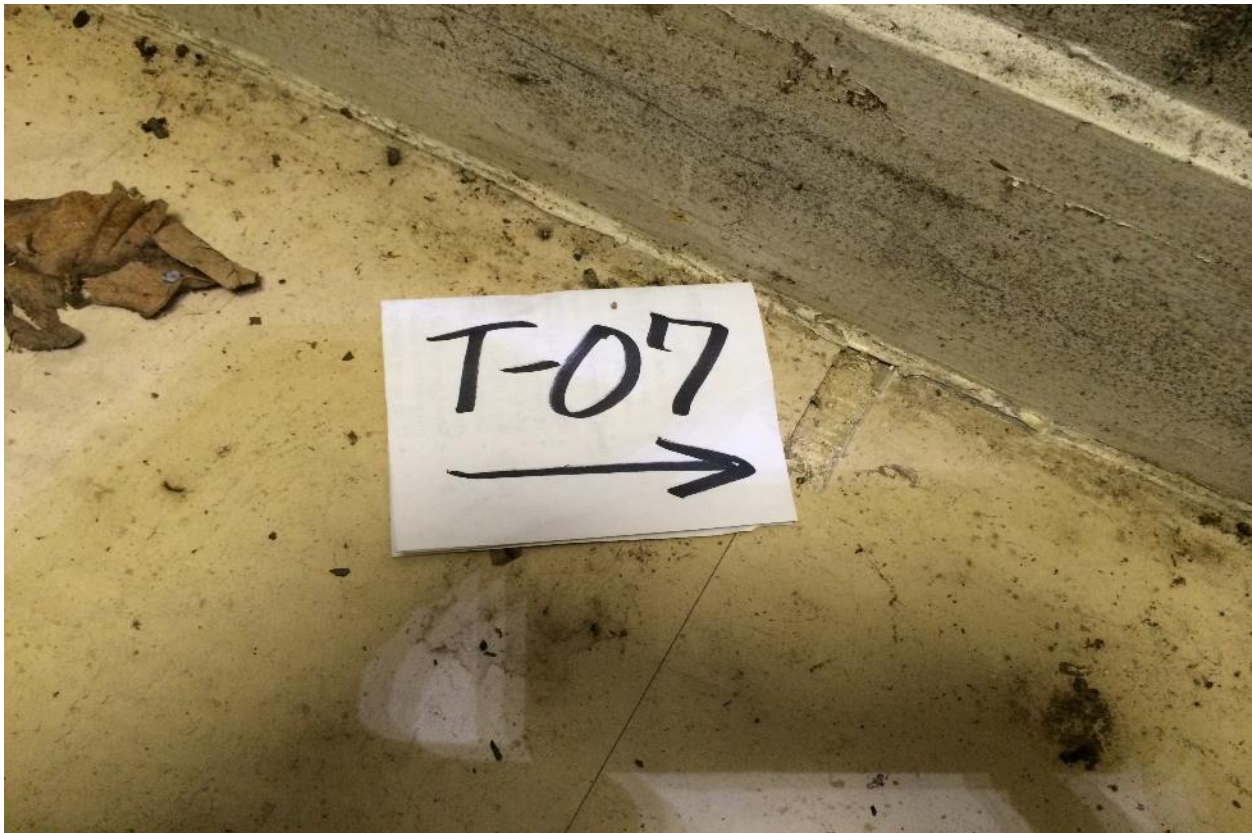
Plate 58: Laboratory analyses did not detect asbestos minerals within the beige floor tile or mastic sample TS-07 collected from the Theatre Building hallway.

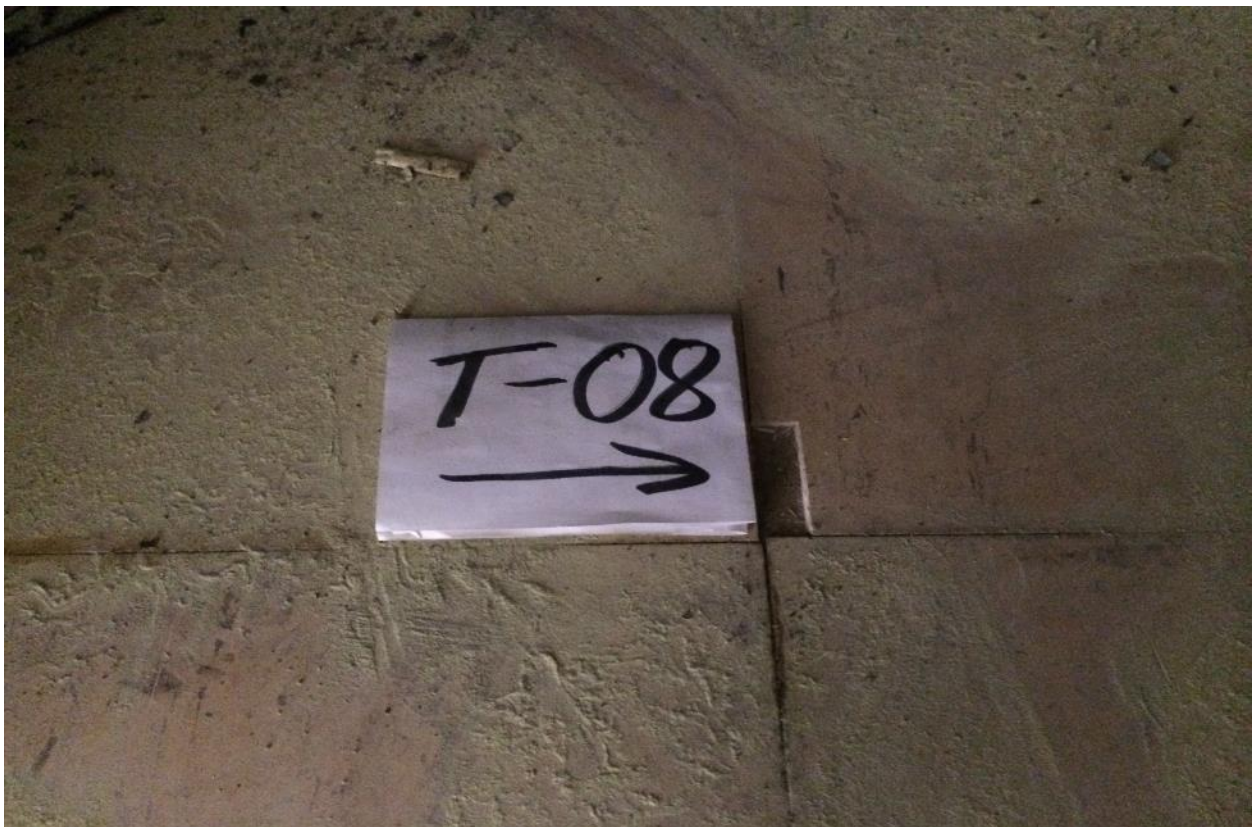
Plate 59: Laboratory analyses did not detect asbestos minerals within the beige floor tile or mastic sample TS-08 collected from the Theatre Building lobby storage room.

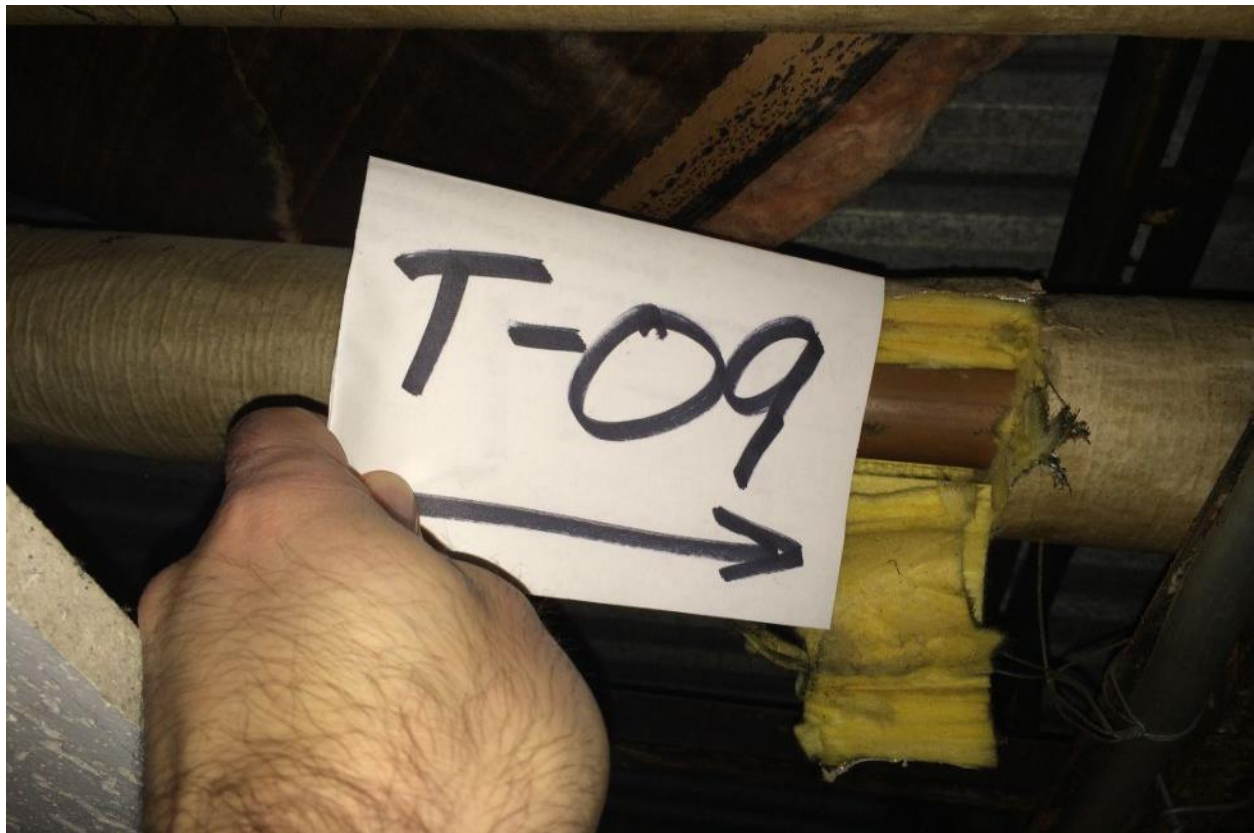
Plate 60: Laboratory analyses did not detect asbestos minerals within plumbing insulation sample TS-09 collected from the Theatre Building lobby ceiling.

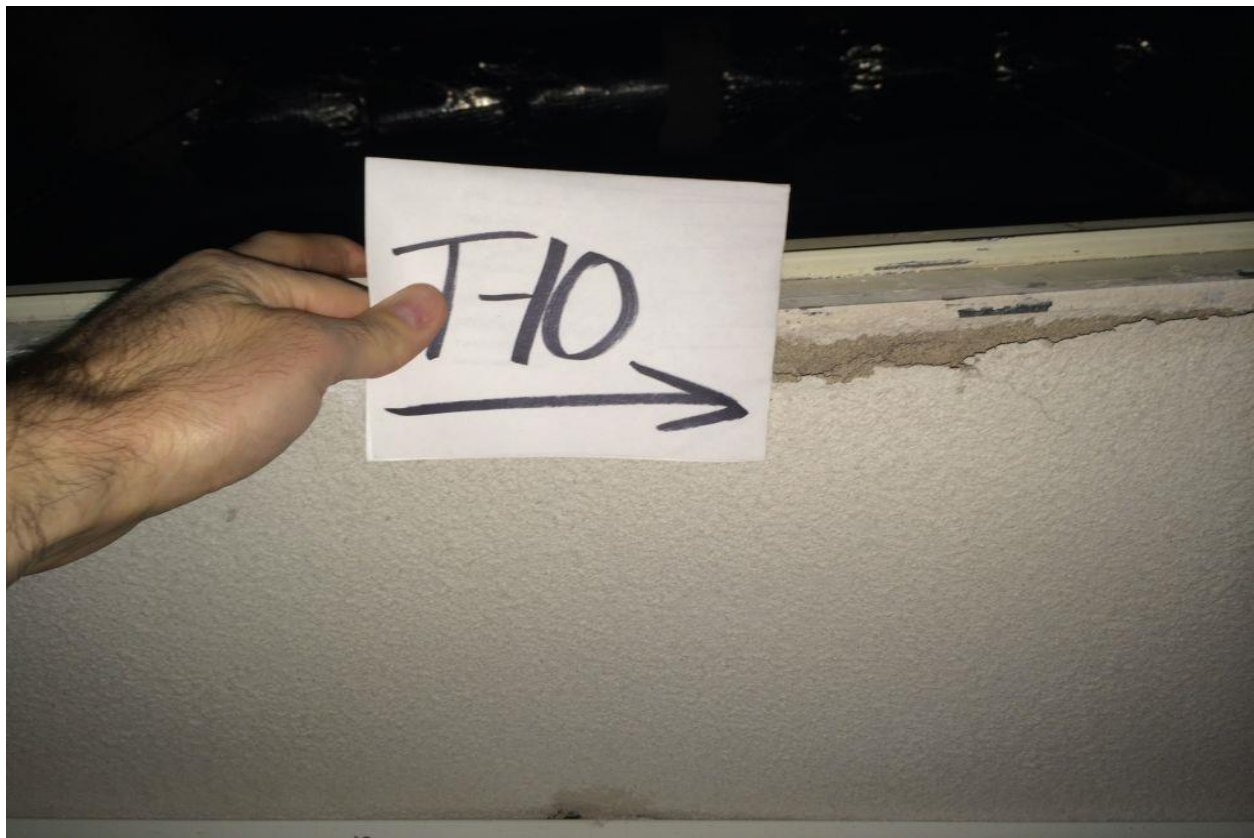
Spray on Surfacing Material: Laboratory analysis detected 20% chrysotile asbestos in samples TS-10 and TS-11 and TS-14 through TS-18 of the gray spray on surfacing material located on the structural steel in the basement and on the ceiling of the upstairs projection room of the theatre building. The surfacing material system is a Regulated Asbestos Containing Material (RACM). All of the structural steel in the basement and approximately 650 square feet of ceiling area in the upstairs projection room of the theatre of the theatre building contain the surfacing material. It is likely that additional structural members that are coated with the surfacing material will be uncovered during demolition.

Plate 61: Laboratory analyses detected 20% chrysotile asbestos within spray on surfacing material sample TS-10 collected from the Theatre Building upstairs projection room ceiling.

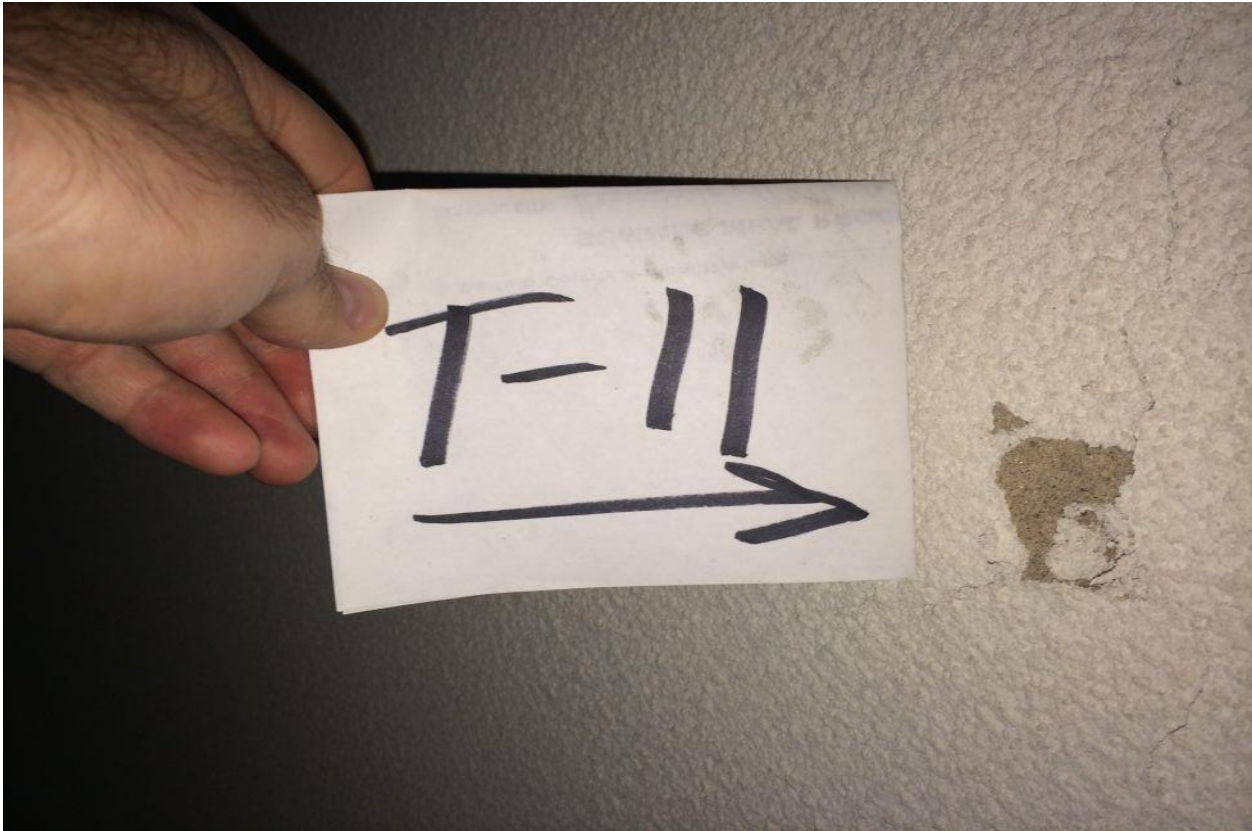
Plate 62: Laboratory analyses detected 20% chrysotile asbestos within spray on surfacing material sample TS-11 collected from the Theatre Building upstairs projection room ceiling.

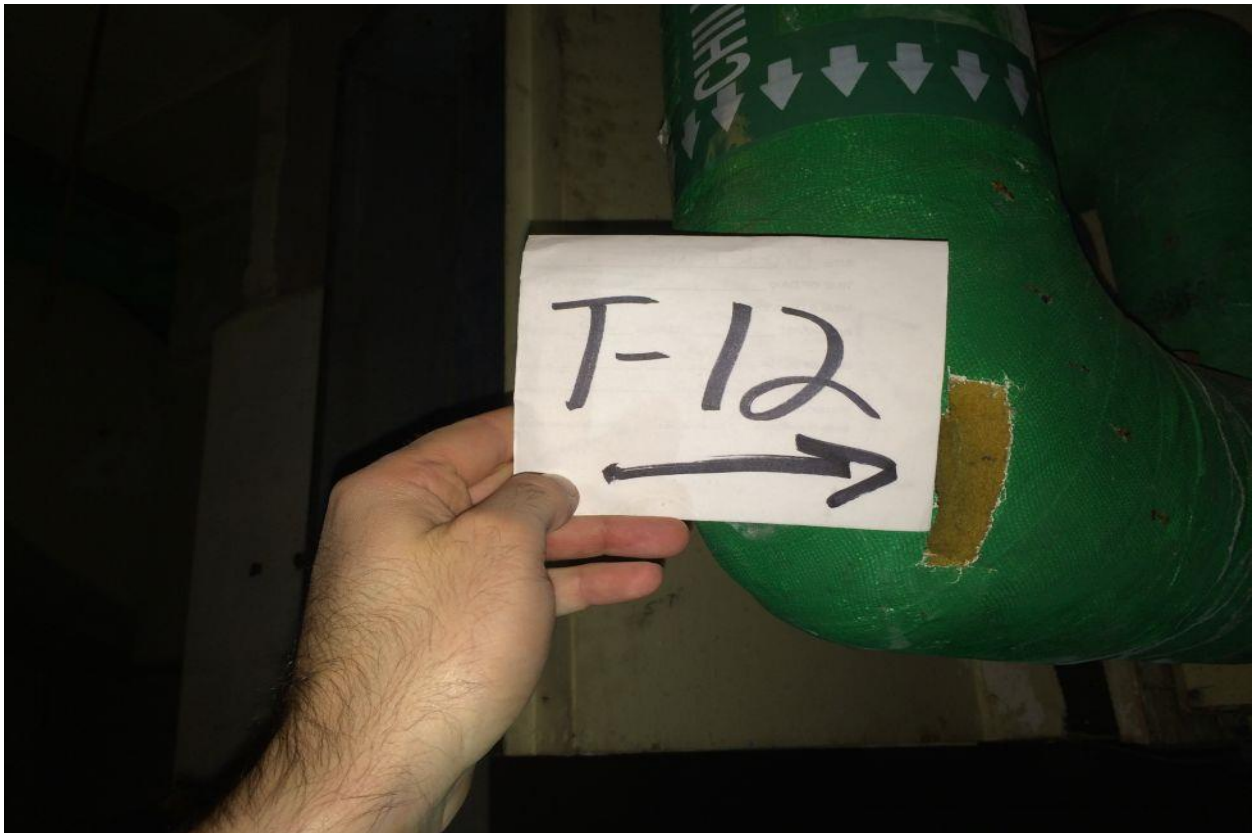
Plate 63: Laboratory analyses did not detect asbestos minerals within plumbing insulation sample TS-12 collected from the Theatre Building basement boiler room.
