Addendum Report of Comprehensive Asbestos Survey

Theatre Building

Brook Run Park

Geo-Hydro Project Number 150114.30

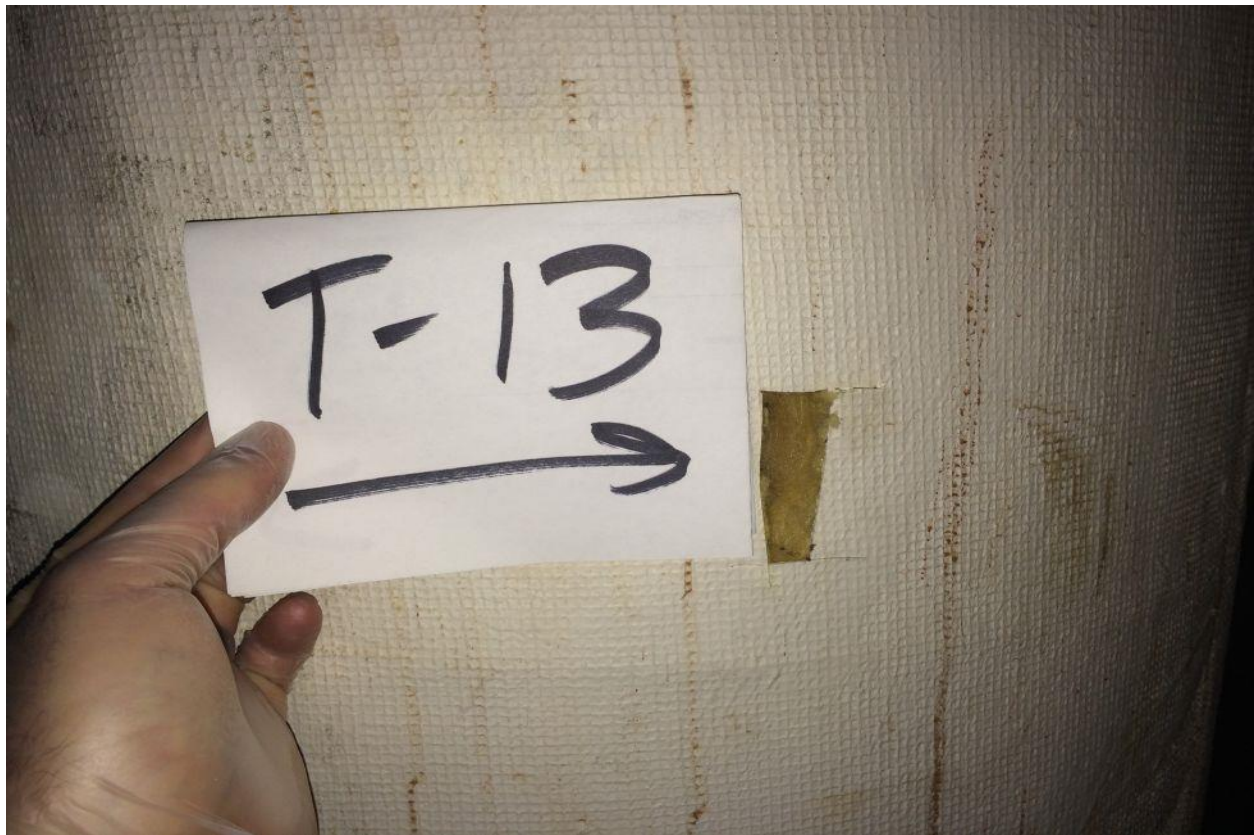
Plate 64: Laboratory analyses did not detect asbestos minerals within boiler wrap insulation sample TS-13 collected from the Theatre Building basement boiler room.

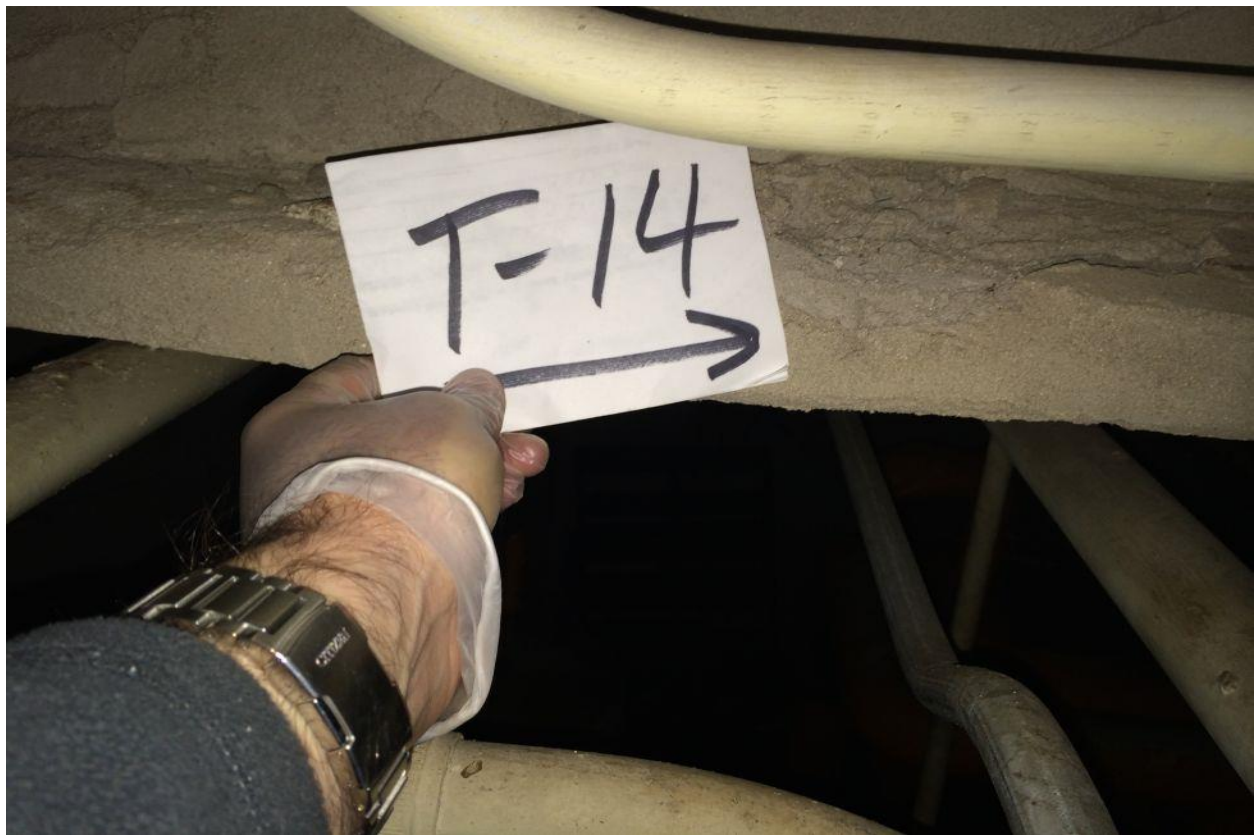
Spray on Surfacing Material: Laboratory analysis detected 20% chrysotile asbestos in samples TS-10 and TS-11 and TS-14 through TS-18 of the gray spray on surfacing material located on the structural steel in the basement and on the ceiling of the upstairs projection room of the theatre building. The surfacing material system is a Regulated Asbestos Containing Material (RACM). All of the structural steel in the basement and approximately 650 square feet of ceiling area in the upstairs projection room of the theatre of the theatre building contain the surfacing material. It is likely that additional structural members that are coated with the surfacing material will be uncovered during demolition.

Plate 65: Laboratory analyses detected 20% chrysotile asbestos within spray on surfacing material sample TS-14 collected from the Theatre Building basement structural steel.

Prior to renovation or demolition, a licensed asbestos abatement contractor should remove and dispose of the asbestos-containing materials identified by this report. Georgia EPD requires notifications for demolition of ACMs encompassing 10 or more square feet. Additionally, ACMs encompassing at least 10 square feet are regulated by the U.S. Environmental Protection Agency (USEPA) under the National Emission Standards for Hazardous Air Pollutants (NESHAP) and also by the Occupational Safety and Health Administration (OSHA) under its worker protection regulations. These regulations require special handling and disposal procedures when asbestos containing materials are disturbed.

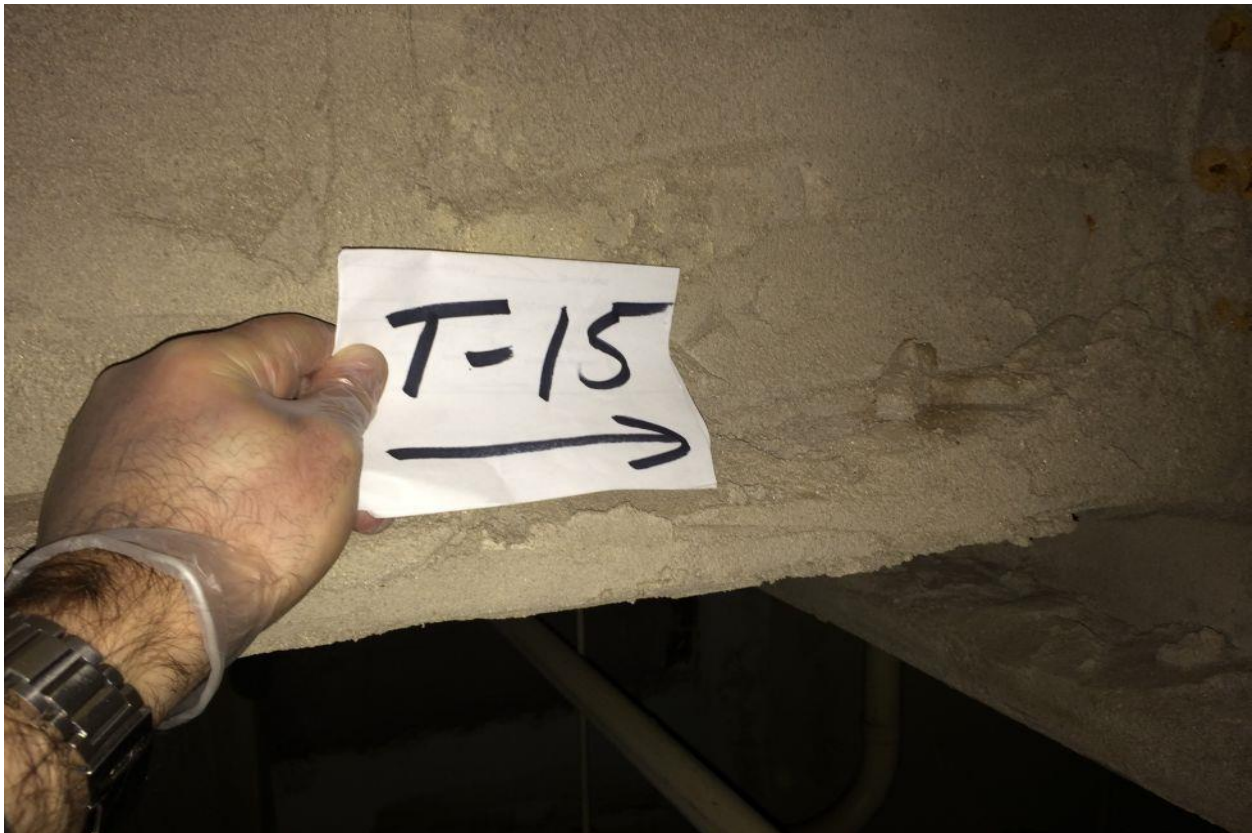
Plate 66: Laboratory analyses detected 20% chrysotile asbestos within spray on surfacing material sample TS-15 collected from the Theatre Building basement structural steel.

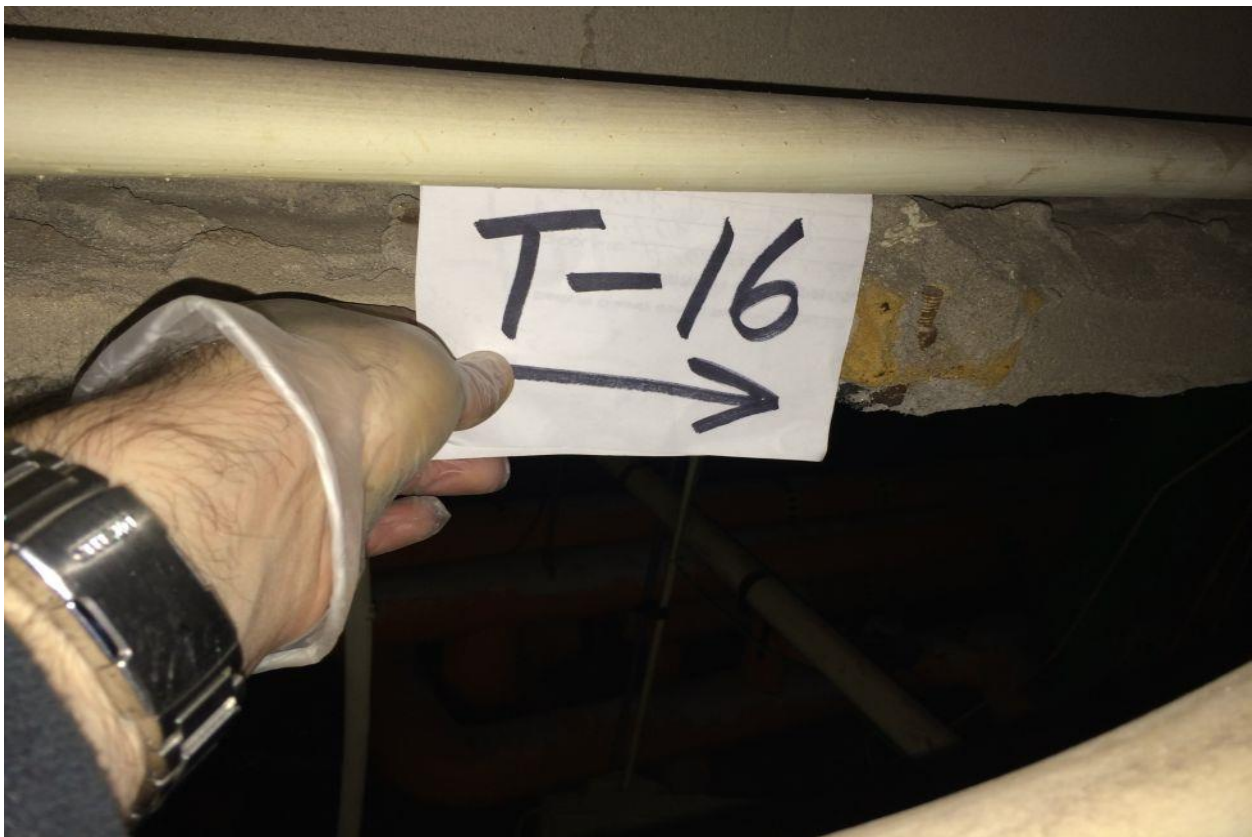
Plate 67: Laboratory analyses detected 20% chrysotile asbestos within spray on surfacing material sample TS-16 collected from the Theatre Building basement structural steel.

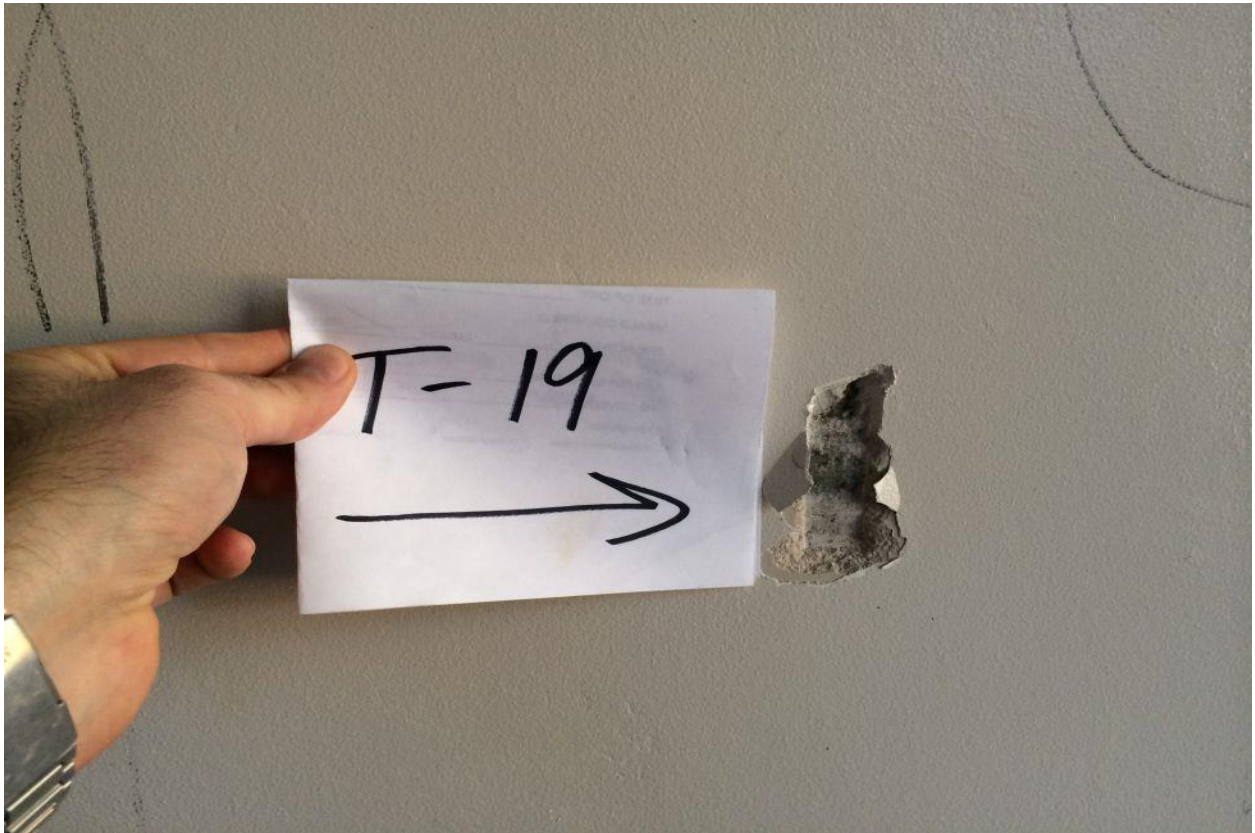
Plate 68: Laboratory analyses did not detect asbestos minerals within troweled on surfacing material sample TS-19 collected from the Theatre Building basement hall wall.

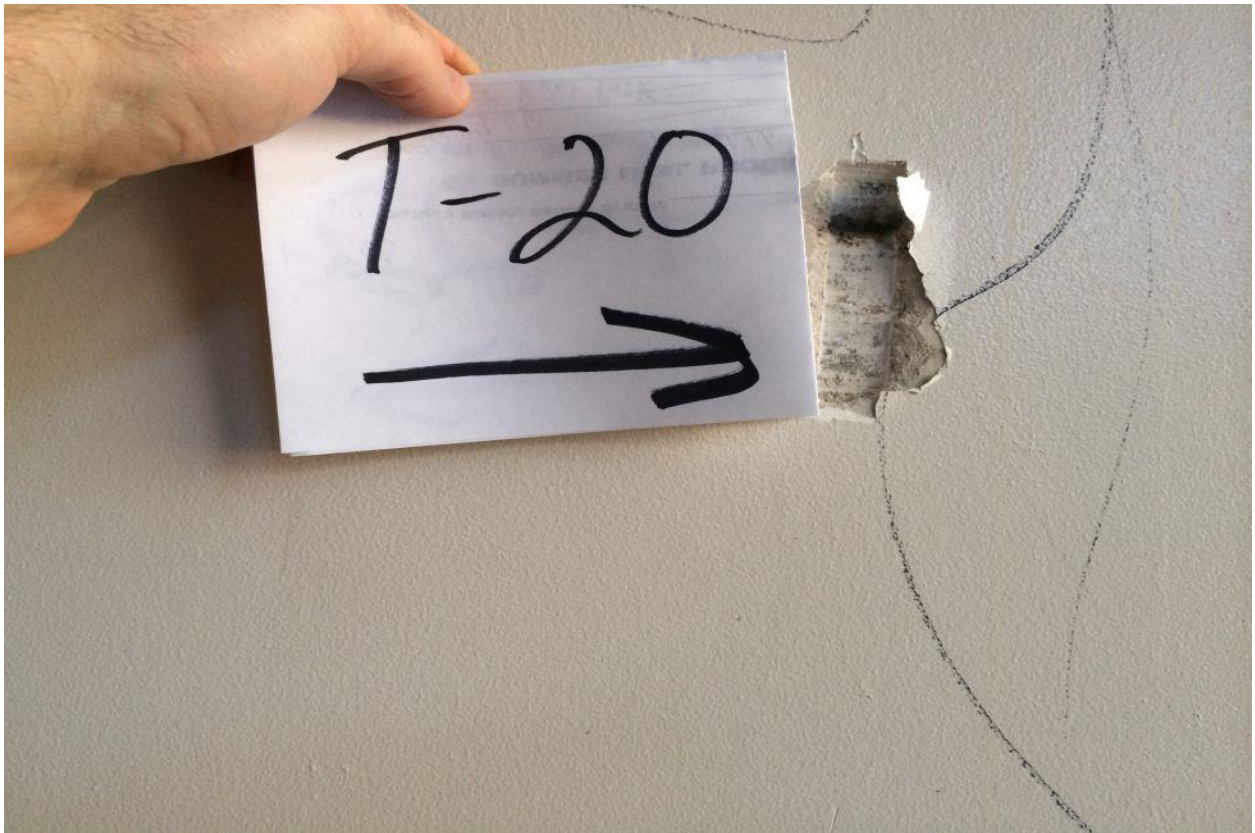
Plate 69: Laboratory analyses did not detect asbestos minerals within troweled on surfacing material sample TS-20 collected from the Theatre Building lobby wall.

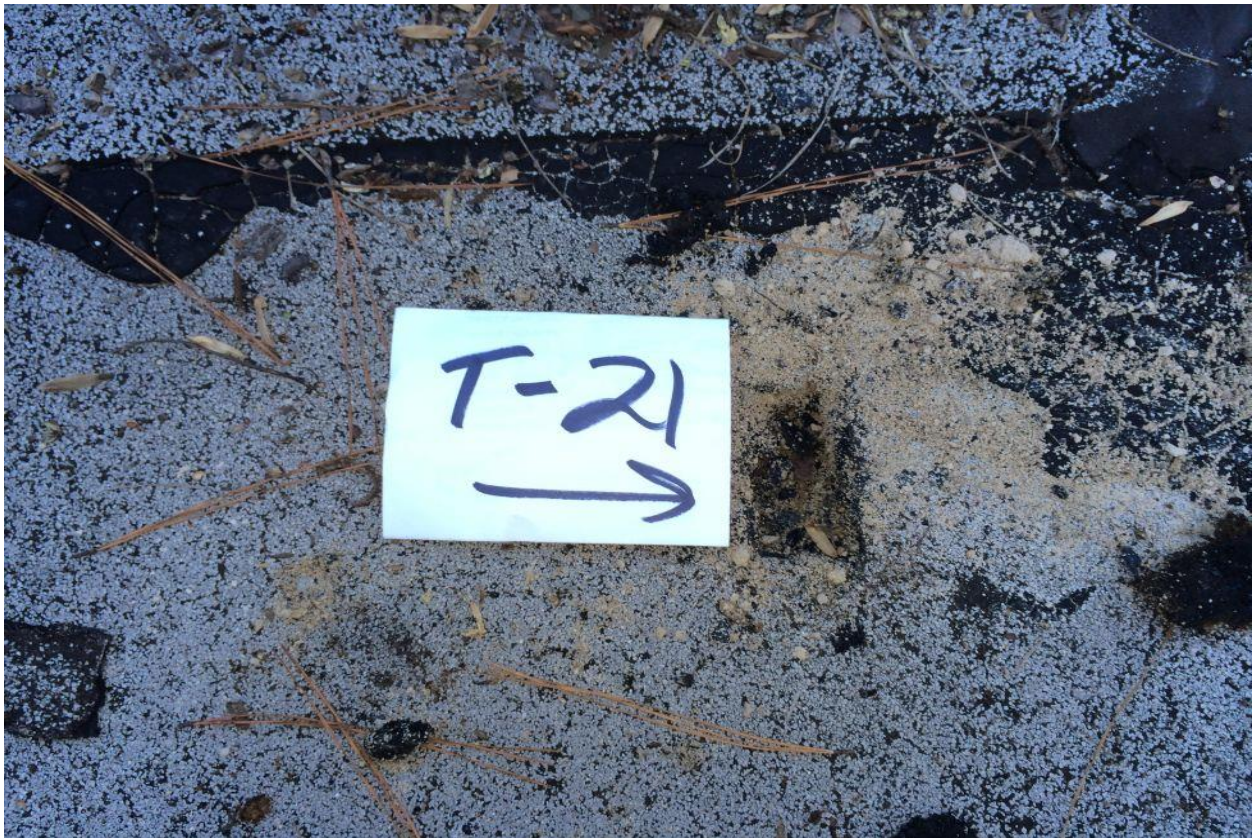
Plate 70: Laboratory analyses did not detect asbestos minerals within asphalt roof sample TS-21 collected from the Theatre Building roof.

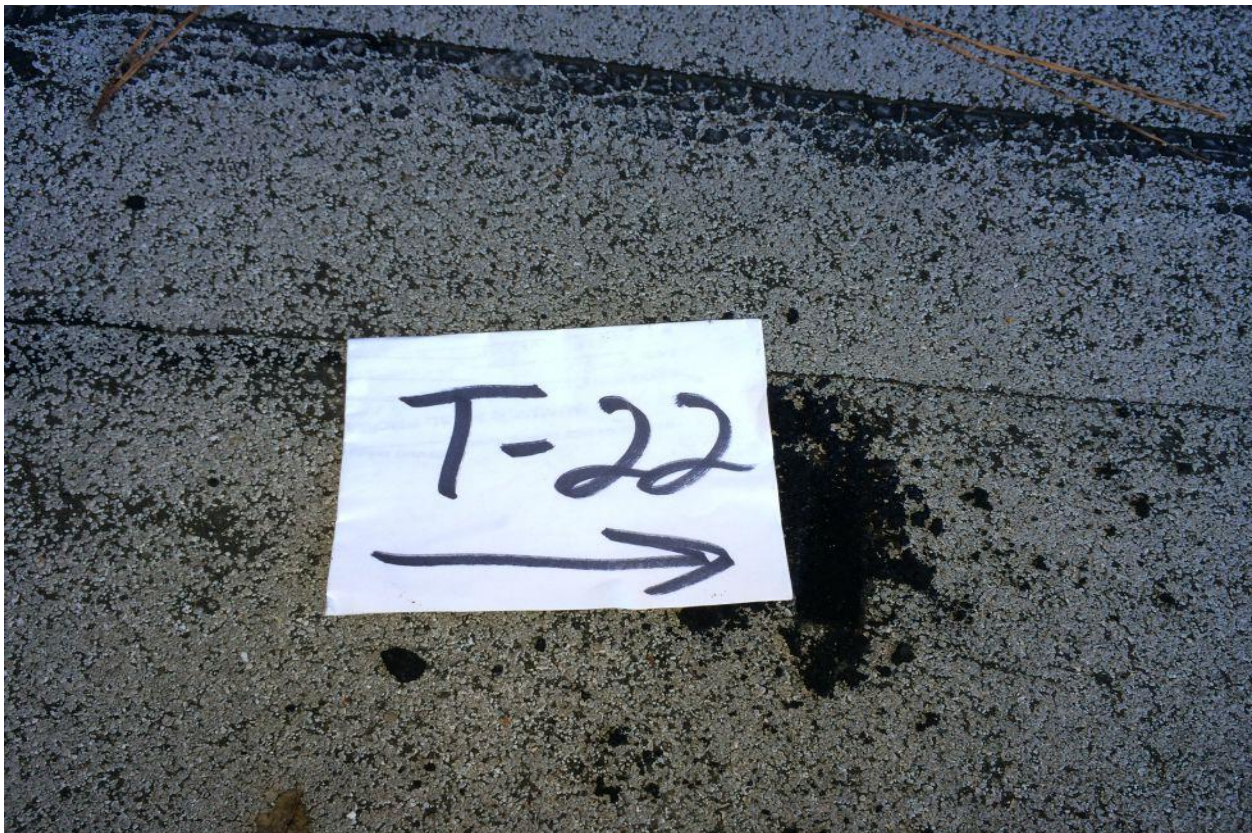
Plate 71: Laboratory analyses did not detect asbestos minerals within asphalt roof sample TS-22 collected from the Theatre Building roof.

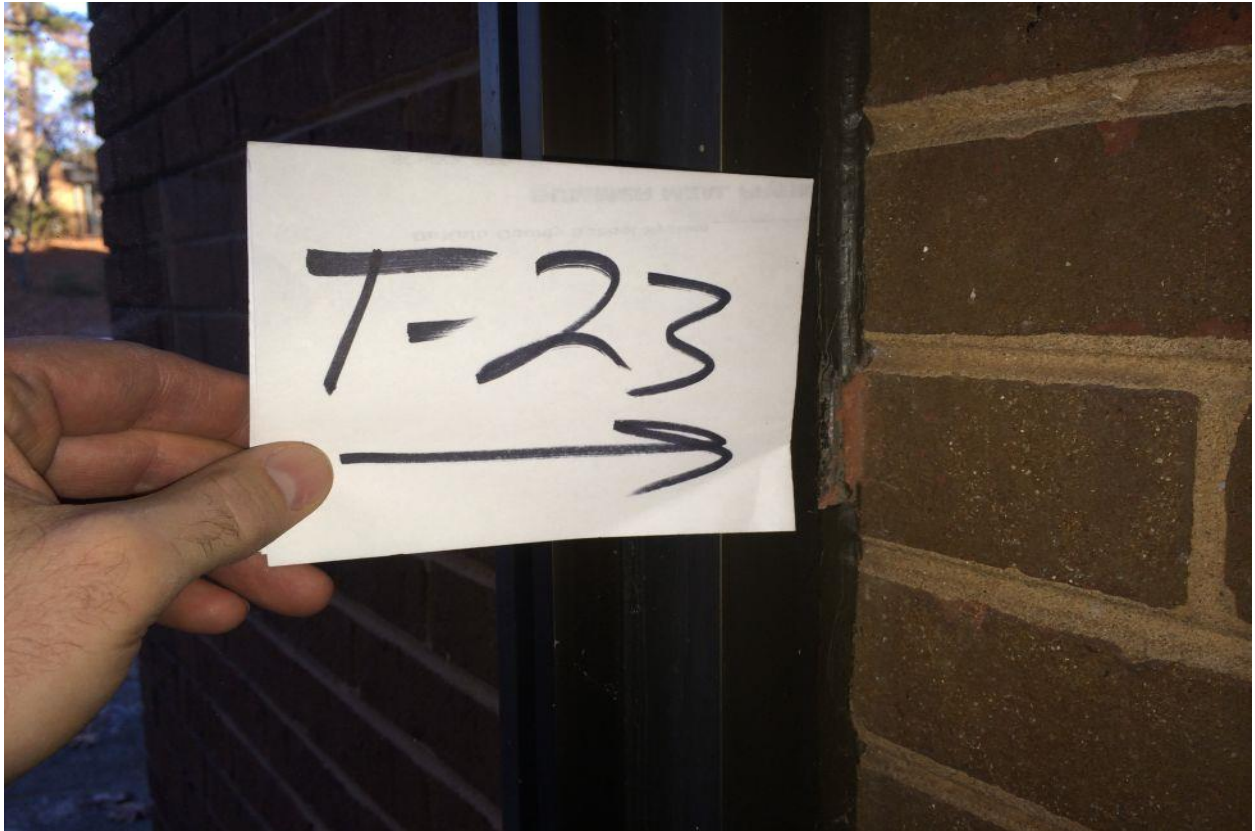
Plate 72: Laboratory analyses did not detect asbestos minerals within the window caulk sample TS-23 collected from the Theatre Building windows.

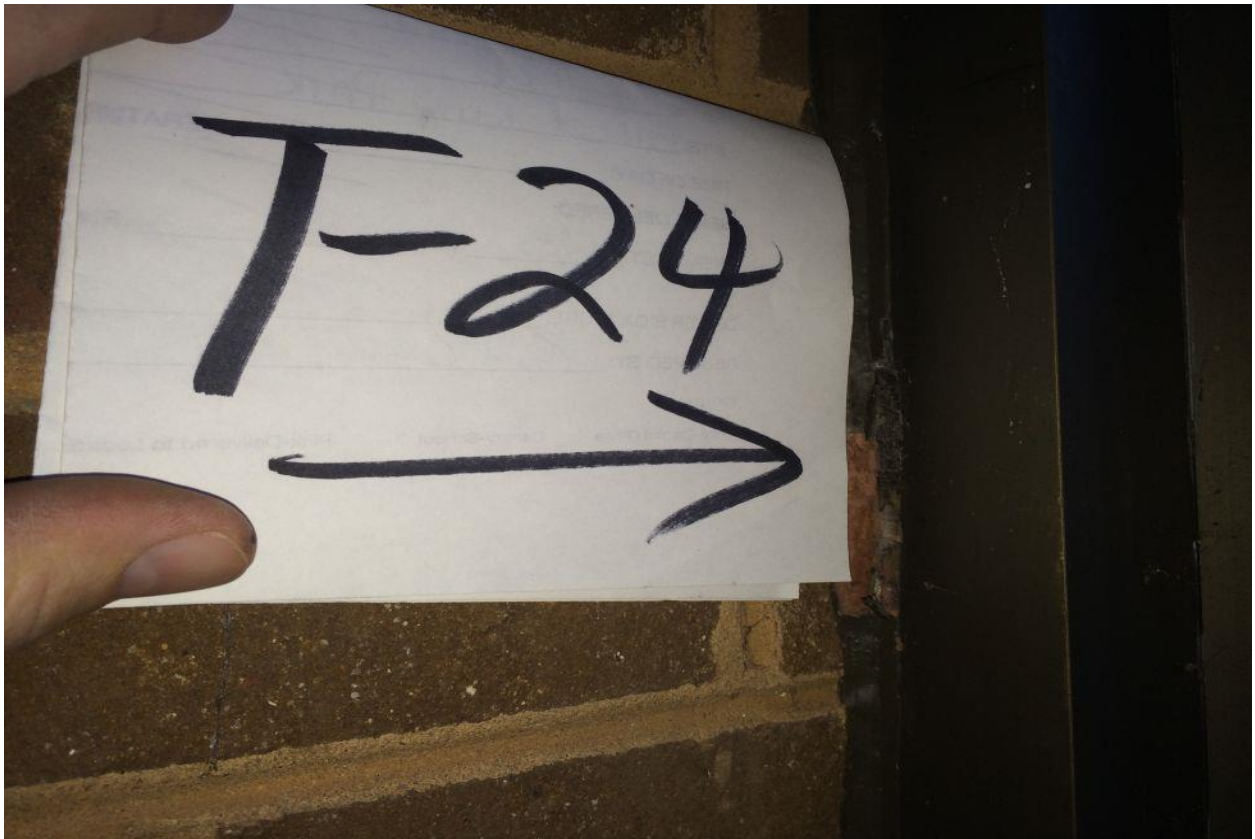
Plate 73: Laboratory analyses did not detect asbestos minerals within the window caulk sample TS-24 collected from the Theatre Building windows.
