Re: Dunwoody Cultural Arts Center HVAC Roof Top Unit System Replacement

# Cultural Arts Center – RTU Assessment

**City of Dunwoody**

Date: 4/18/2025

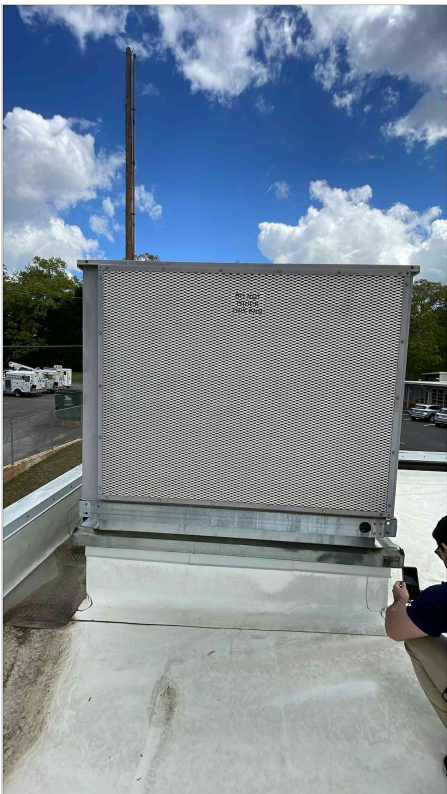
Condenser Section.jpg

The condenser section is in a good condition.

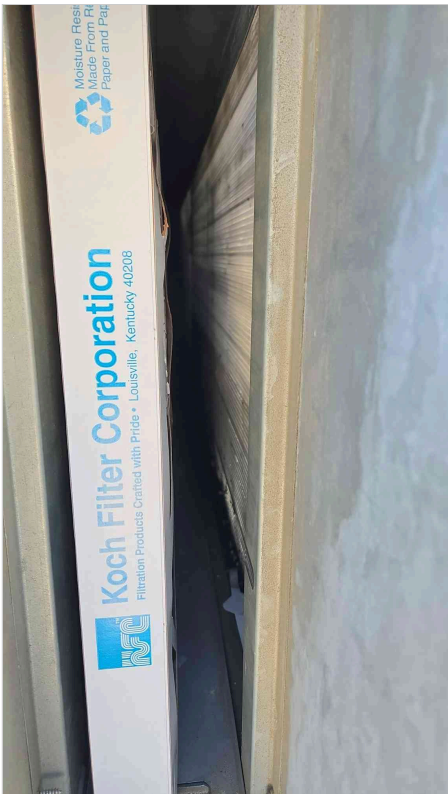
Filter.jpeg

The filters are clean.

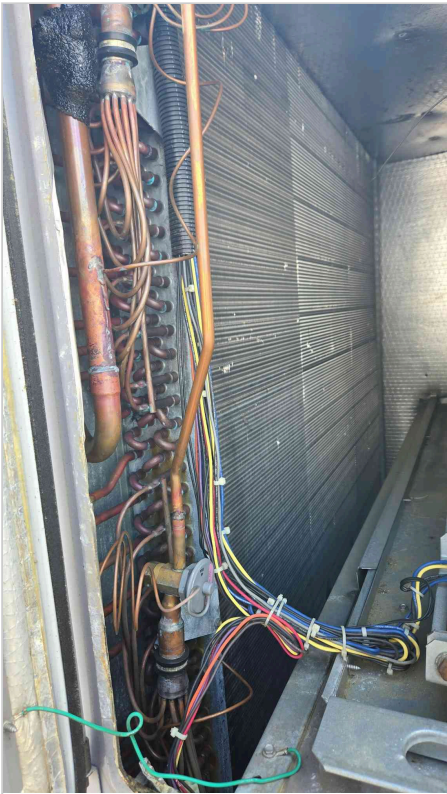
DX Coil.jpeg

The coils are in a good condition. The unit is generally clean.

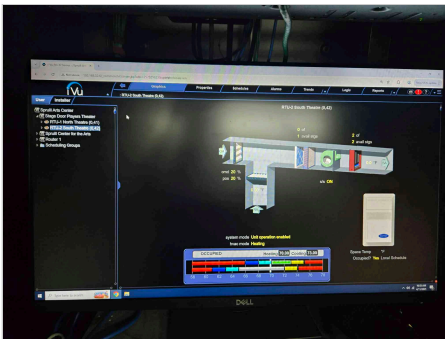
BAS.jpg

| Number | Description | Status | Priority | Asset | Assigned | Due Date |
|---|---|---|---|---|---|---|
| FO-1-13 | Controls Overview:<br><br>- Space temperature is not shown on graphics.<br><br>- RA temperature displayed as 0.0F on graphics. Is this point integrated and installed?<br><br>- Supply Air Temperature sensor cycles its reporting and operation. Unreliable. | OPEN | | RTU-2 | | 4/14/2025 |

**Recommendation:** Continue with regular mechanical maintenance to extend the useful life of the units but consider upgrading or repairing the BAS system to improve proper monitoring and control functionality. Enhancing the control interface will improve operational oversight and may contribute to reduced comfort complaints.

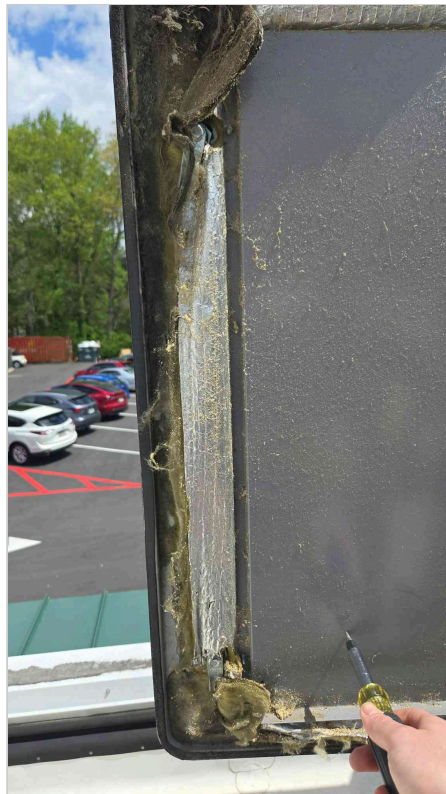
Insulation.jpg

| Number | Description | Status | Priority | Asset | Assigned | Due Date |
|---|---|---|---|---|---|---|
| FO-1-2 | The insulation on the interior of the unit needs to be replaced. This is common for units of this age. | OPEN | | RTU-2 | | 4/14/2025 |

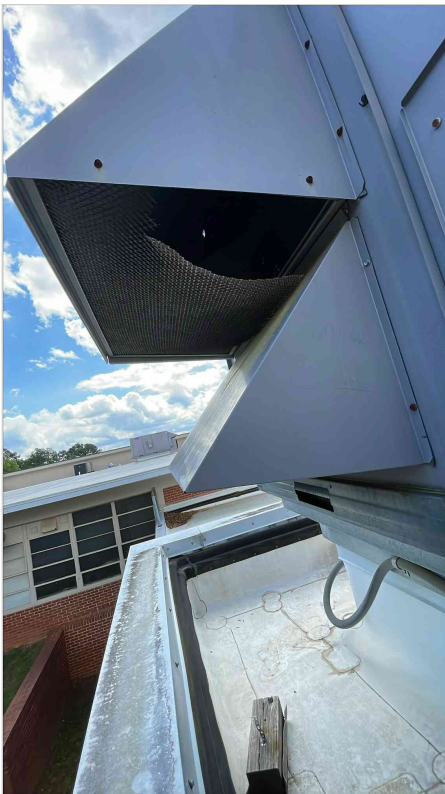
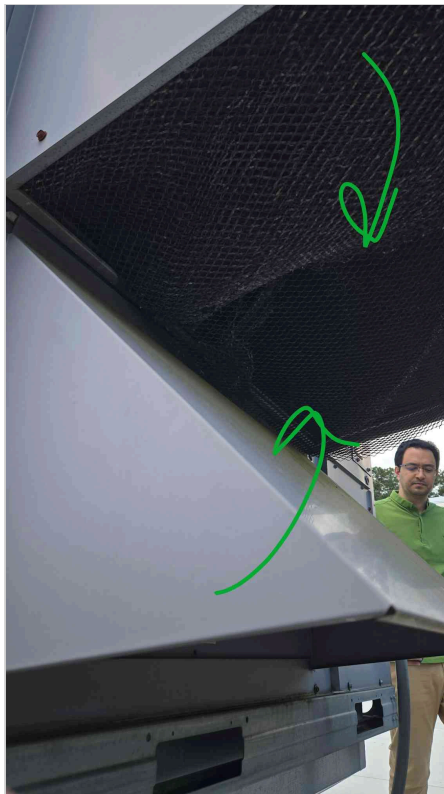
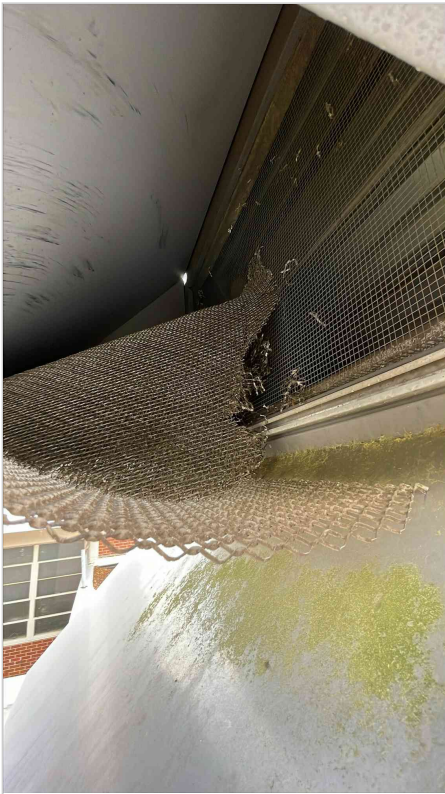
| Number | Description | Status | Priority | Asset | Assigned | Due Date |
|---|---|---|---|---|---|---|
| FO-1-1 | OA in take bird screen is broken. | OPEN | | RTU-2 | | 4/14/2025 |

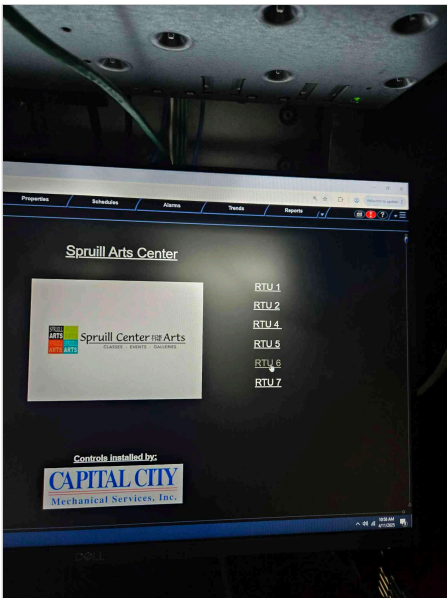
Controls Overview.jpg

| Number | Description | Status | Priority | Asset | Assigned | Due Date |
|---|---|---|---|---|---|---|
| FO-1-17 | It seems that RTU-3 is not connected with the BAS system. Unable to determine if unit is able to enter into heating and cooling. At the time of testing, the unit was running and recirculating air (not heating or cooling). | OPEN | | RTU-3 | | 4/14/2025 |

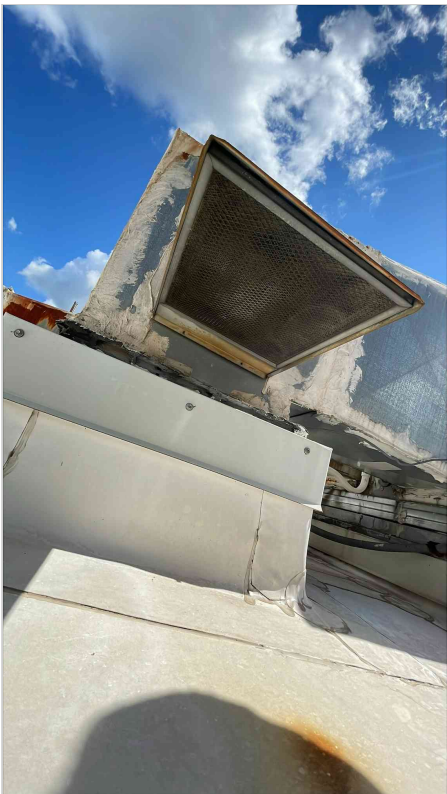
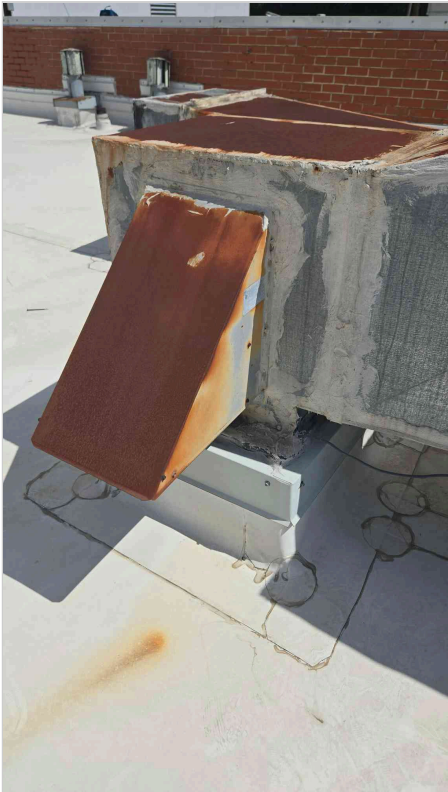
OA Intake.jpg

| Number | Description | Status | Priority | Asset | Assigned | Due Date |
|---|---|---|---|---|---|---|
| FO-1-3 | OA intake is clogged. There is no way to set OA flow. | OPEN | | RTU-3 | | 4/14/2025 |

- **Full replacement** of RTUs 3, 4, 5, 6, and 7 is recommended due to age and physical condition.

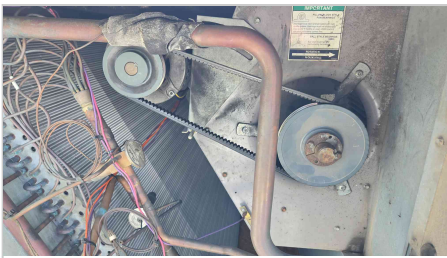
DRIVE.jpeg

Based on visual observation, the drive assembly for the fan is in good condition and the belt is well tensioned however the unit is off.

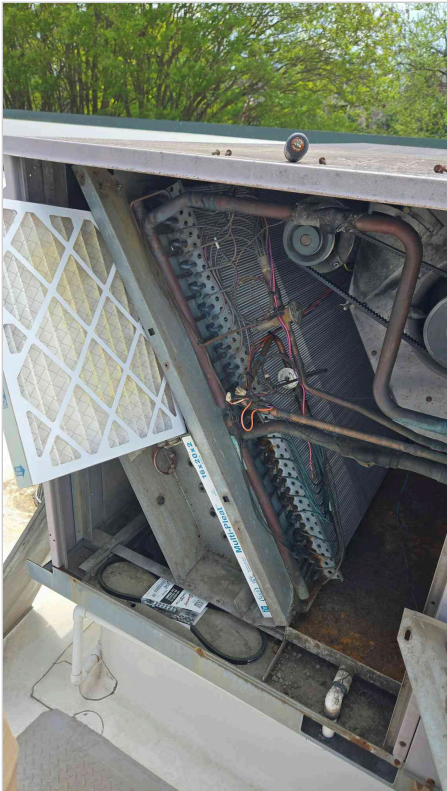
FILTER.jpeg

Filters are partially loaded. Cooling coil in clean condition.

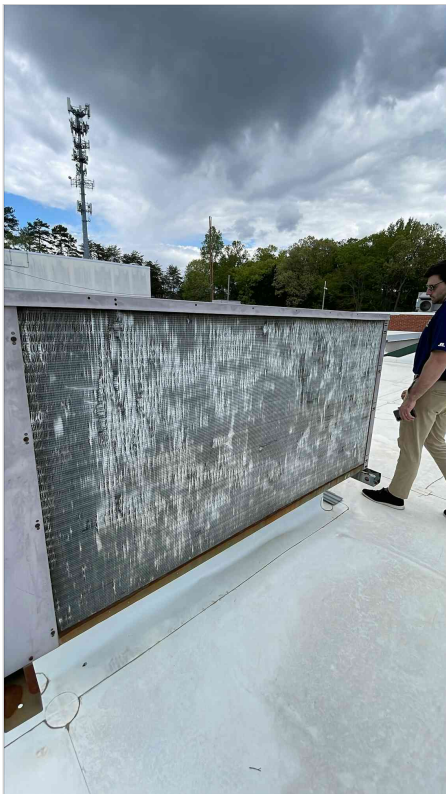
COIL.jpg

| Number | Description | Status | Priority | Asset | Assigned | Due Date |
|---|---|---|---|---|---|---|
| FO-1-9 | Condenser coil is damaged. | OPEN | | RTU-5 | | 4/14/2025 |

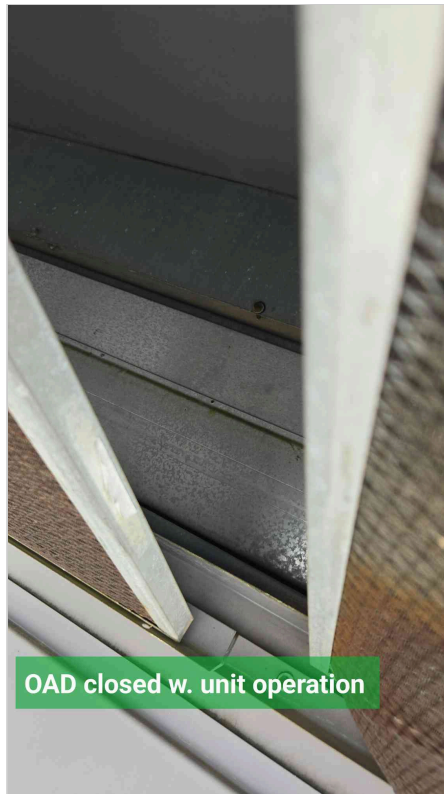
OA.jpg

| Number | Description | Status | Priority | Asset | Assigned | Due Date |
|---|---|---|---|---|---|---|
| FO-1-8 | The bird screen is damaged. | OPEN | | RTU-5 | | |
| FO-1-7 | Outdoor Air Damper was closed while the unit was operating. | OPEN | | RTU-5 | | 4/14/2025 |

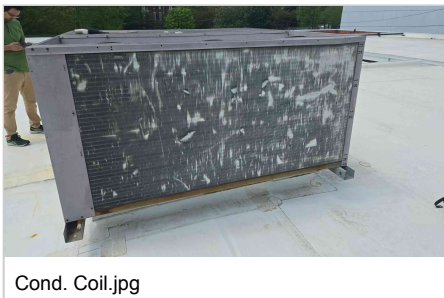
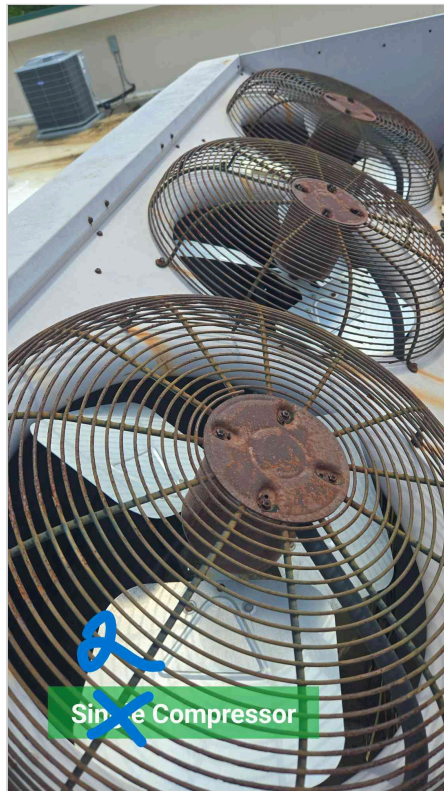
Cond. Coil.jpg

| Number | Description | Status | Priority | Asset | Assigned | Due Date |
|---|---|---|---|---|---|---|
| FO-1-10 | Condensing coil is damaged. | OPEN | | RTU-6 | | 4/14/2025 |

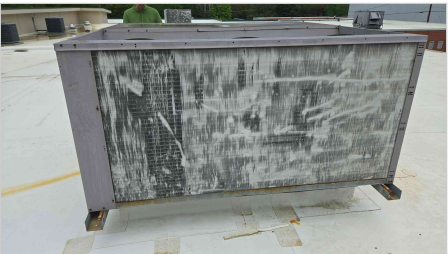
Cond. Coil.jpg

| Number | Description | Status | Priority | Asset | Assigned | Due Date |
|---|---|---|---|---|---|---|
| FO-1-11 | The condensing coil is damaged. | OPEN | | RTU-7 | | 4/14/2025 |

The controls update appears to have addressed some temp control issues in the short-term; however, replacement of the unit is recommended due to age and physical condition.

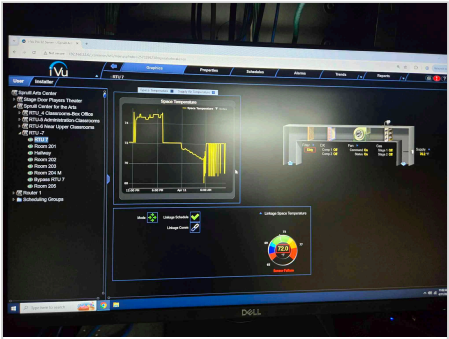
BAS Screen Shot.jpg

| Number | Description | Status | Priority | Asset | Assigned | Due Date |
|---|---|---|---|---|---|---|
| FO-1-20 | The room temperature sensor is failed. However, space temp trends (from an unknown source) appear to show the space satisfied. | OPEN | | RTU-7 | | 4/14/2025 |

The controls for RTU-7 were recently replaced. The graphics are clean and generally well-organized; however, the space sensor appears failed or not linked properly.
