## **MEMORANDUM**

**Subject:** **Funding for 4772 Coldstream Drive Storm Repairs**

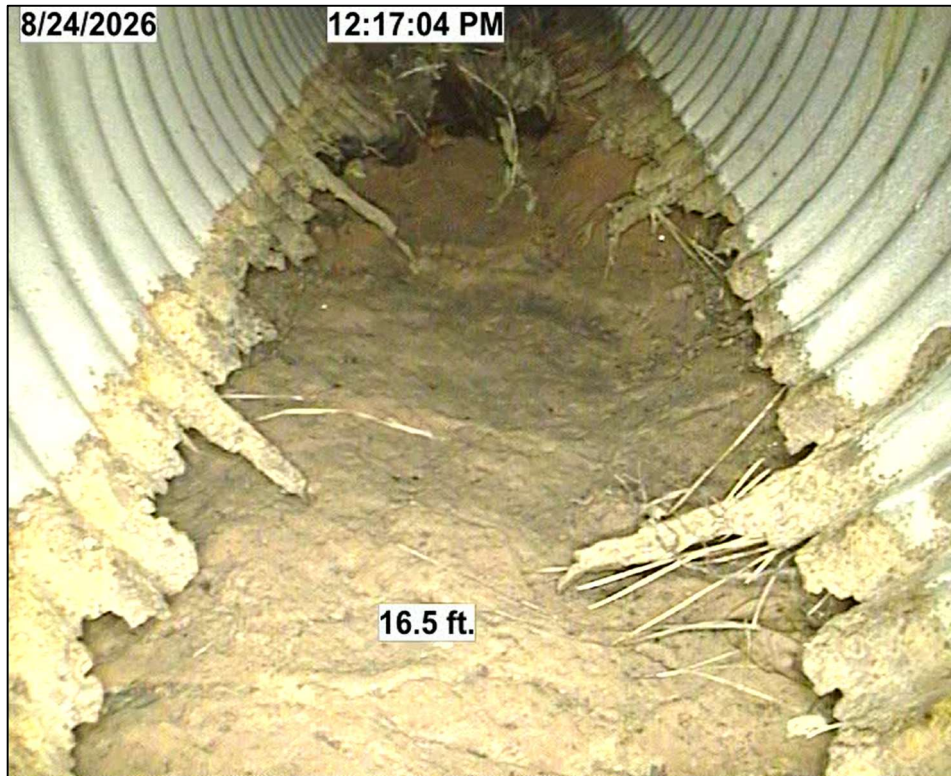
Structural deficiencies to the storm system at 4772 Coldstream Drive were confirmed by Closed-Caption Television (CCTV) inspection of the stormwater system to be the cause of a sinkhole that has formed at the project location. The storm system is composed of an 18-inch corrugated metal pipe (CMP) measuring +/-116 linear feet. The system is approximately 58 years old and is in poor condition.

CCTV – Downstream Viewing Direction, Measured 16.5 LF from Catch Basin.

- Filling of all voids along length of invert
- Point Repairs to +/-18 LF of damaged 18-inch CMP
- Repair +/-116 LF of 18-inch CMP with CIPP

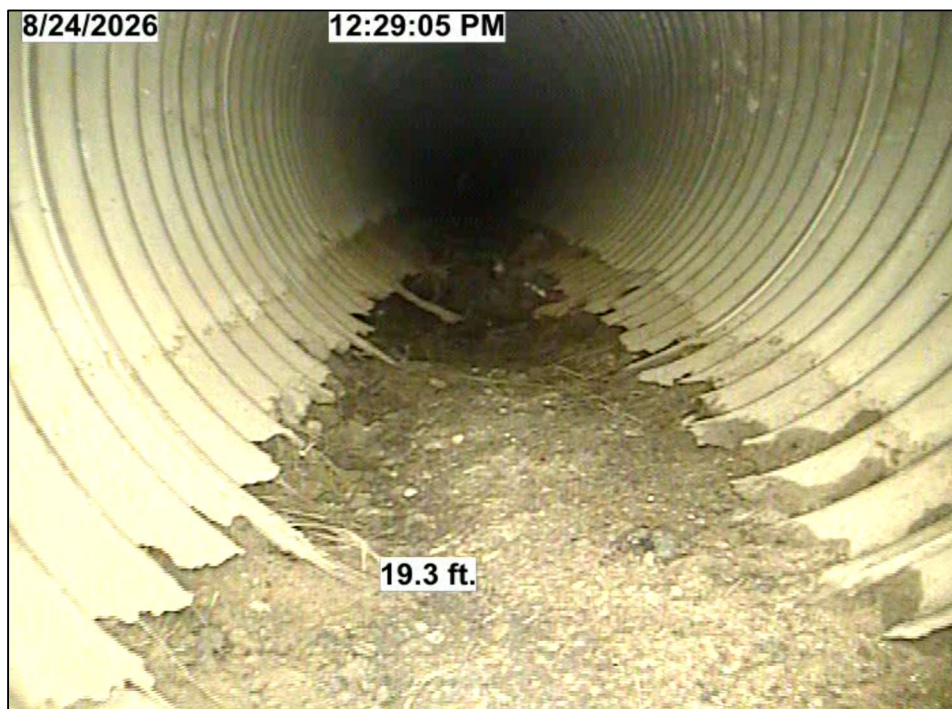
CCTV – Upstream Viewing Direction, Measured 19.3 LF from outlet.
