February 25, 2021

Dekalb County Scott Candler Water Treatment Plant Reservoirs1 and 2 – 2021 Safe Dams Inspection

Please find attached the Embankment Dam Inspection Form (EDIF) for the 2021 inspection cycle for the Scott Candler Water Treatment Plant Reservoirs 1 and 2. The Plant is located at 4830 Winters Chapel Road, Atlanta, GA 30360. An aerial view of the reservoirs is shown in **Figure 1**.

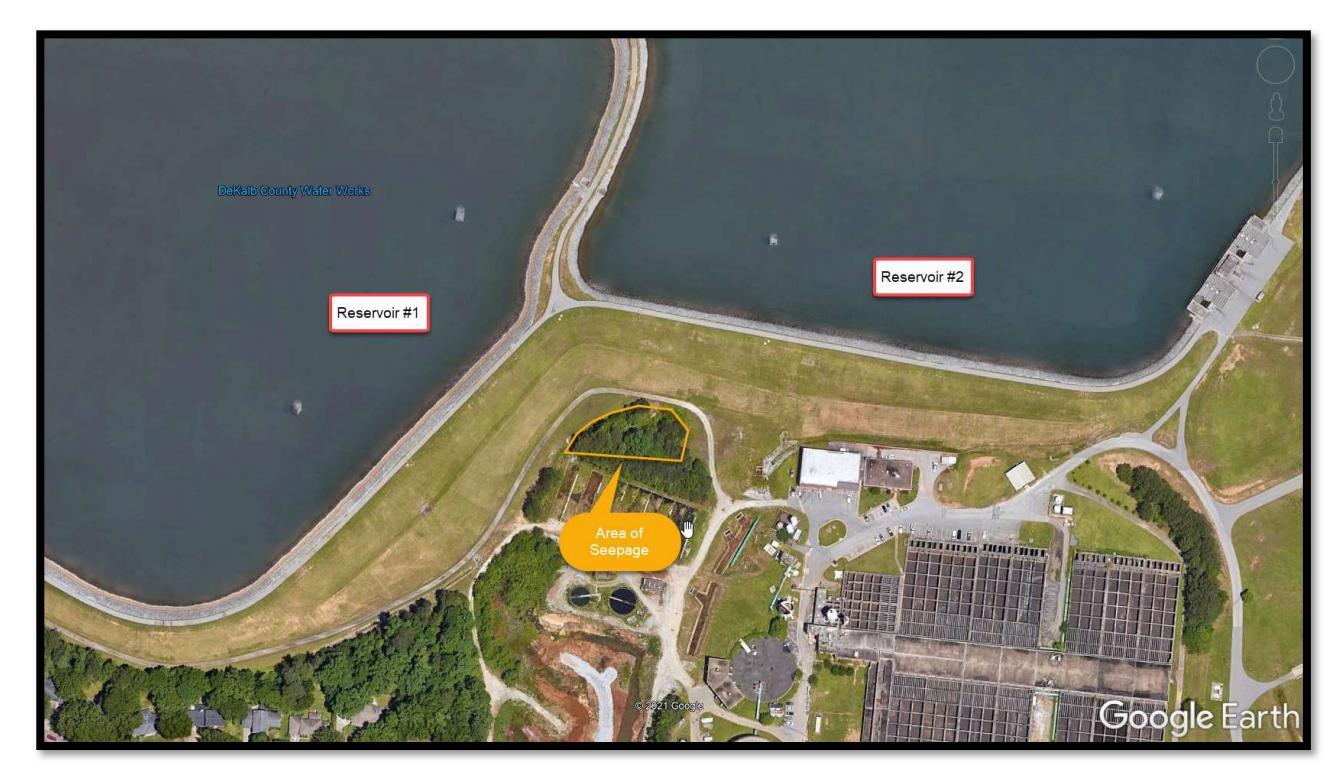
Figure 2: Area of New Seepage

Some evidence of seepage of Reservoir 1 was observed in the form of rust-colored flow and ponding below a toe drain discharging on the southeast slope of Reservoir 1 and to the south of the common embankment dividing Reservoirs 1 and 2 (see **Figure 2**).

This appears to be a newly observed seepage location. We have recommended to DWM staff that the discharge be measured and sampled to determine if the rust color is iron bacteria caused by seepage through the embankment. We have recommended that the origin and path of the drain be identified to enable closer monitoring for depressions that might lie along the flow path, and that future monitoring, inspections, and potential seepage reduction measures follow Georgia Safe Dams Program guidelines.¹

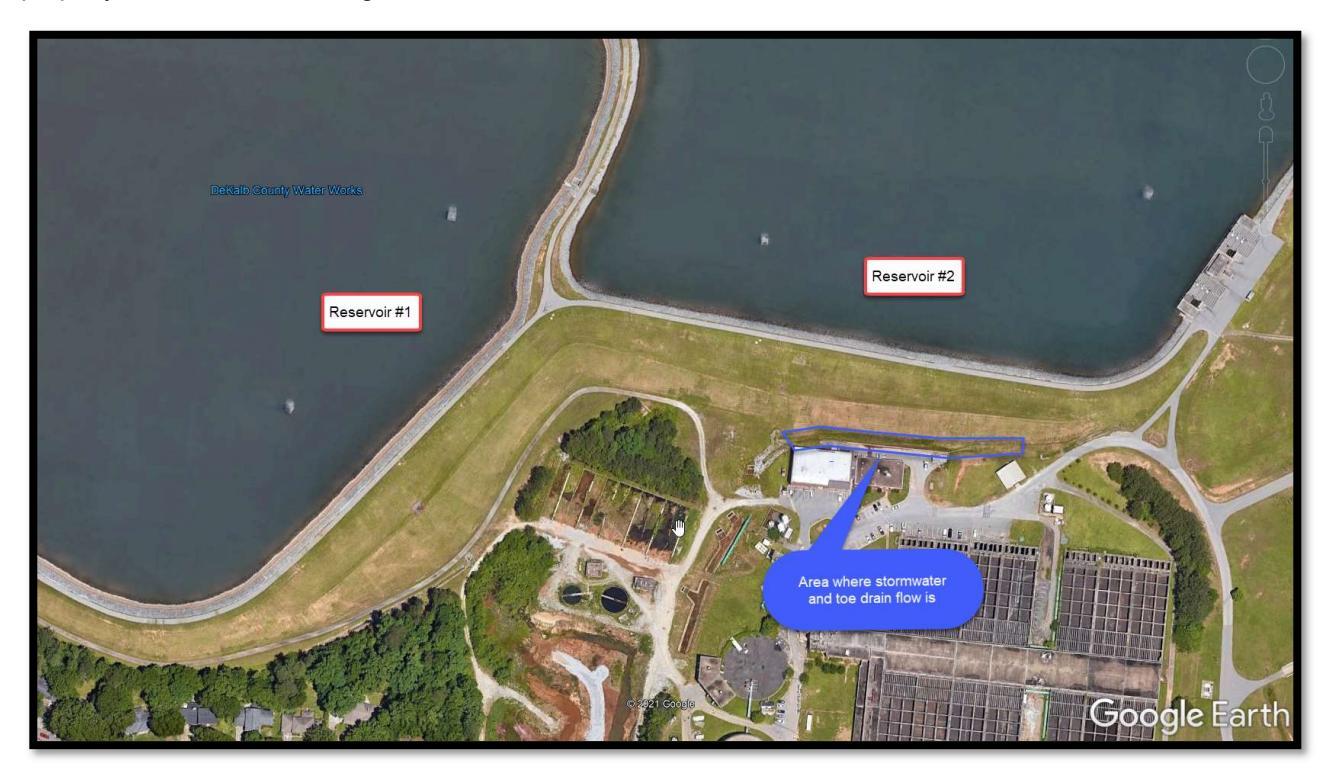
Figure 3: Soft Soil and Residual Moisture Area

Toe drains were also inspected around the two reservoirs, and their discharge was examined. The toe drains appeared to be in good condition and, other than the Reservoir 1 drain described above, flowed clear. Some of the toe drains were exposed at the surface and should be covered with soil as a corrective action. Soft soils and residual moisture were identified at the discharge and downstream of one of the toe drain outlets for Reservoir 2, shown in **Figure 3**. This area was determined to be a result of not properly managing discharge from the toe drain. A temporary fix of additional piping was implemented between the

first and second visits, and the area showed signs of significant improvement. A permanent solution to properly channel this discharge is recommended as a corrective action.

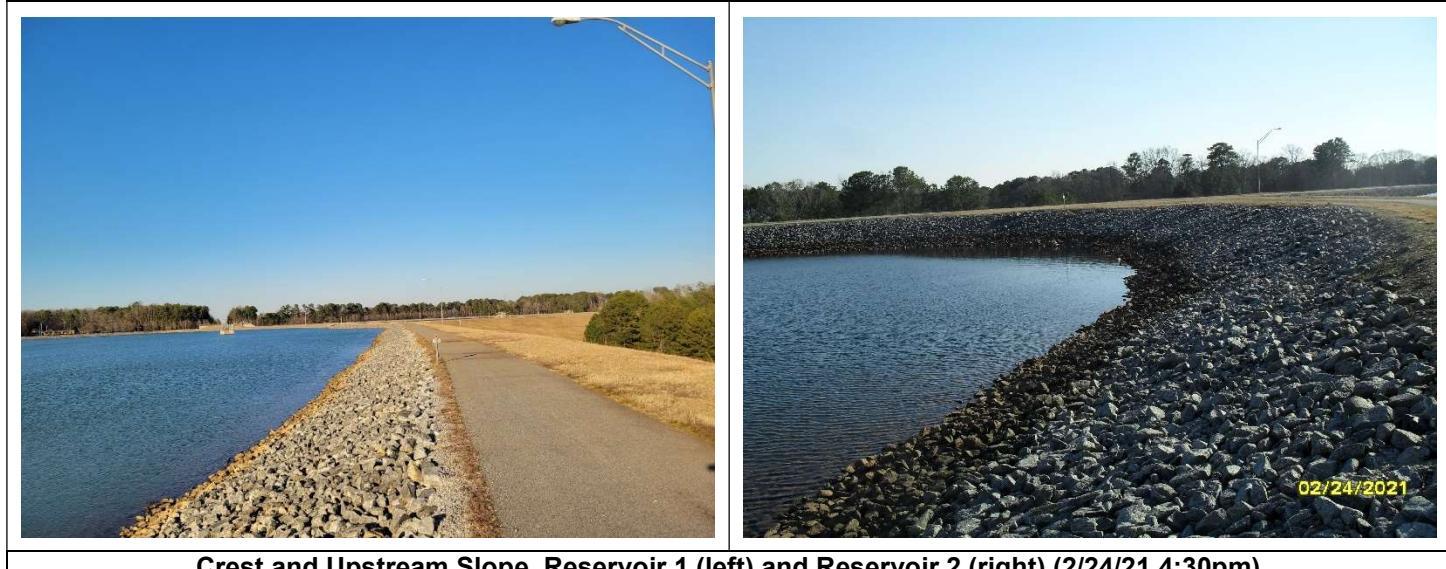
Crest and Upstream Slope, Reservoir 1 (left) and Reservoir 2 (right) (2/24/21 4:30pm) Left – Reservoir 1 Right – Reservoir 2

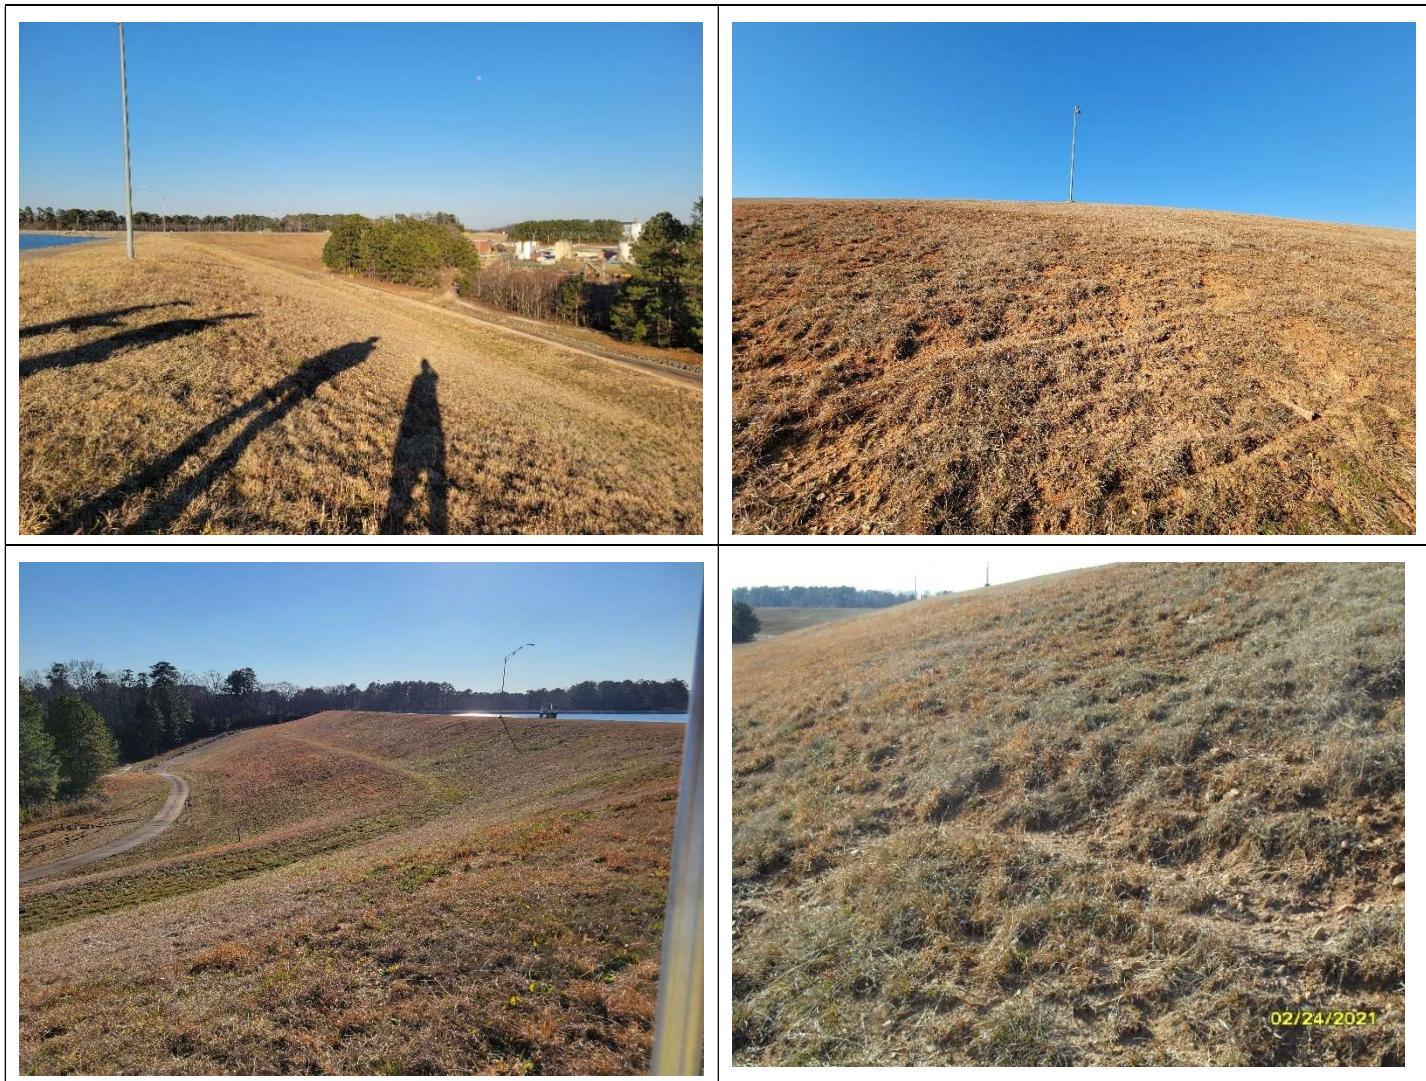
Downstream slope, Reservoir 2 (2/25/21 – 5:30 pm) Top Left – Reservoir 1 (Reservoir 2 in distance) Top Right – Reservoir 2 Bottom Left – Reservoir 2 (Reservoir 1 in distance) Bottom Right – Reservoir 2

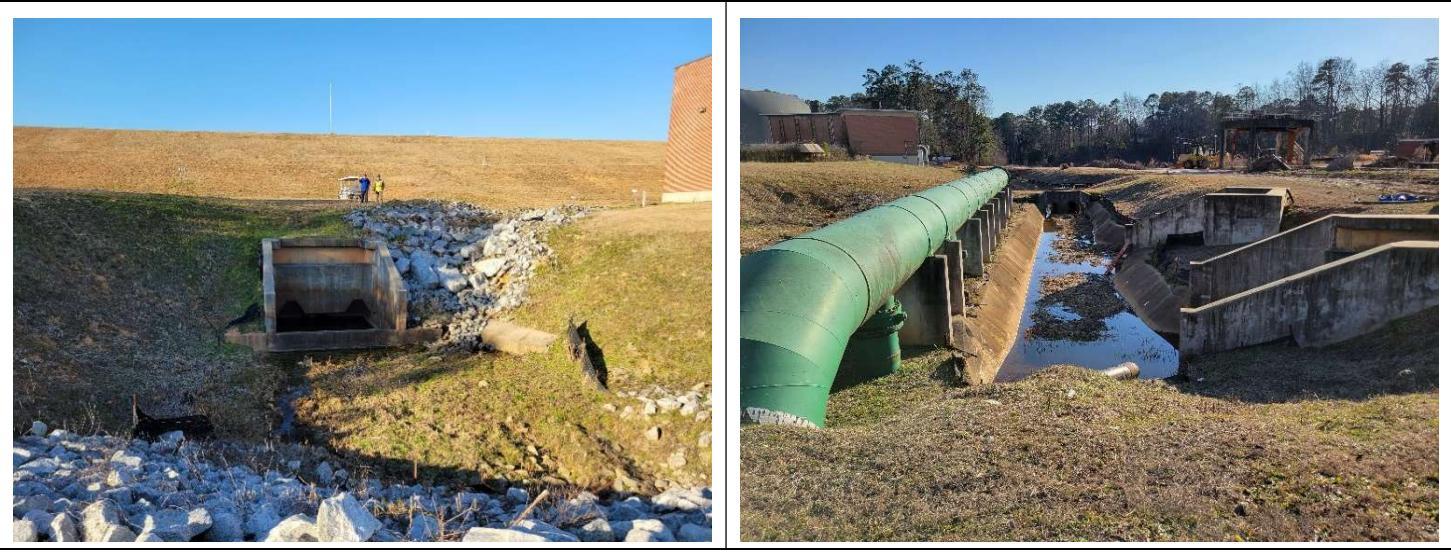
Plunge Pool and Emergency Spillway (5/24/21 – 5:00pm) Left – Plunge pool for Reservoir 2 Right – Combined emergency overflow (near) – Plunge Pool for Reservoir #2 (far)

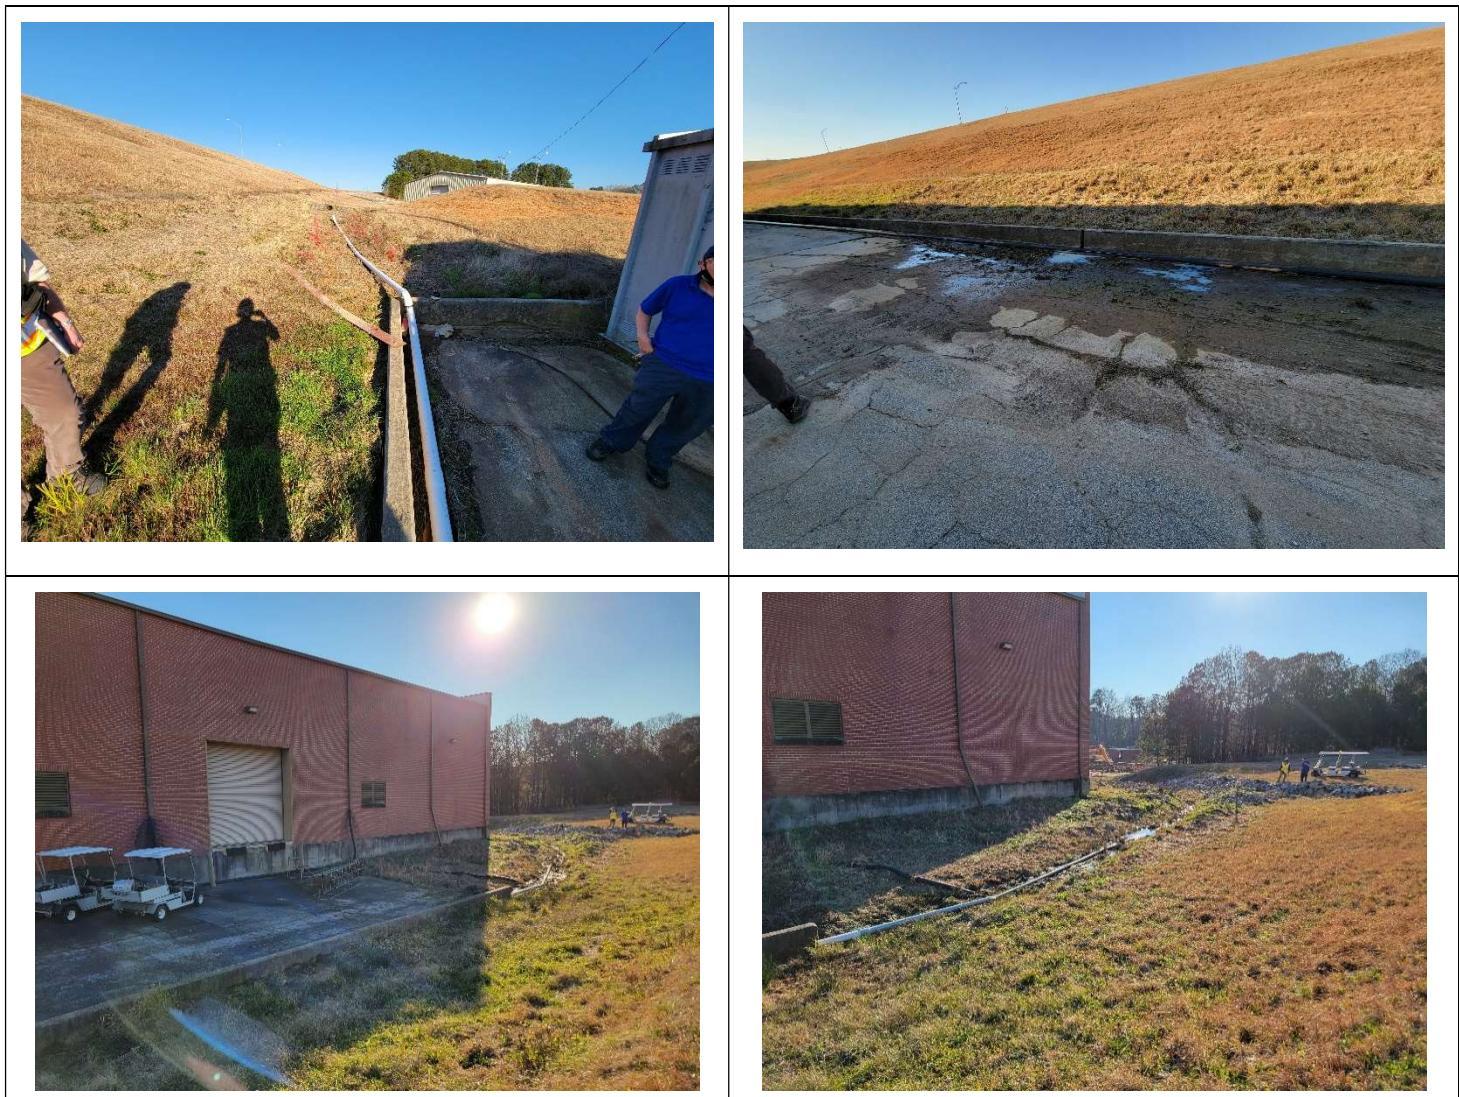
Toe drain discharge Area (5/25/21 5:00pm)Top Left – Reservoir 2 west toe drain outlet and collection pipeTop Right – Low point that is collecting surface water along wall.Bottom Left – View of stormwater from building and stormwater from dam collecting together.Bottom Right – View of discharge pipe running to rip-rap stormwater collection area.
