## Invitation to Bid

### **ITB 16-06 Demolition of the Theater at Brook Run Park**

The City of Dunwoody is soliciting competitive sealed bids from qualified contractors for **Demolition of the Theater Building at Brook Run Park** for the Department of Parks and Recreation.

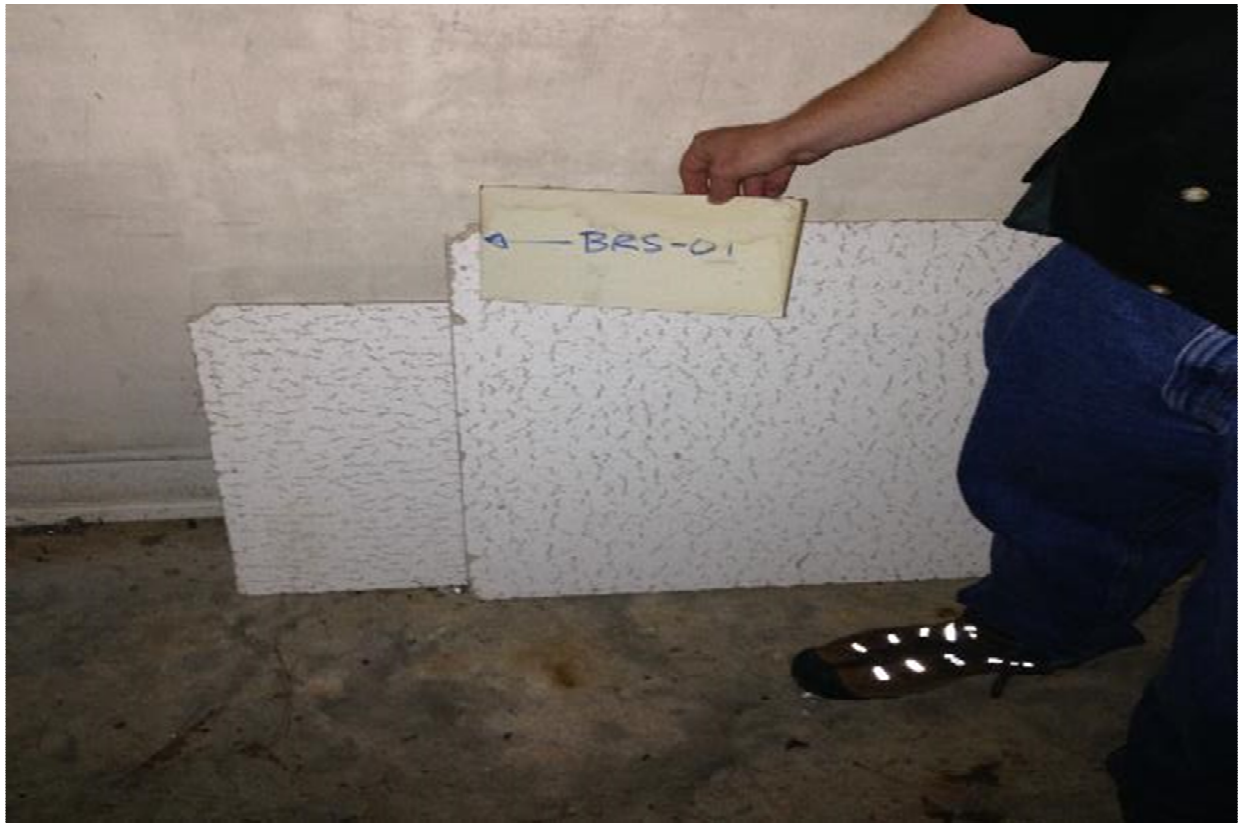
Plate 1: Laboratory analyses did not detect asbestos minerals within suspended ceiling tile sample BRS-01 collected from the South Administrative Building west room.

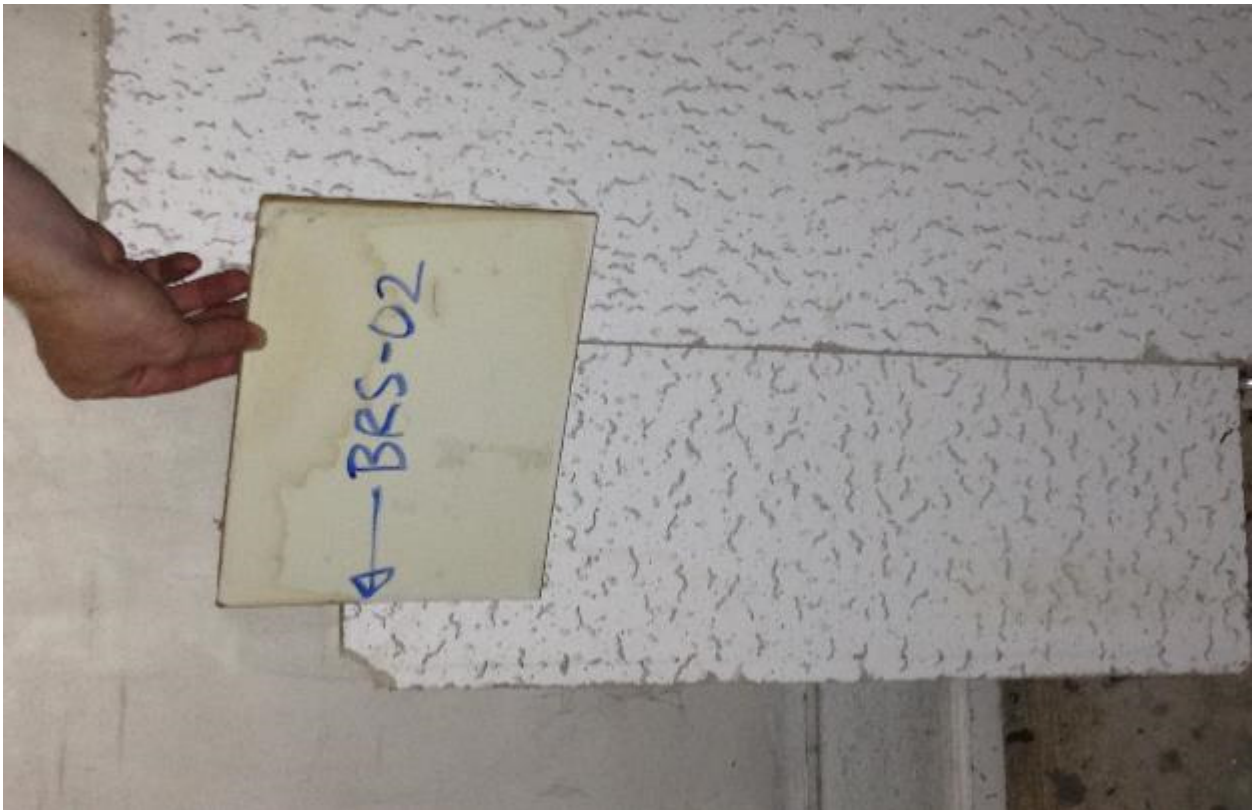
Plate 2: Laboratory analyses did not detect asbestos minerals within suspended ceiling tile sample BRS-02 collected from the South Administrative Building west room.

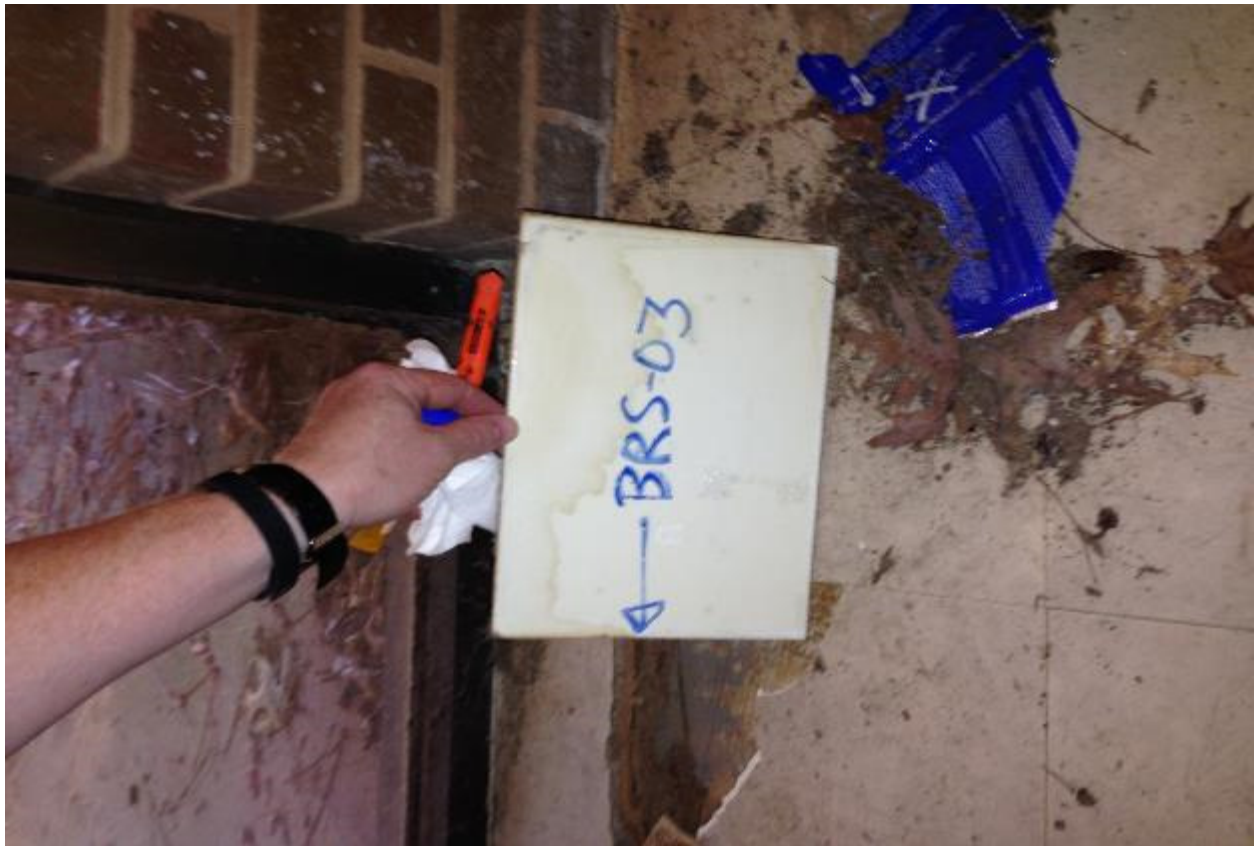
Plate 3: Laboratory analyses did not detect asbestos minerals within the floor tile or mastic sample BRS-03 collected from the South Administrative Building east room.

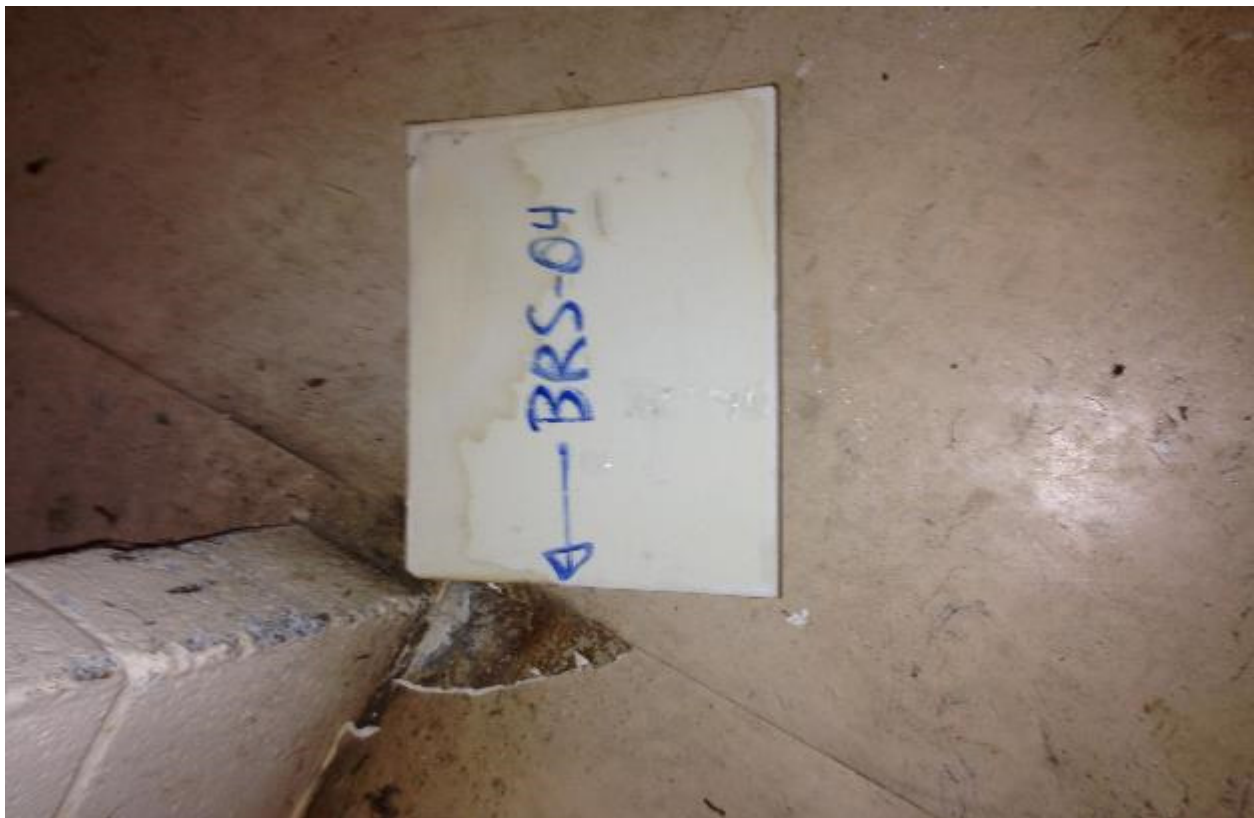
Plate 4: Laboratory analyses did not detect asbestos minerals within the floor tile or mastic sample BRS-03 collected from the South Administrative Building east room.

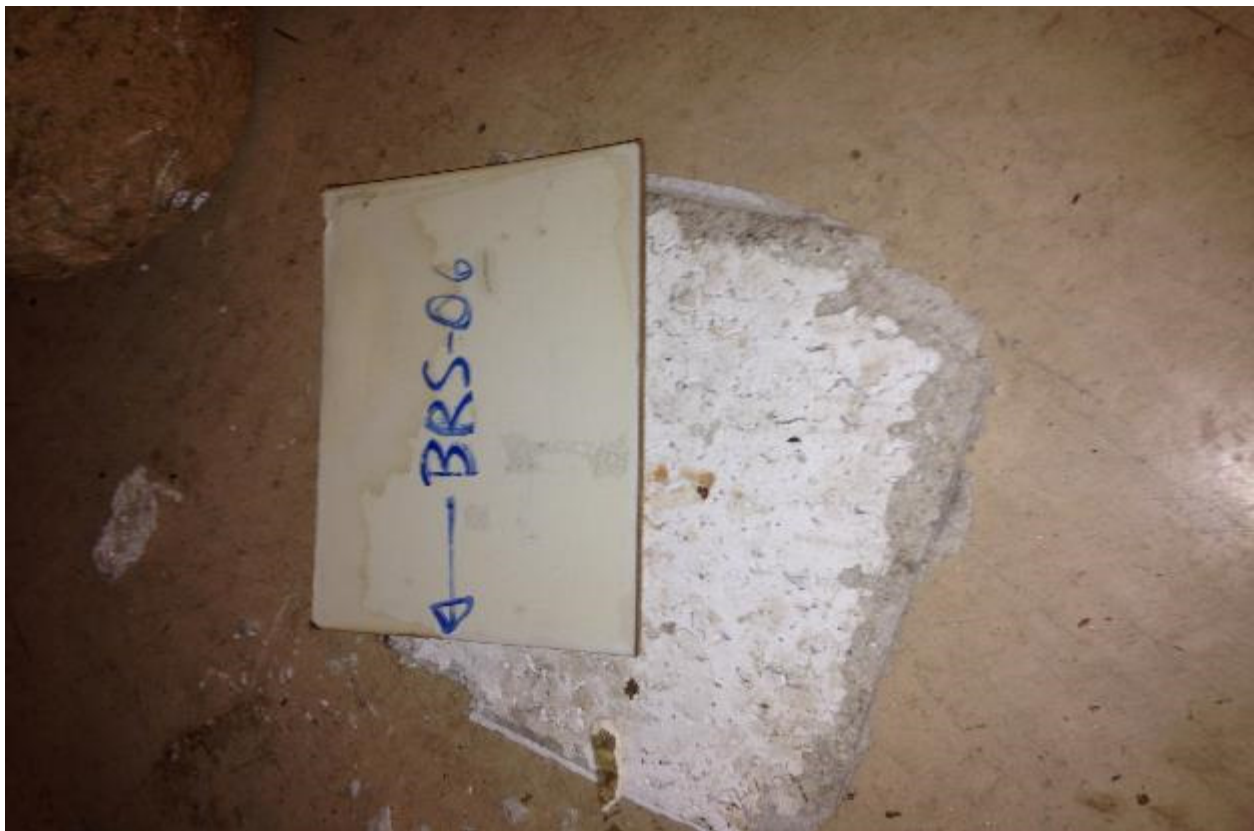
Plate 6: Laboratory analyses detected 2% chrysotile asbestos and 2% amosite asbestos within suspended ceiling tile sample BRS-06 collected from the South Administrative Building east rooms.

White (12-Inch Square) Ceiling Tile: Laboratory analysis detected 2% chrysotile asbestos and 2% amosite asbestos in samples BRS-05 and BRS-06 of ceiling tile. The ceiling tile system is a Category I non-friable ACM as long as the ceiling tile system is removed using methods that will not cause the ceiling tile system to be friable. Approximately 3,800 square feet of ceiling tile were observed in the northern administrative building, and approximately 2,600 square feet of ceiling tile were observed in the northern administrative building.

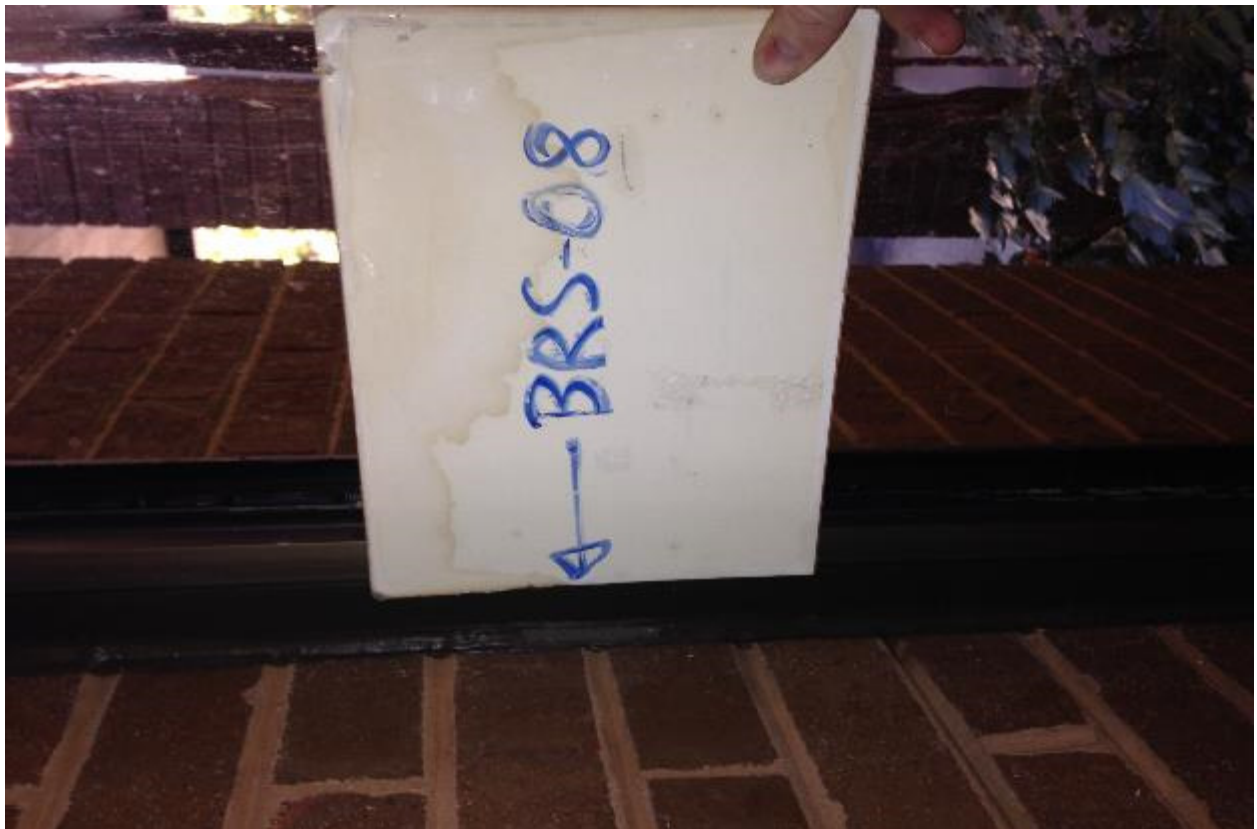
Plate 8: Laboratory analyses did not detect asbestos minerals within the window caulk sample BRS-08 collected from the South Administrative Building windows.

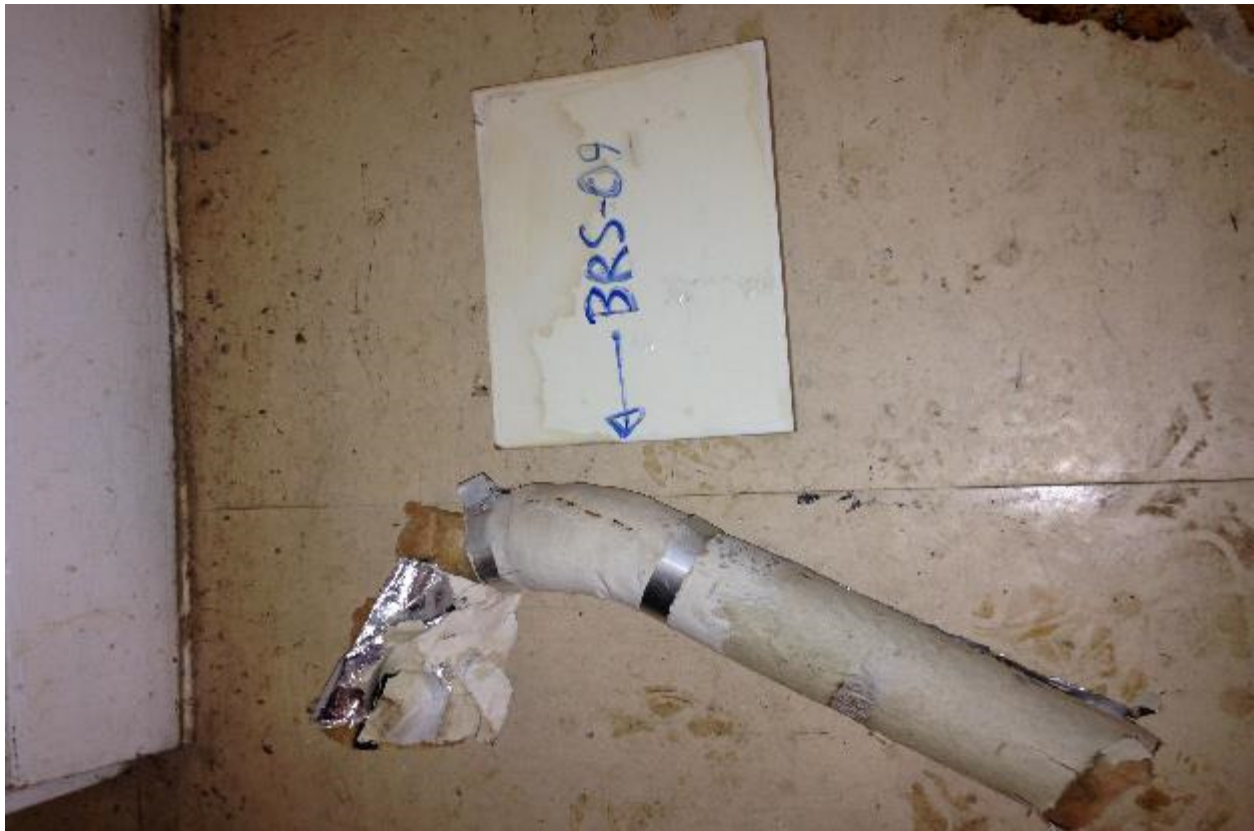
Plate 9: Laboratory analyses did not detect asbestos minerals within pipe elbow wrap sample BRS-09 collected from the South Administrative Building east rooms.

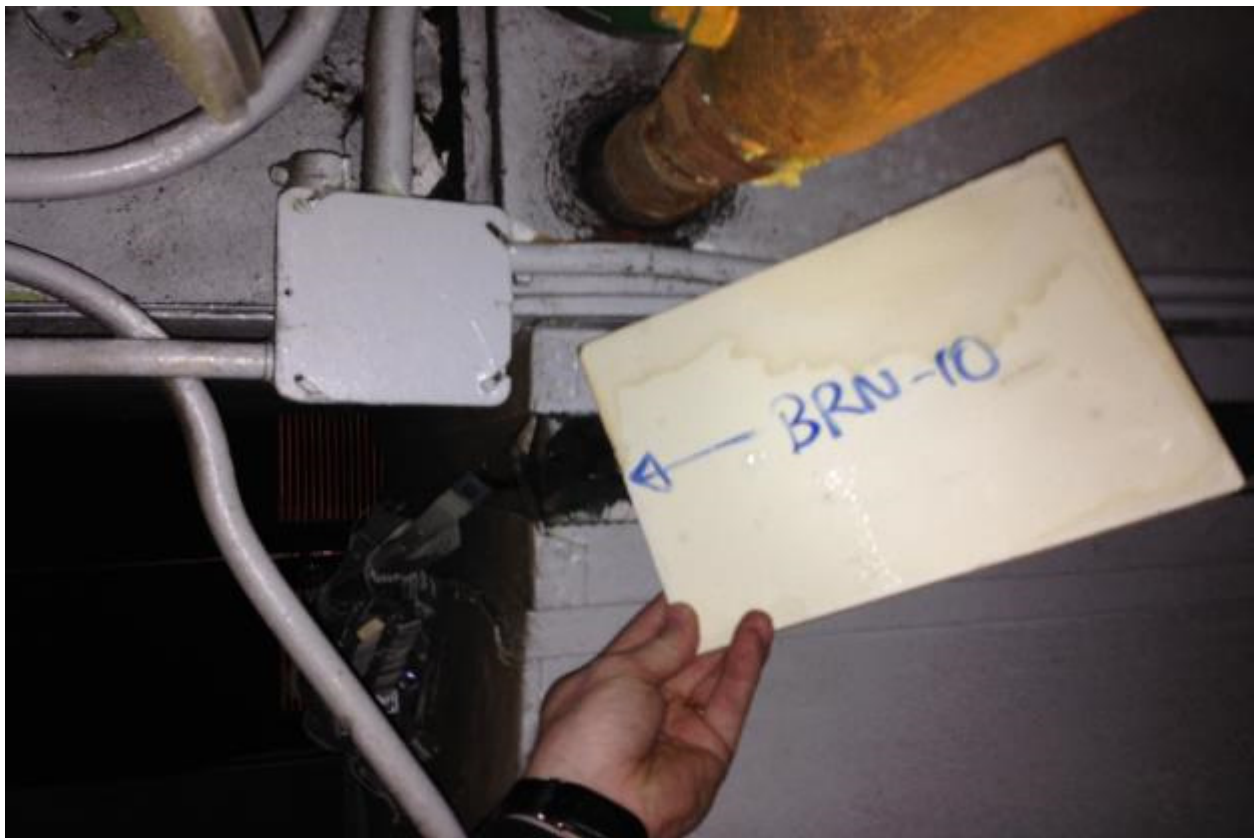
Plate 10: Laboratory analyses did not detect asbestos minerals within HVAC gasket sample BRN-10 collected from the North Administrative Building mechanical room.

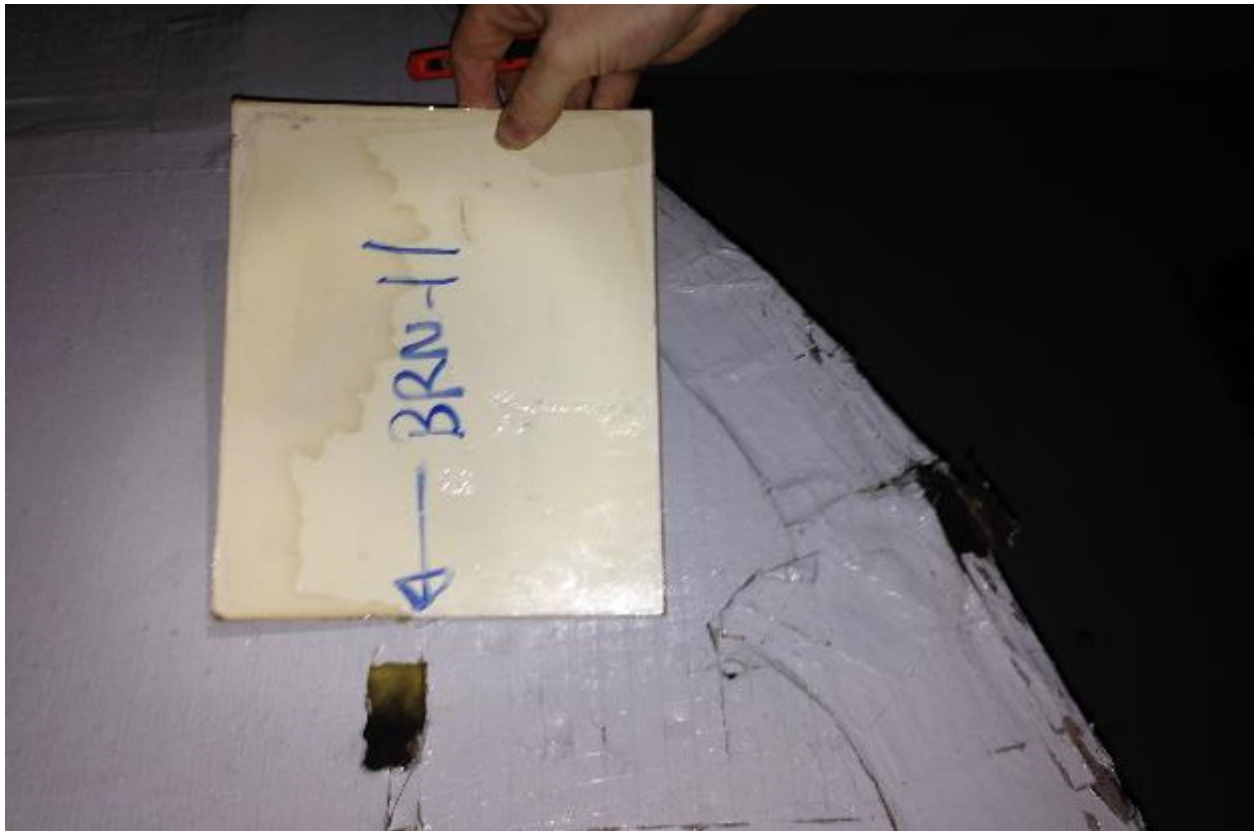
Plate 11: Laboratory analyses did not detect asbestos minerals within HVAC insulation sample BRN-11 collected from the North Administrative Building mechanical room.

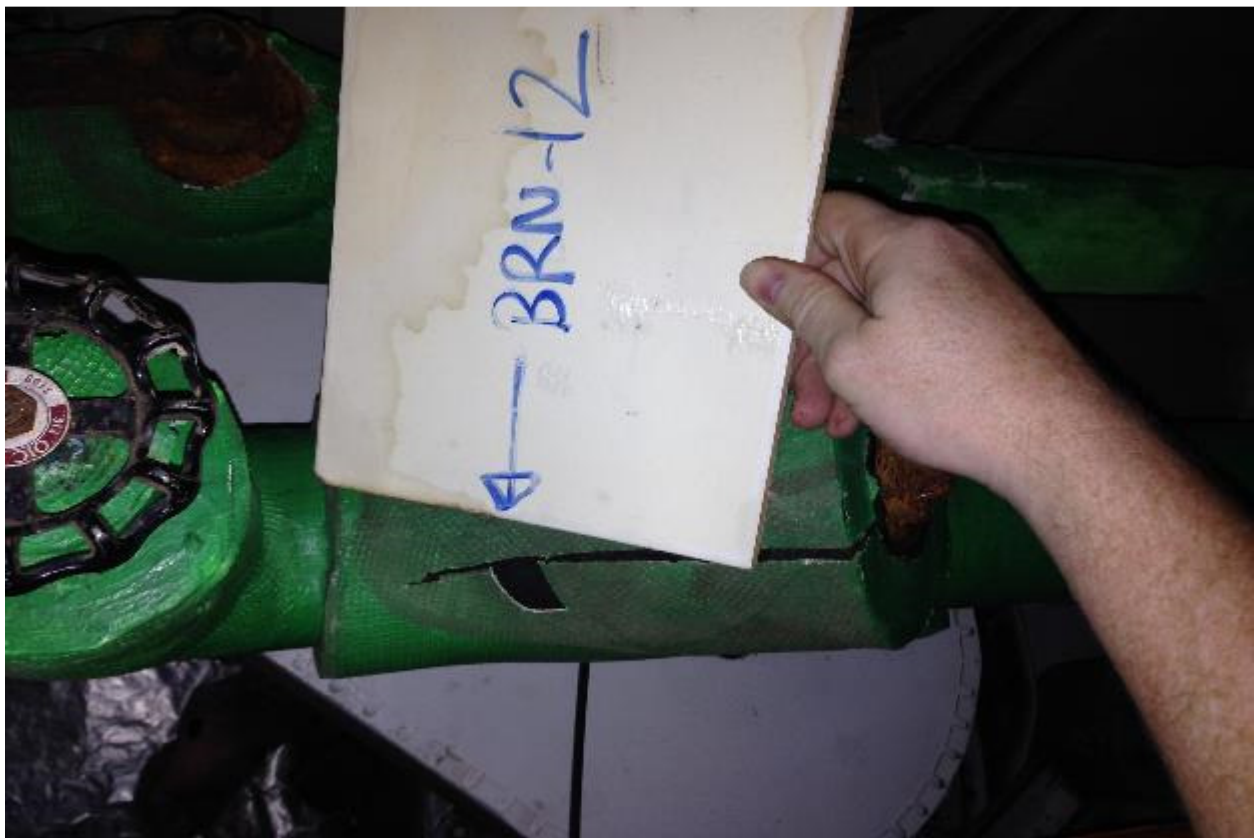
Plate 12: Laboratory analyses did not detect asbestos minerals within plumbing insulation sample BRN-12 collected from the North Administrative Building mechanical room.

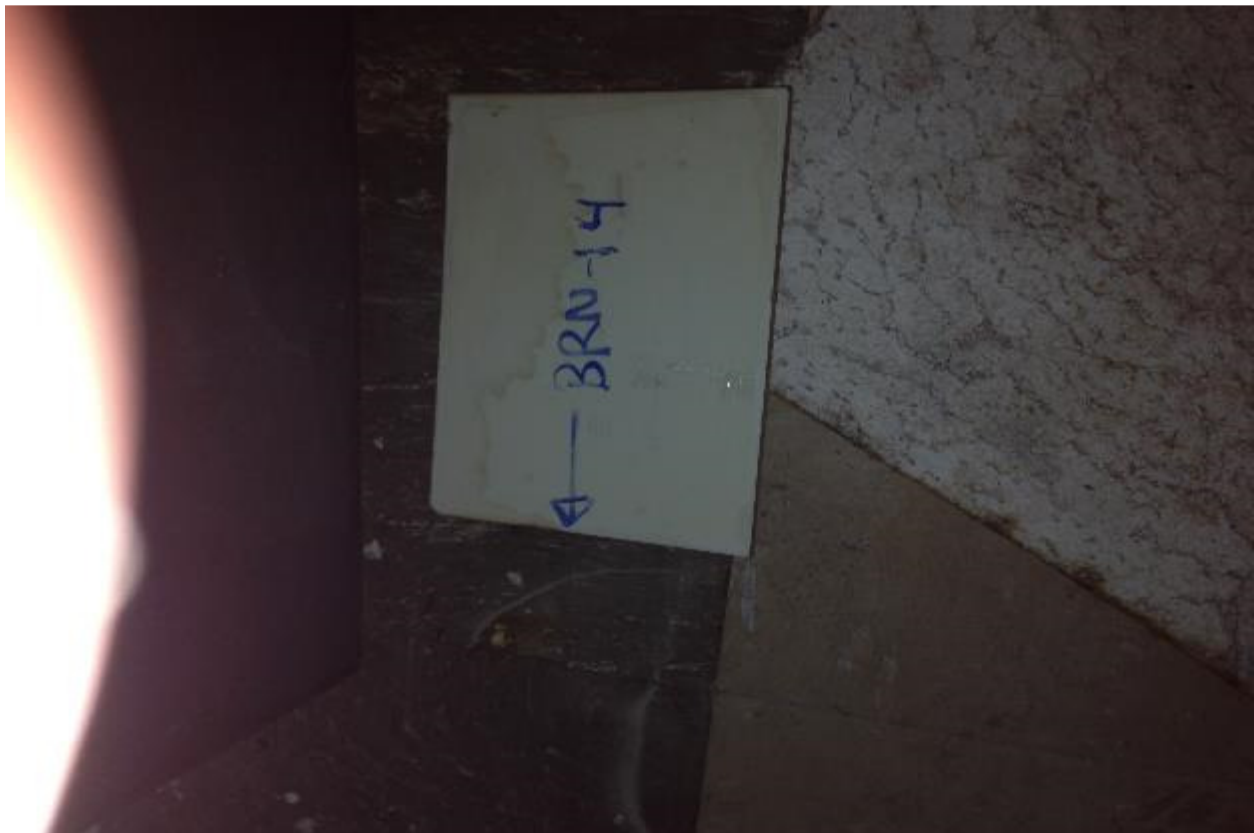
Plate 14: Laboratory analyses did not detect asbestos minerals within the floor tile or mastic sample BRN-14 collected from the North Administrative Building north rooms.

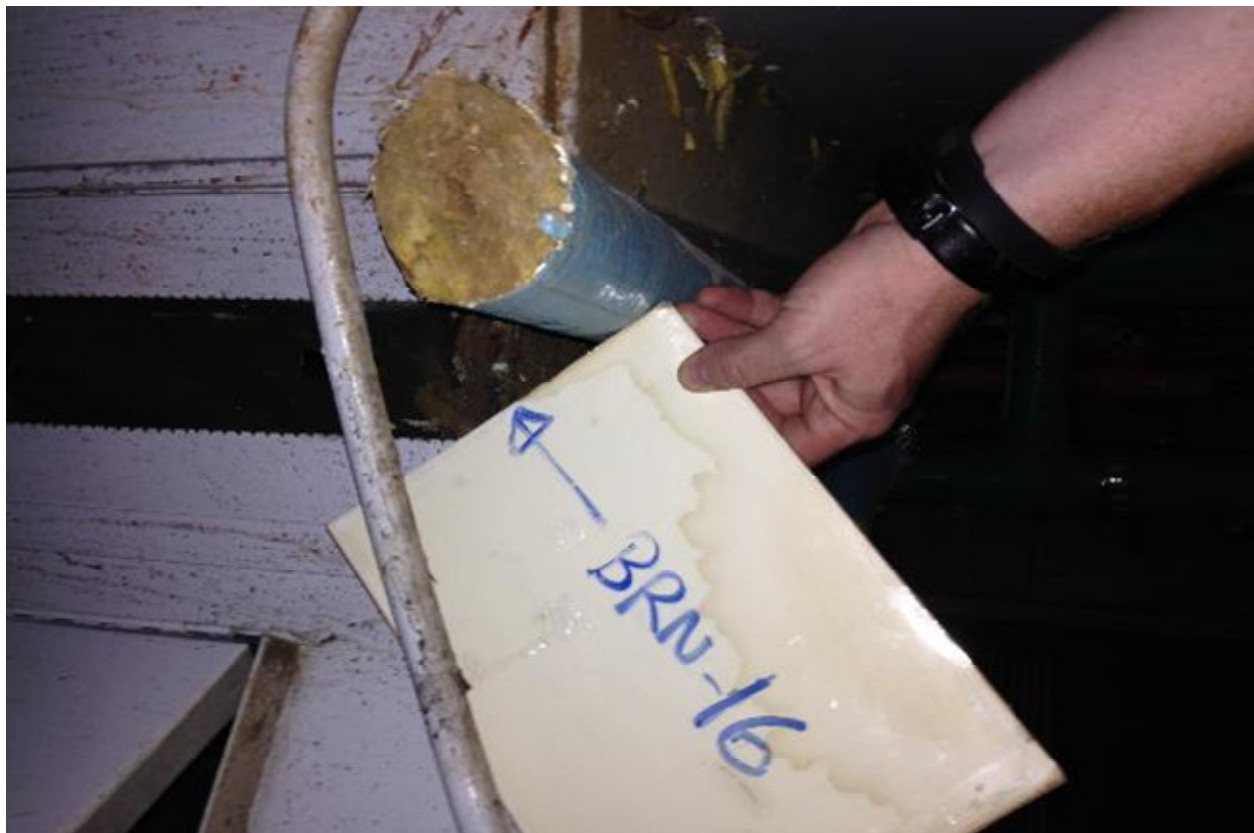
Plate 16: Laboratory analyses did not detect asbestos minerals within HVAC gasket sample BRN-16 collected from the North Administrative Building mechanical room.

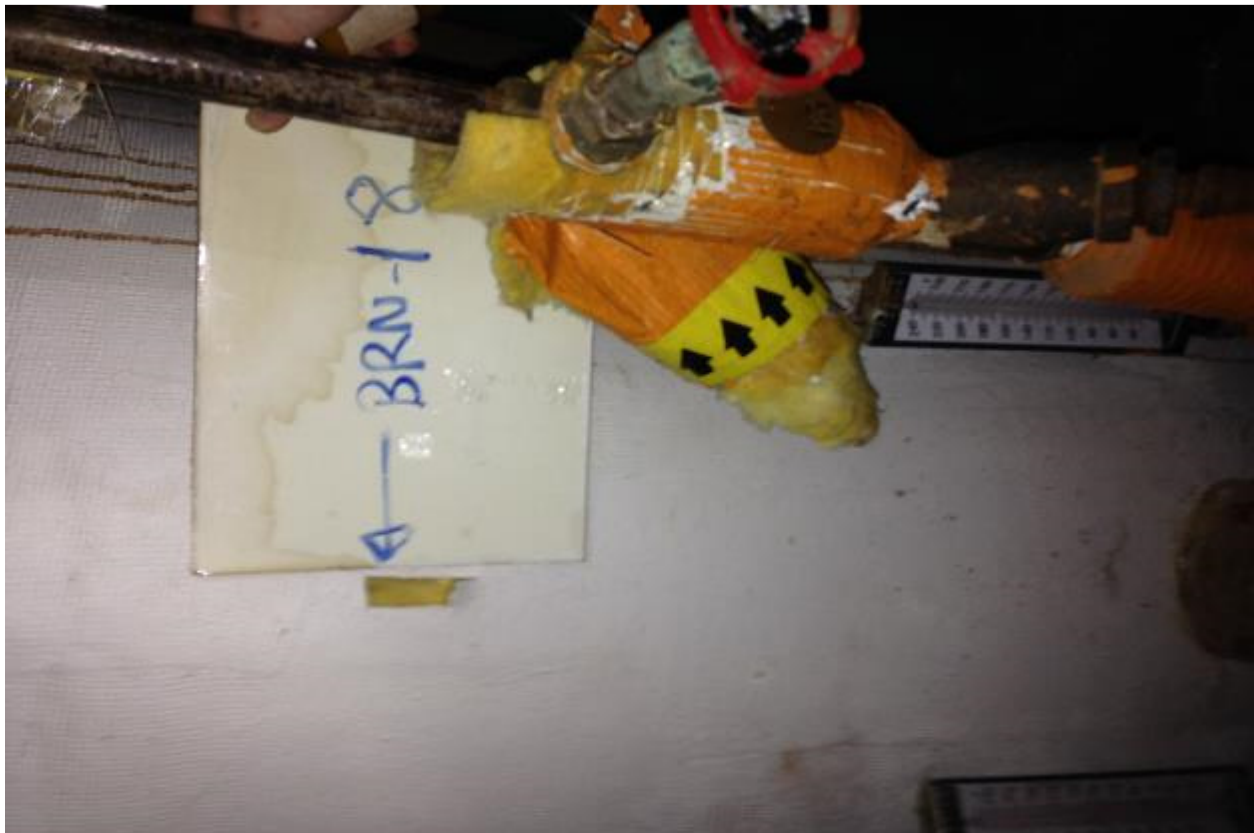
Plate 18: Laboratory analyses did not detect asbestos minerals within Boiler Wrap sample BRN-18 collected from the North Administrative Building mechanical room.

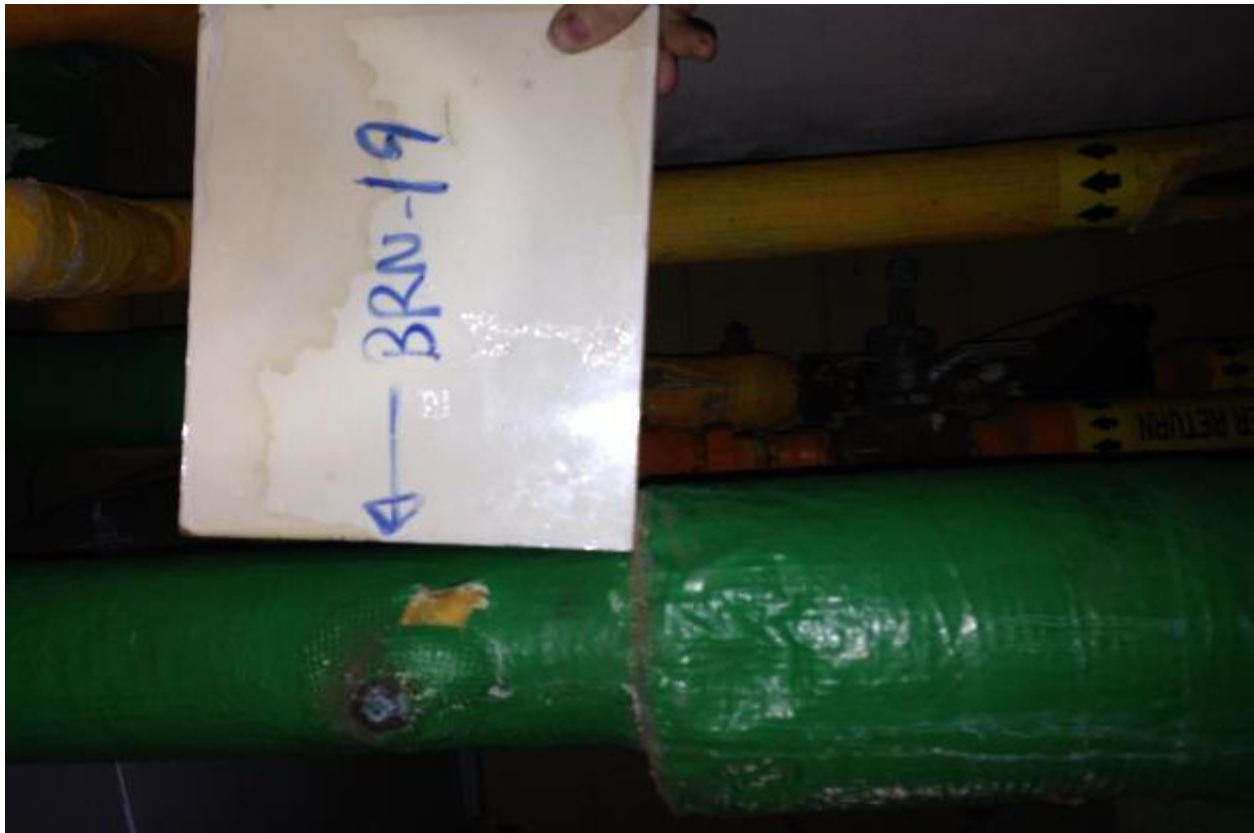
Plate 19: Laboratory analyses did not detect asbestos minerals within plumbing insulation sample BRN-19 collected from the North Administrative Building mechanical room.

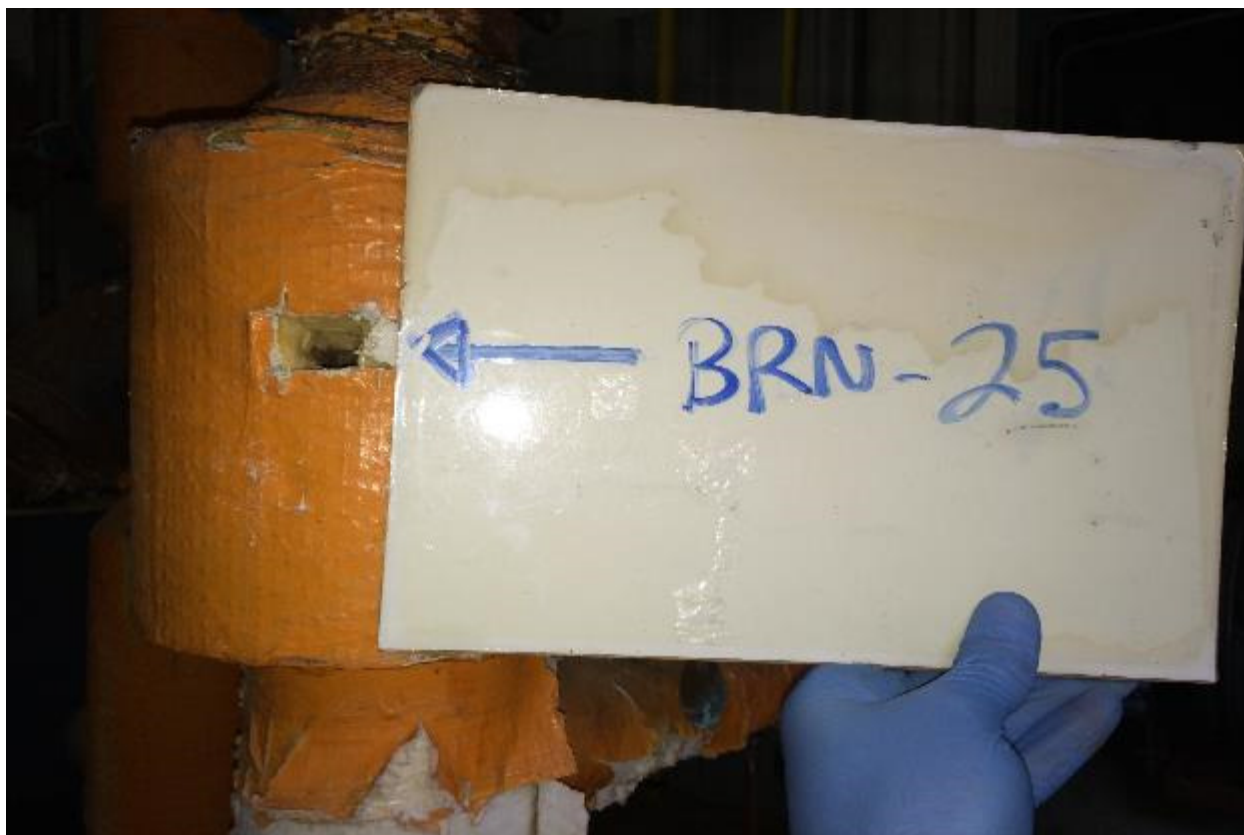
Plate 25: Laboratory analyses did not detect asbestos minerals within plumbing insulation sample BRN-25 collected from the South Administrative Building outdoor mechanical room.

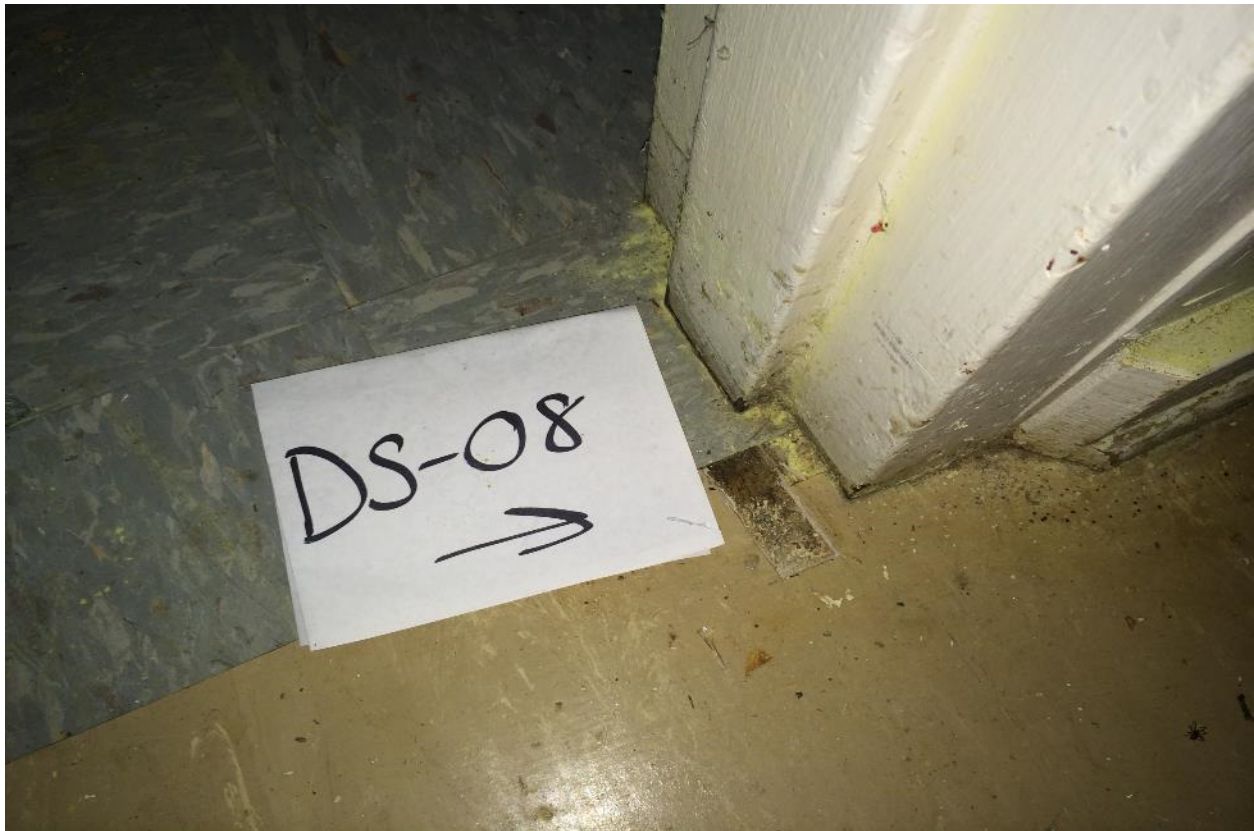
Plate 33: Laboratory analyses did not detect asbestos minerals within the beige floor tile or mastic sample DS-08 collected from the Dormitory Building upstairs hallway.

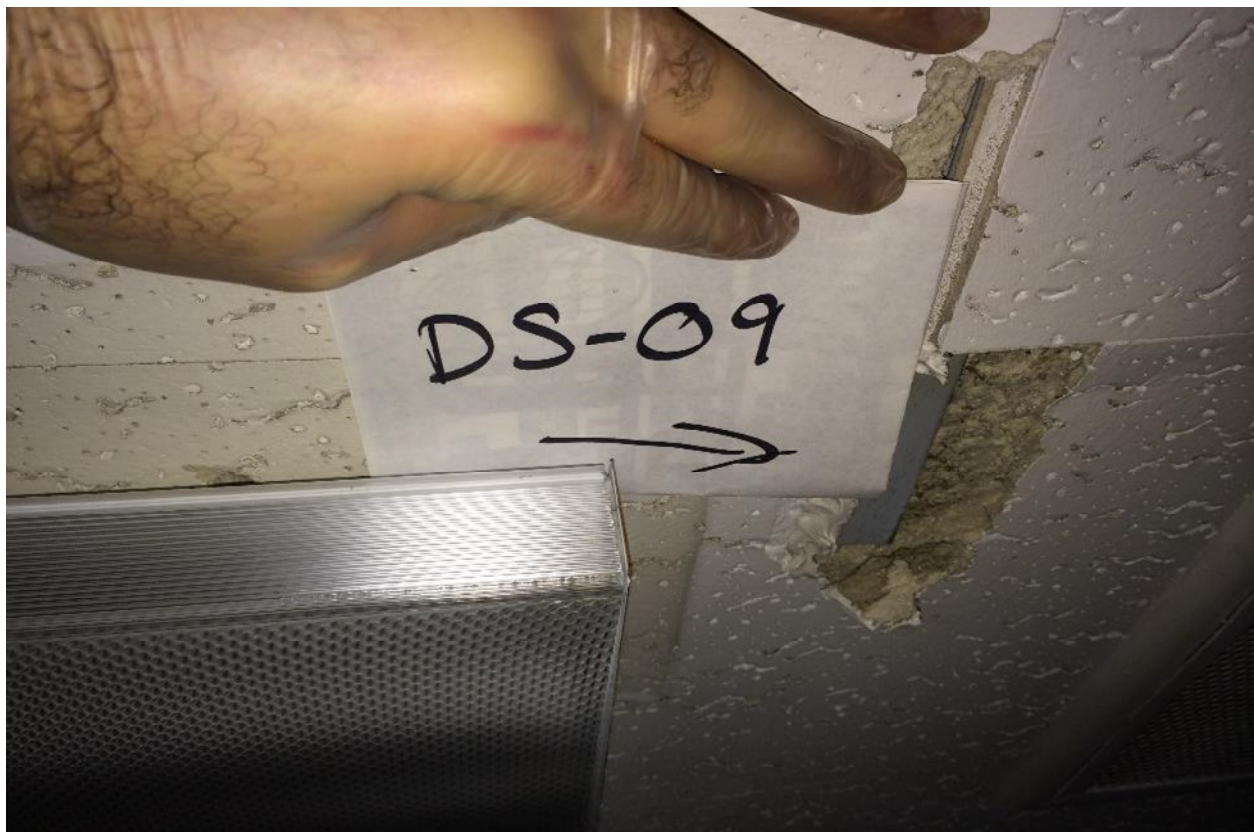
Plate 34: Laboratory analyses detected 3% chrysotile asbestos and 3% amosite asbestos within suspended ceiling tile sample DS-09 collected from the Dormitory Building upstairs computer room.

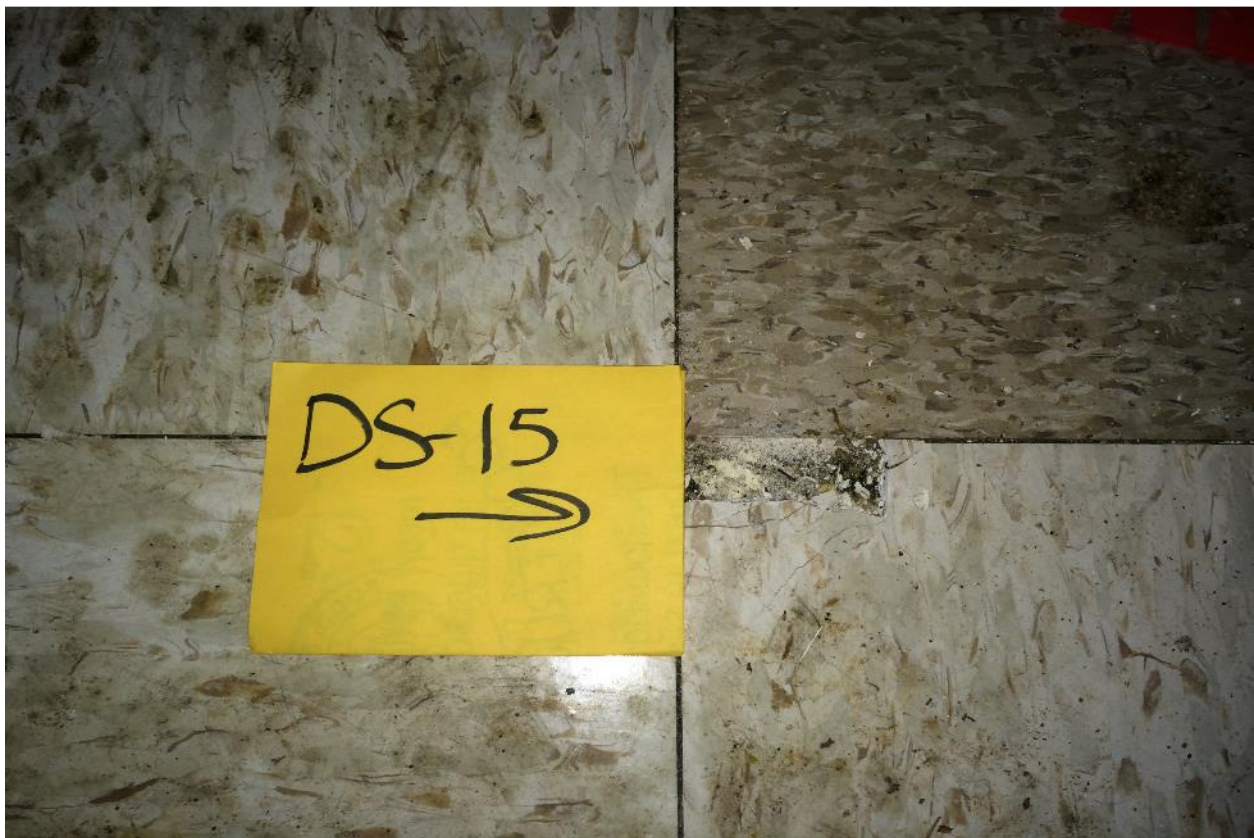
Plate 40: Laboratory analyses did not detect asbestos minerals within the tan and white floor tile or mastic sample DS-15 collected from the Dormitory Building downstairs hallways.

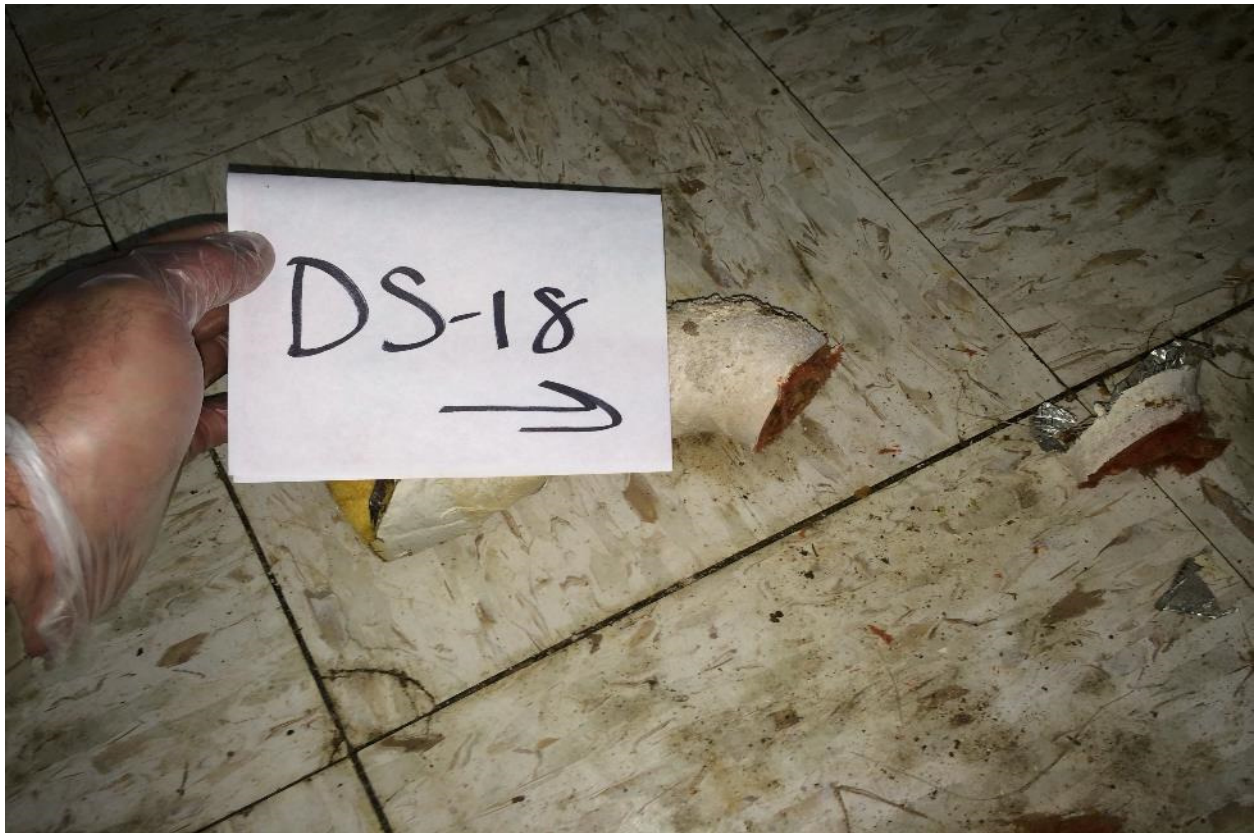
Plate 43: Laboratory analyses did not detect asbestos minerals within plumbing insulation sample DS-18 collected from the Dormitory Building downstairs training room.

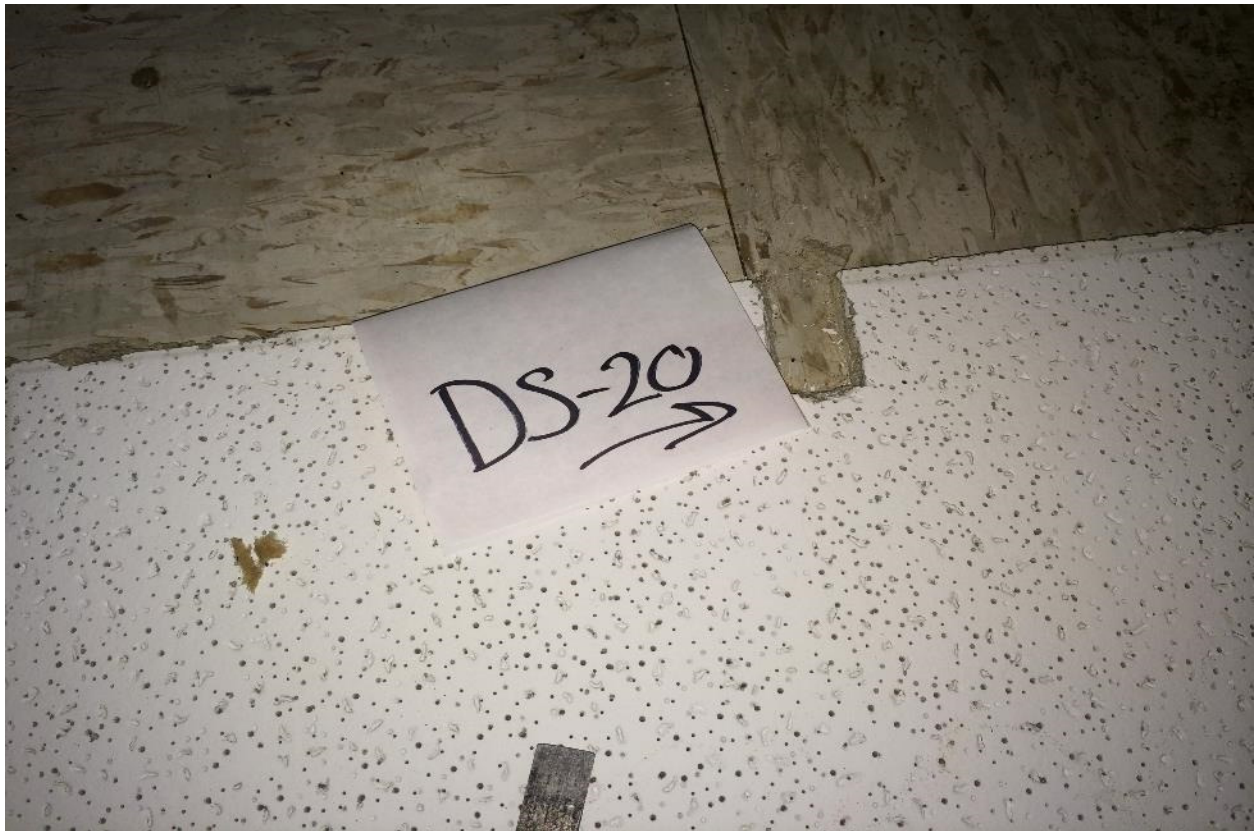
Plate 45: Laboratory analyses did not detect asbestos minerals within suspended ceiling tile sample DS-20 collected from the Dormitory Building downstairs hallways.

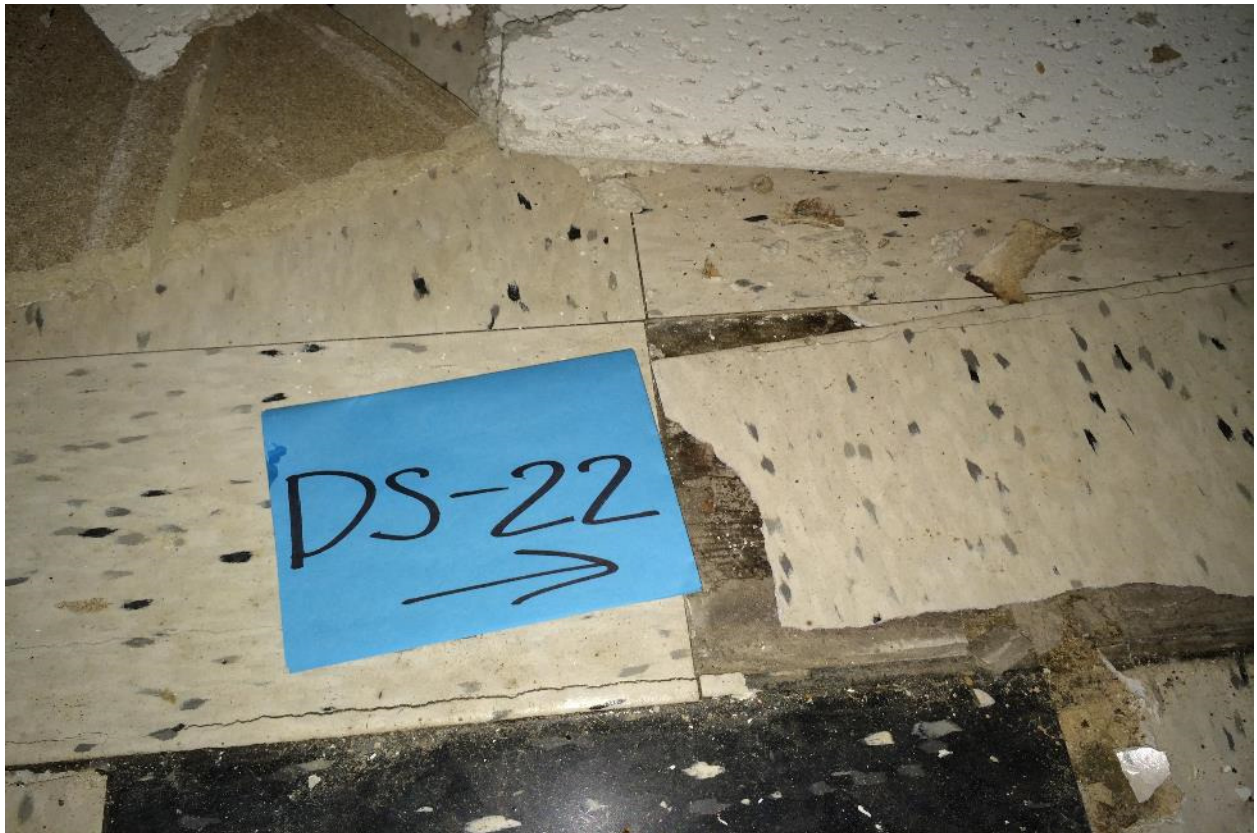
Plate 47: Laboratory analyses did not detect asbestos minerals within the black and white floor tile or mastic sample DS-22 collected from the Dormitory Building downstairs training room.
