## Invitation to Bid

### **ITB 16-06 Demolition of the Theater at Brook Run Park**

The City of Dunwoody is soliciting competitive sealed bids from qualified contractors for **Demolition of the Theater Building at Brook Run Park** for the Department of Parks and Recreation.

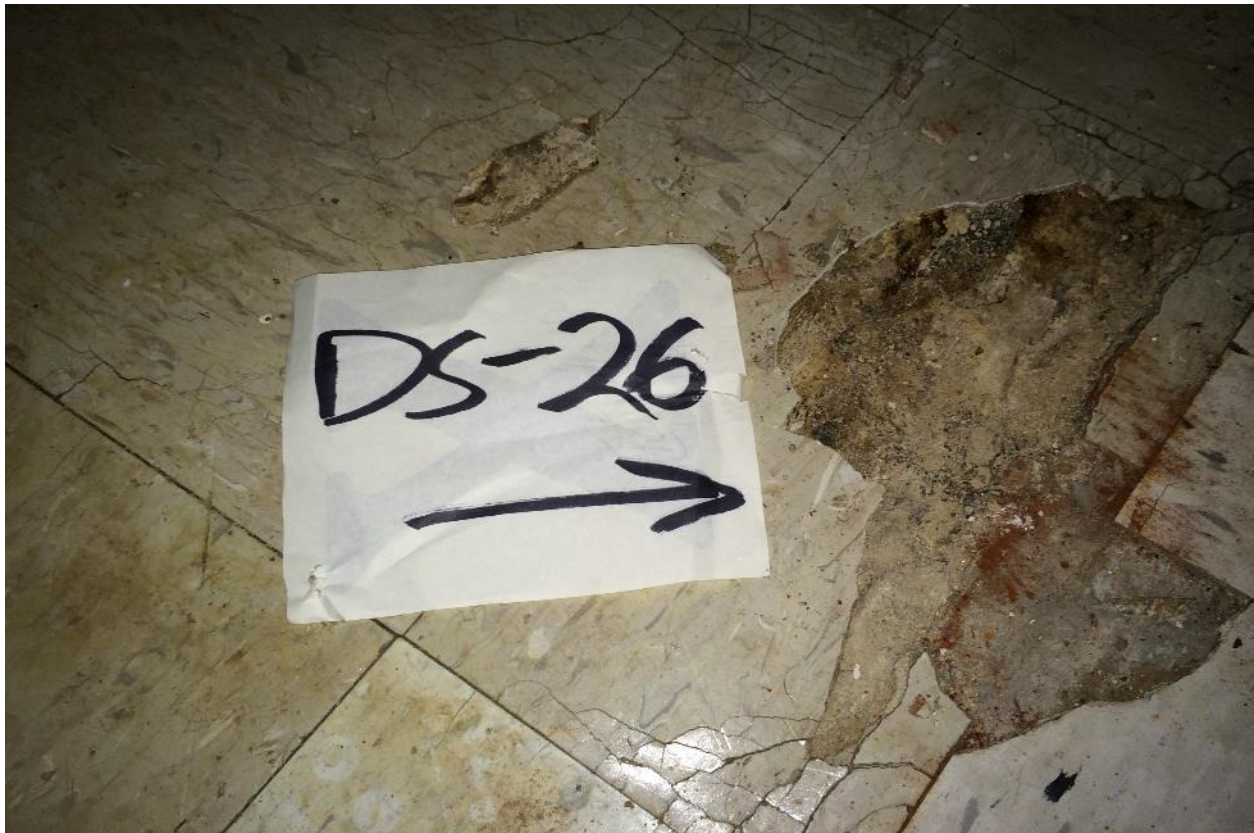
Plate 51: Laboratory analyses did not detect asbestos minerals within the black floor tile or mastic sample DS-26 collected from the Dormitory Building downstairs east miscellaneous rooms.

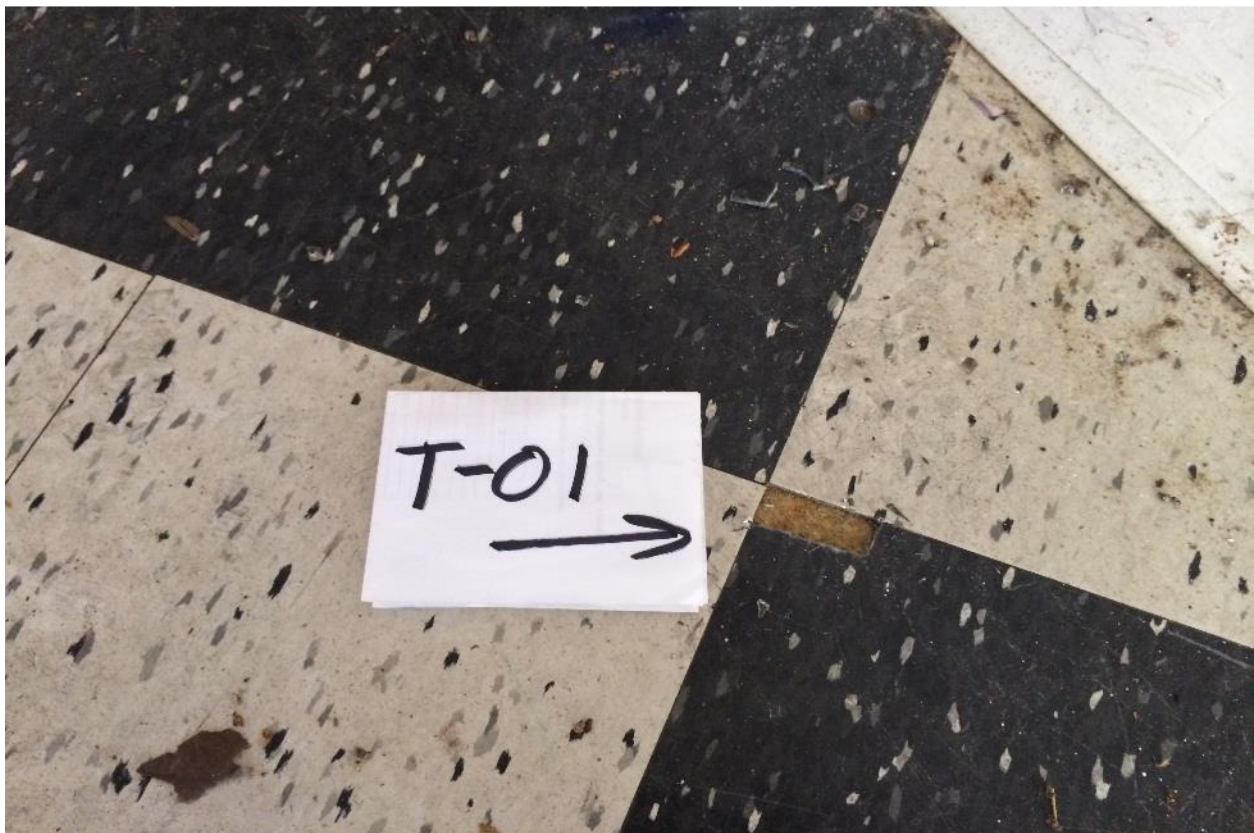
Plate 52: Laboratory analyses did not detect asbestos minerals within the black floor tile from sample TS-01 but did detect 5% chrysotile asbestos in the mastic from sample TS-01 collected from the Theatre Building lobby area.

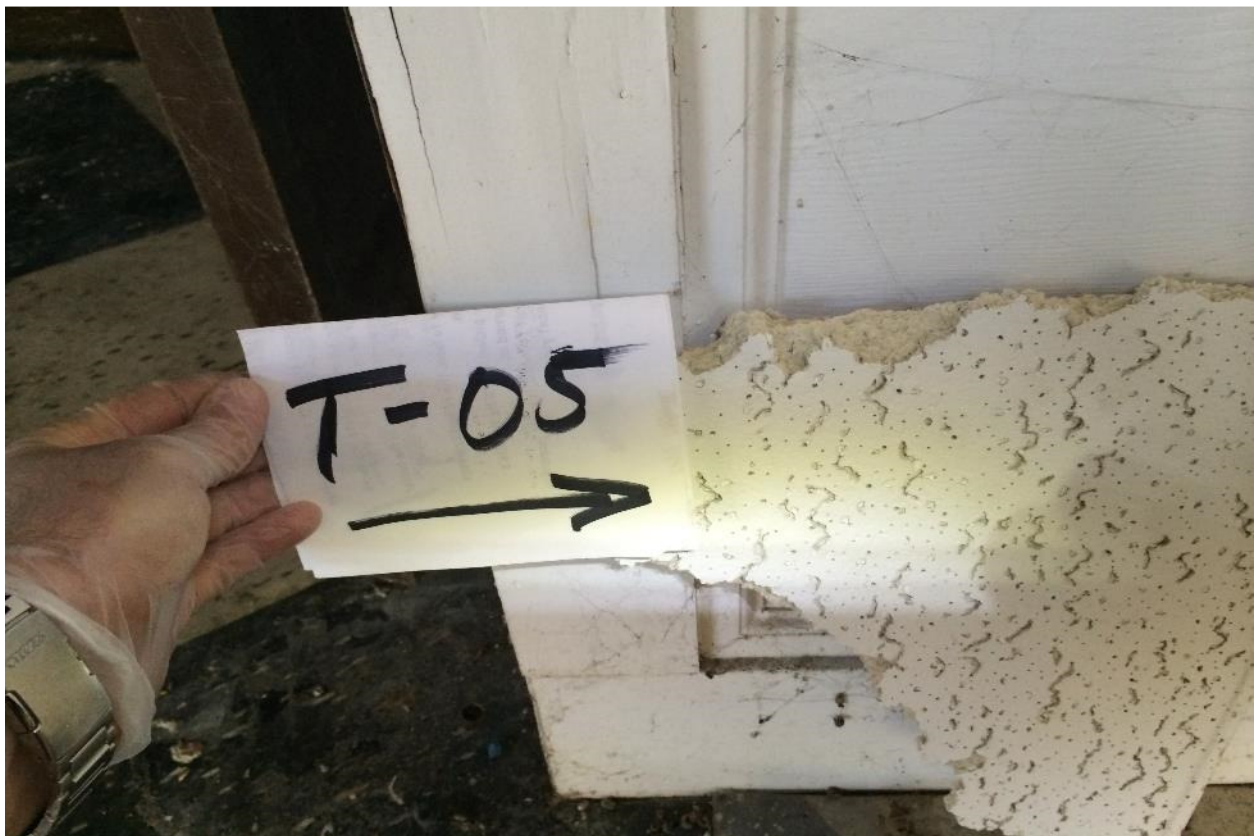
Plate 56: Laboratory analyses detected 2% chrysotile asbestos within suspended ceiling tile sample TS-05 collected from the Theatre Building lobby area.

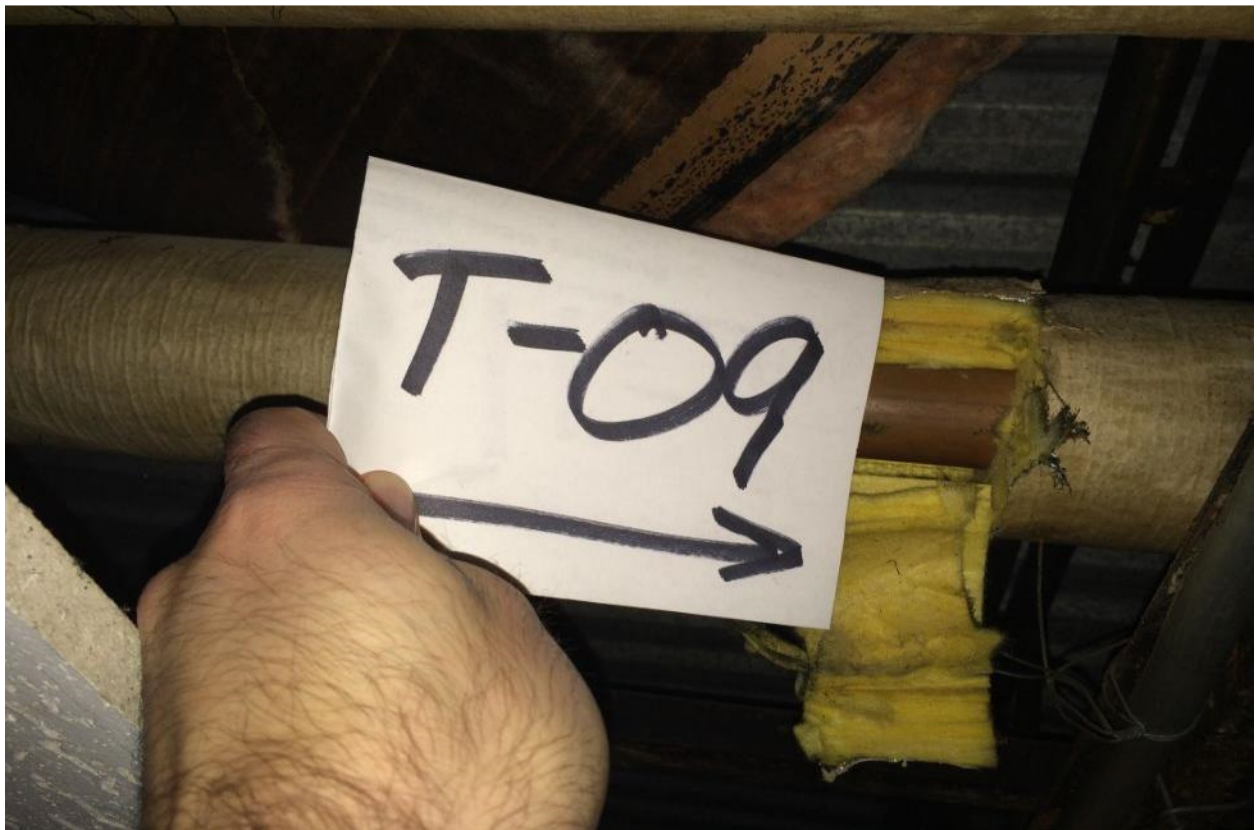
Plate 60: Laboratory analyses did not detect asbestos minerals within plumbing insulation sample TS-09 collected from the Theatre Building lobby ceiling.

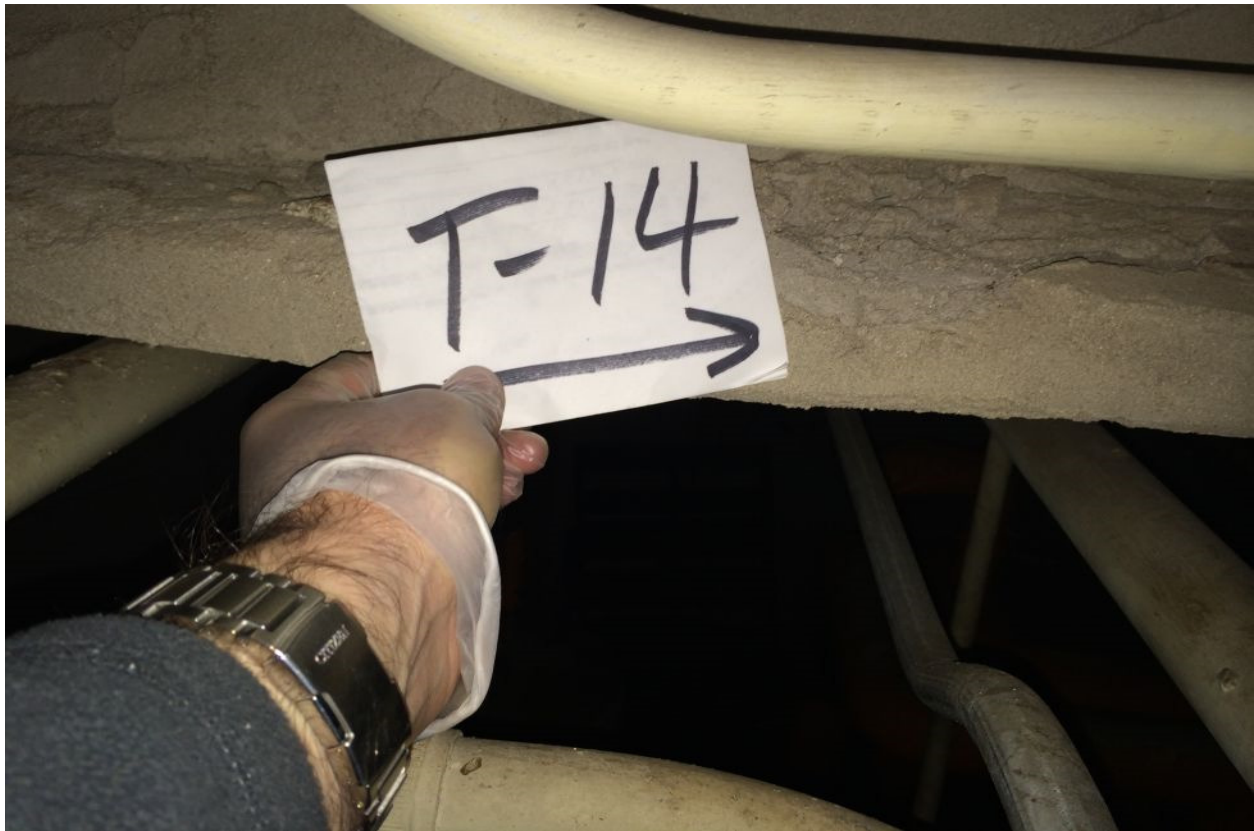
Plate 65: Laboratory analyses detected 20% chrysotile asbestos within spray on surfacing material sample TS-14 collected from the Theatre Building basement structural steel.

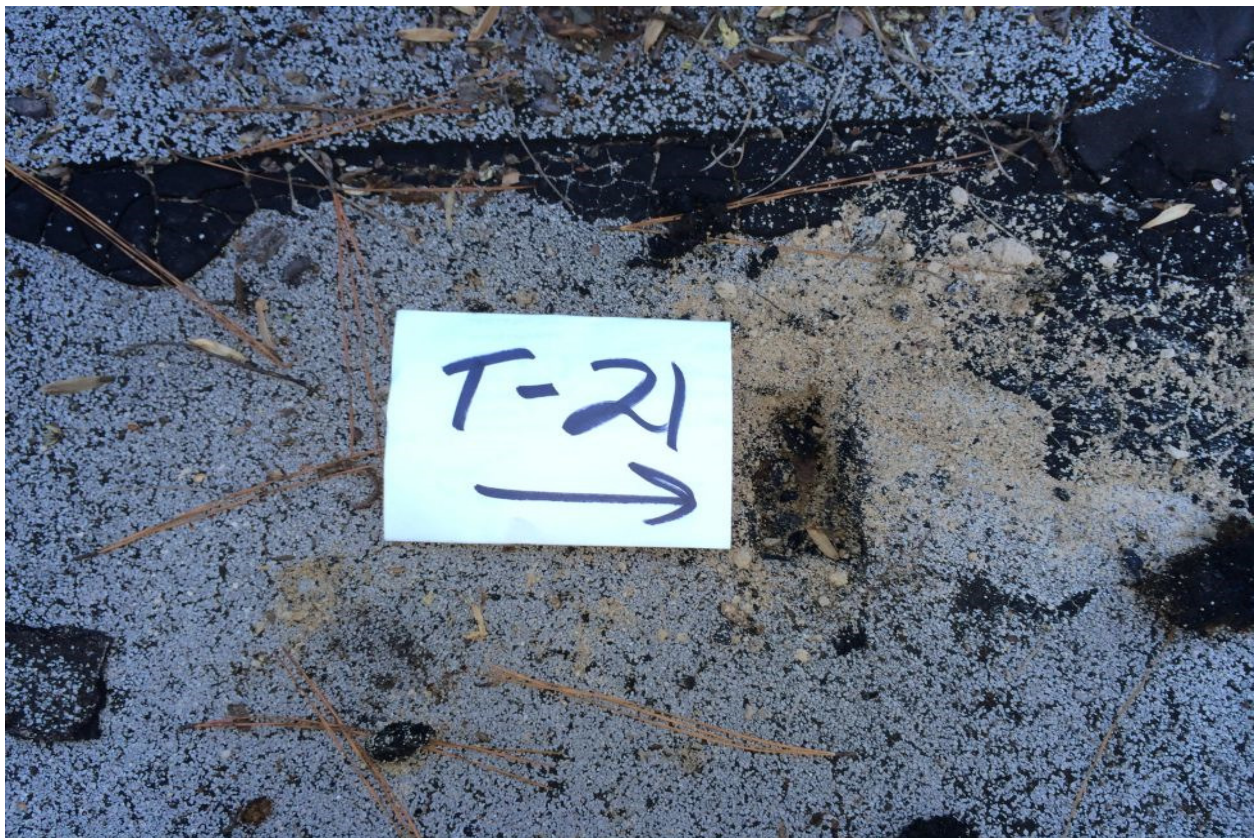
Plate 70: Laboratory analyses did not detect asbestos minerals within asphalt roof sample TS-21 collected from the Theatre Building roof.

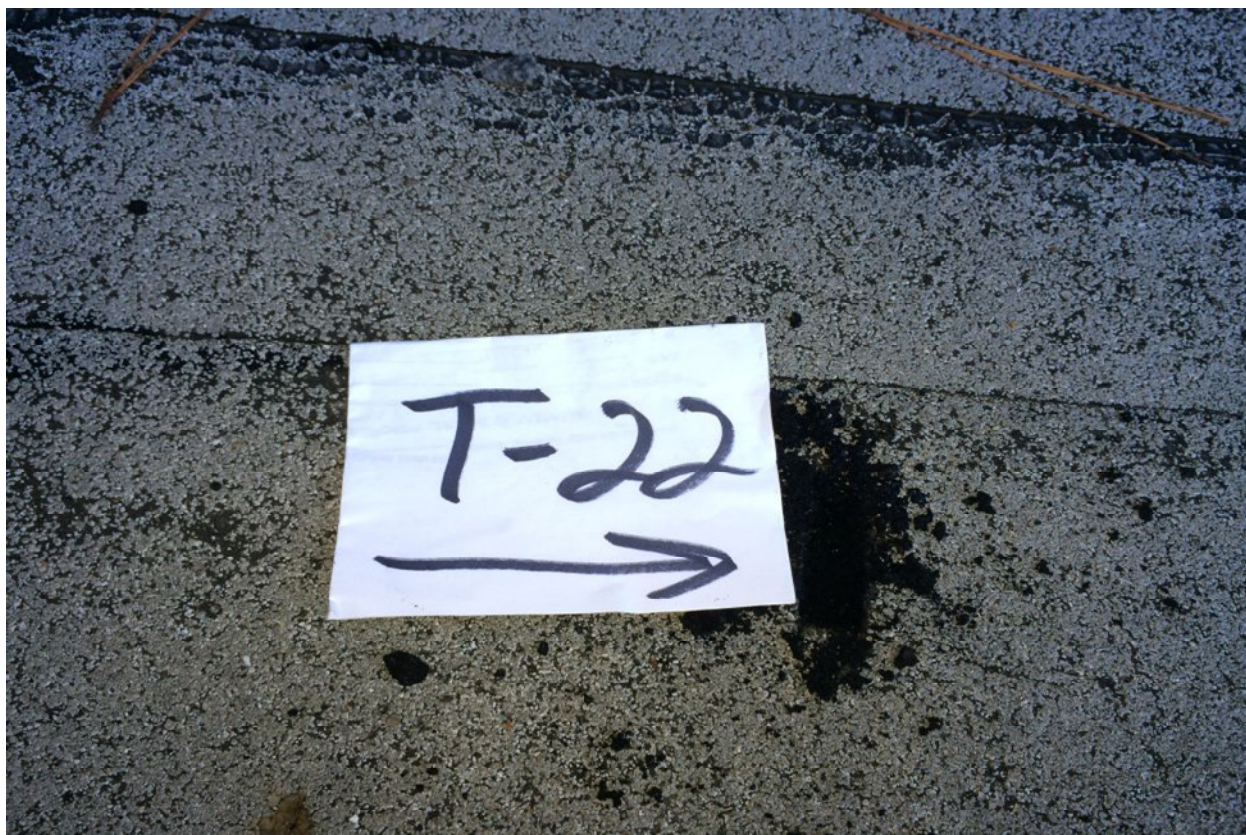
Plate 71: Laboratory analyses did not detect asbestos minerals within asphalt roof sample TS-22 collected from the Theatre Building roof.

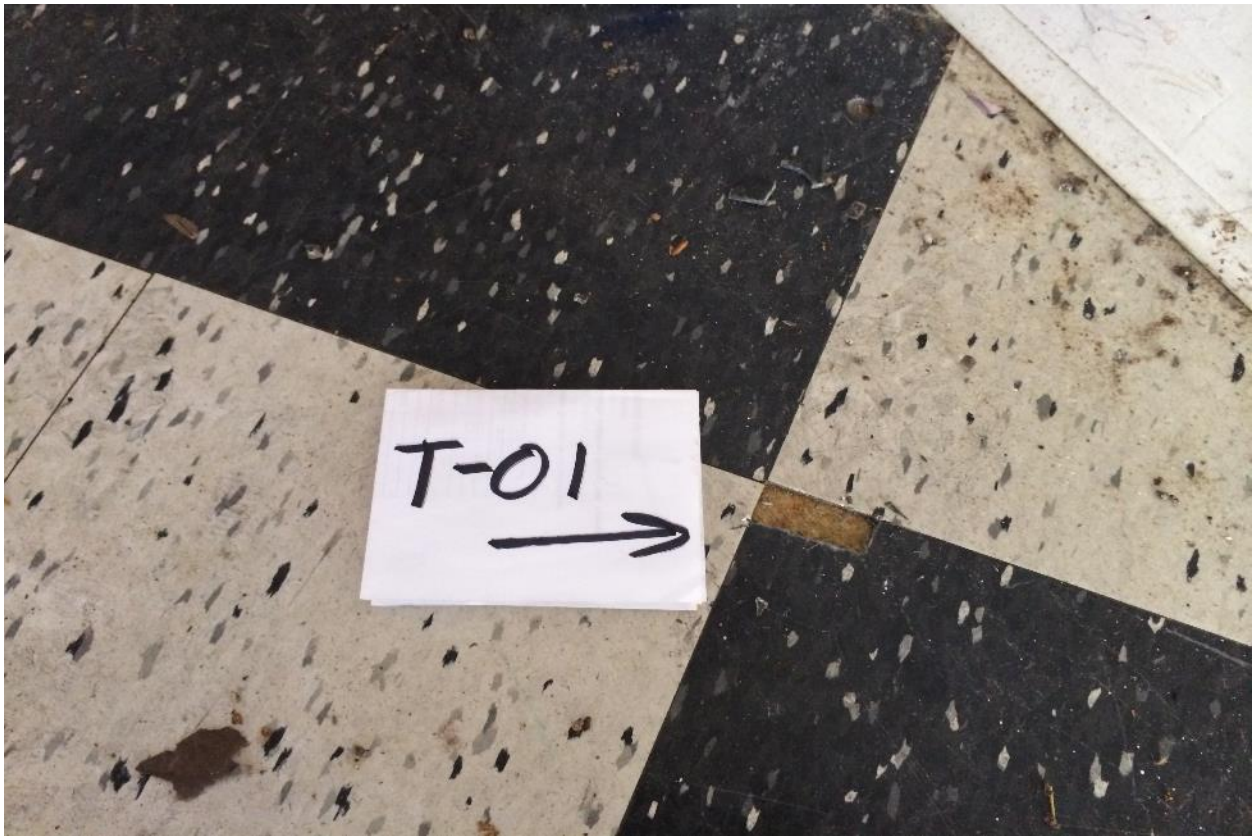
Plate 52: Laboratory analyses did not detect asbestos minerals within the black floor tile from sample TS-01 but did detect 5% chrysotile asbestos in the mastic from sample TS-01 collected from the Theatre Building lobby area.

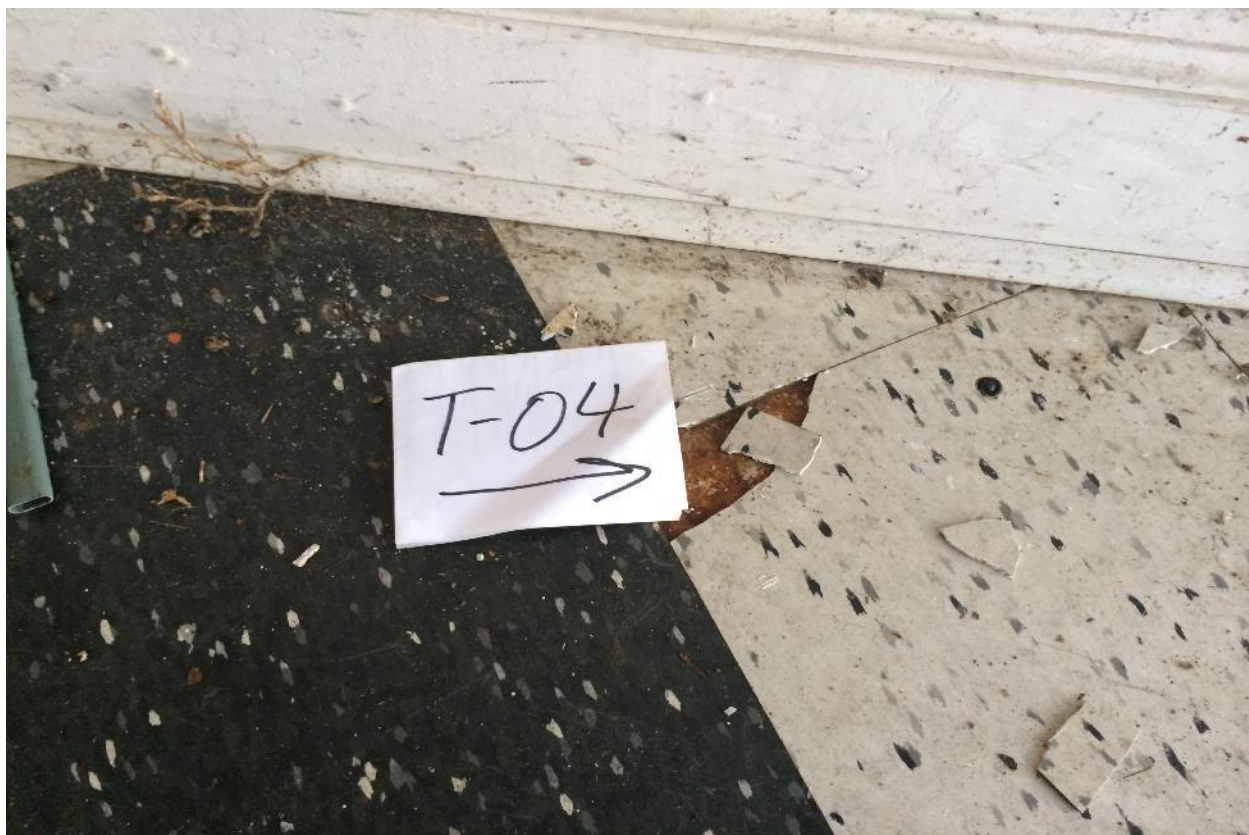
Plate 55: Laboratory analyses did not detect asbestos minerals within the white floor tile from sample TS-04 but did detect 5% chrysotile asbestos in the mastic from sample TS-04 collected from the Theatre Building lobby area.

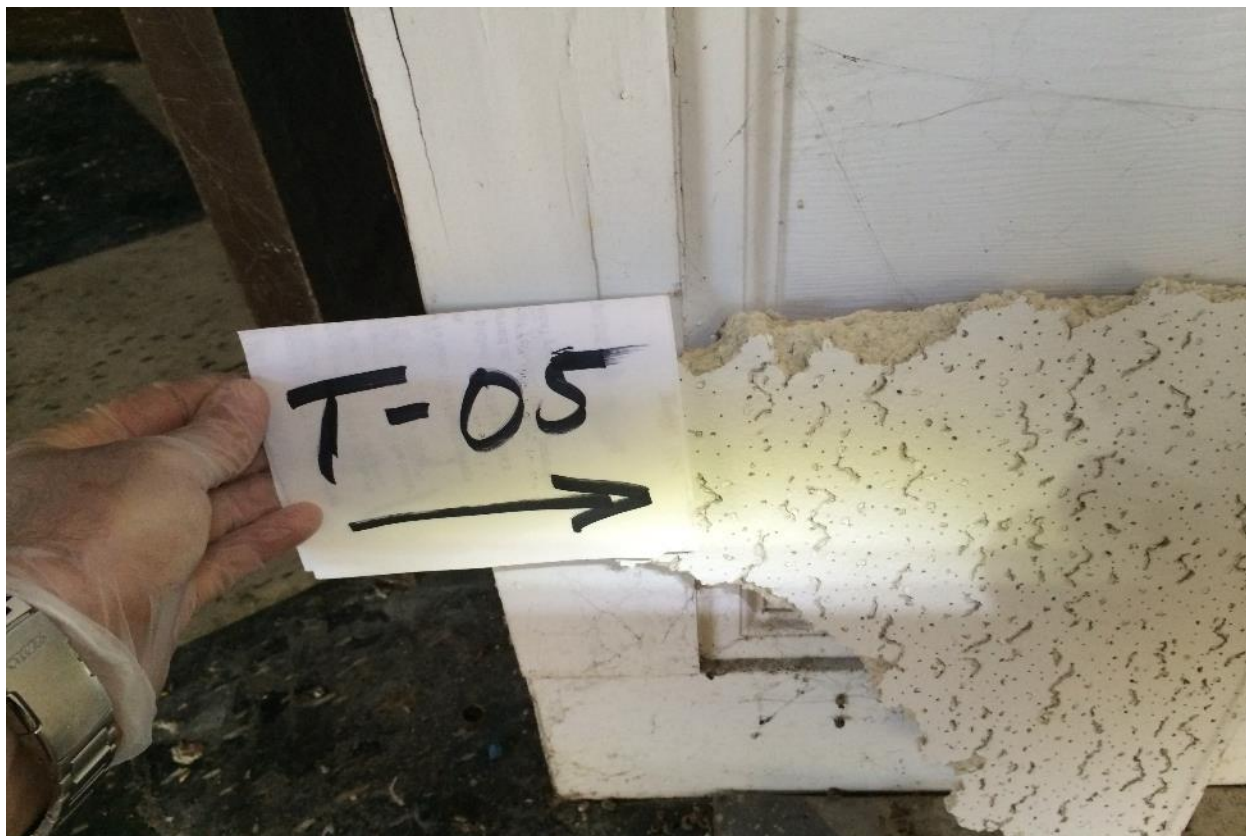
Plate 56: Laboratory analyses detected 2% chrysotile asbestos within suspended ceiling tile sample TS-05 collected from the Theatre Building lobby area.

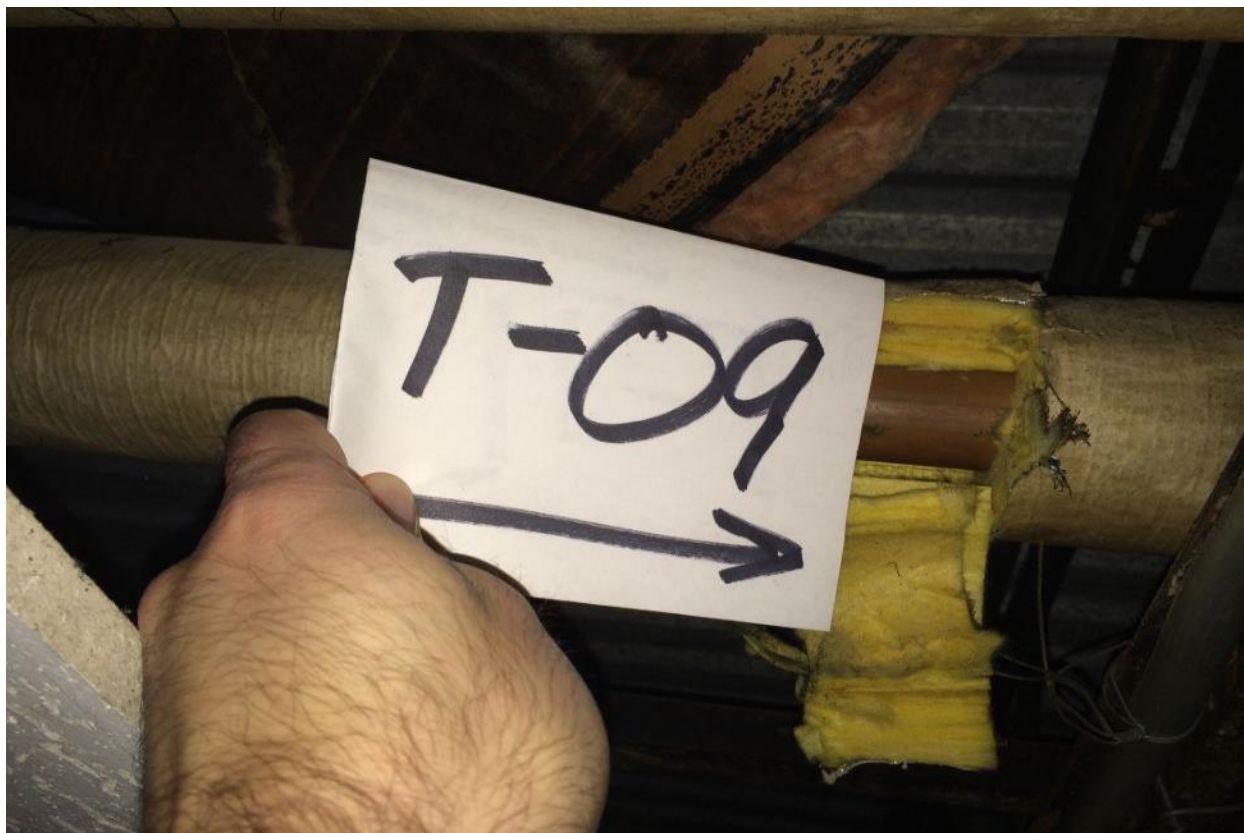
Plate 60: Laboratory analyses did not detect asbestos minerals within plumbing insulation sample TS-09 collected from the Theatre Building lobby ceiling.

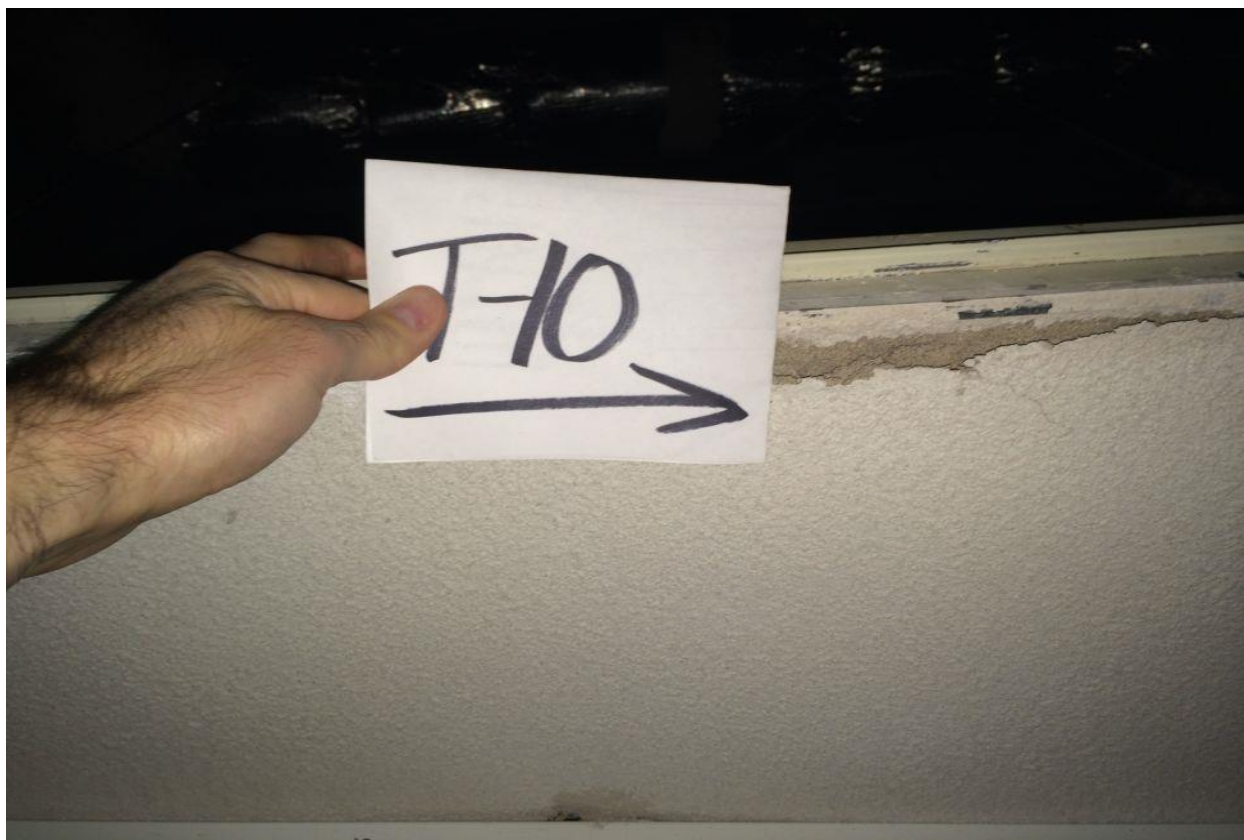
Plate 61: Laboratory analyses detected 20% chrysotile asbestos within spray on surfacing material sample TS-10 collected from the Theatre Building upstairs projection room ceiling.

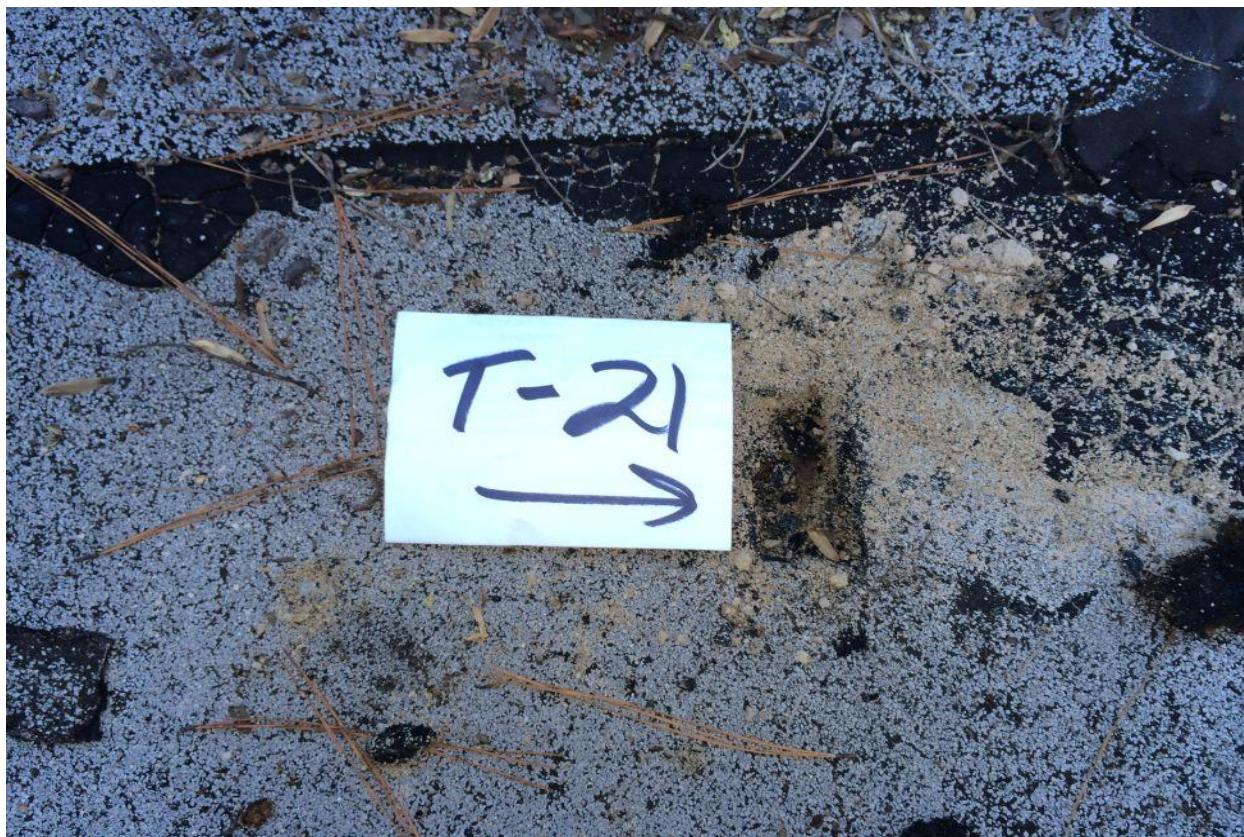
Plate 70: Laboratory analyses did not detect asbestos minerals within asphalt roof sample TS-21 collected from the Theatre Building roof.

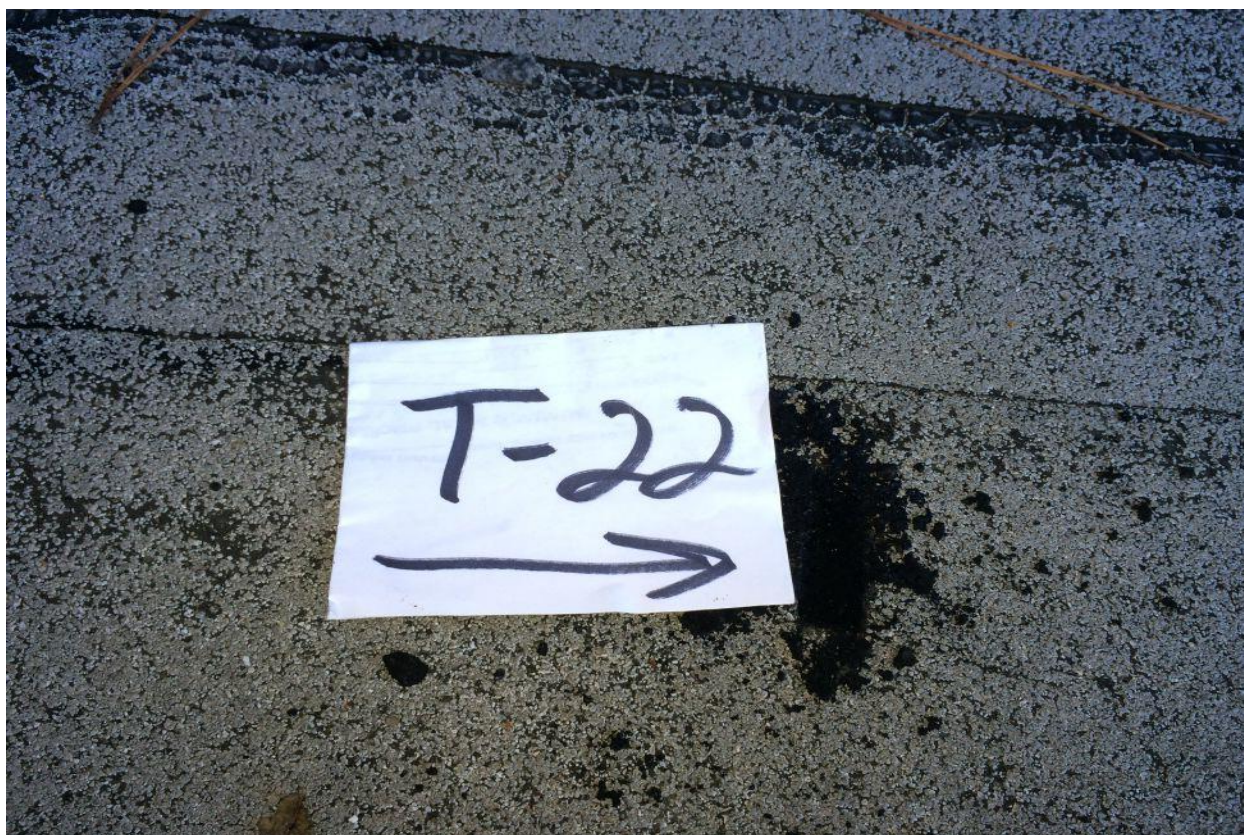
Plate 71: Laboratory analyses did not detect asbestos minerals within asphalt roof sample TS-22 collected from the Theatre Building roof.
