**The Brook Run Theater
Feasibility Study**

**Report of Findings and Recommendations
Regarding Rehabilitation, Adaptive Re-Use and Operations**

January 2016

City of Dunwoody
Brook Run Park Theater

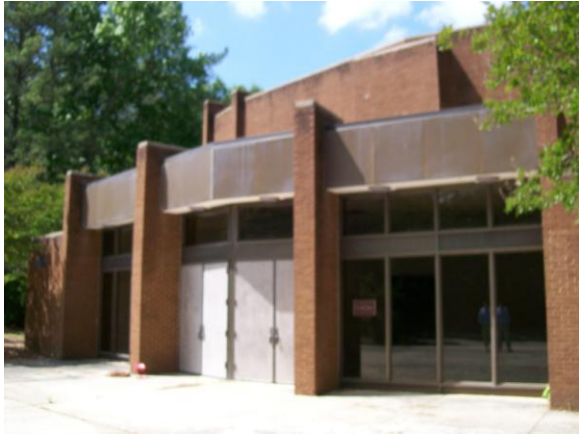
Main Entry of Theater

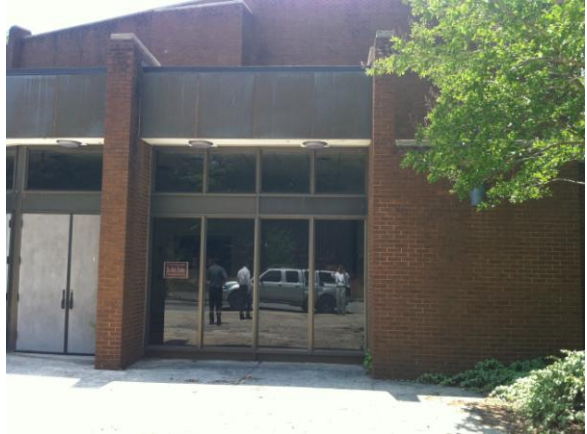
Original Glazing in Aluminum Storefront

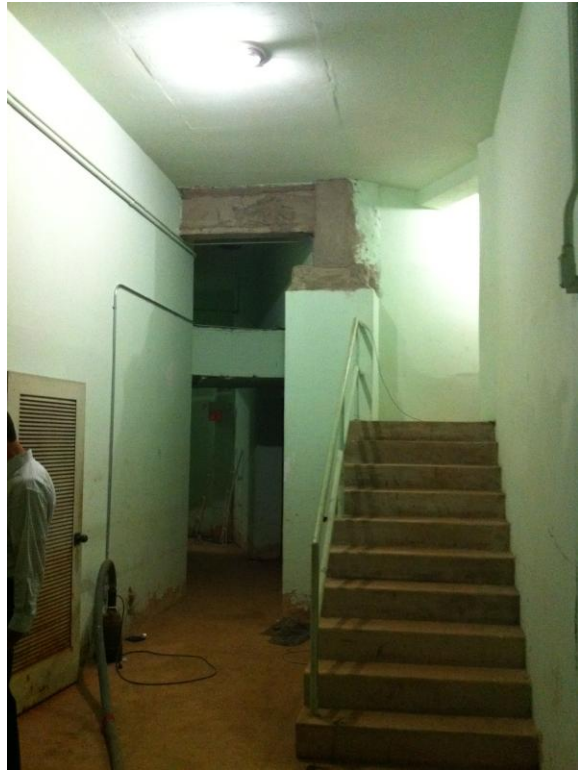
Deteriorated Basement Door & Hardware

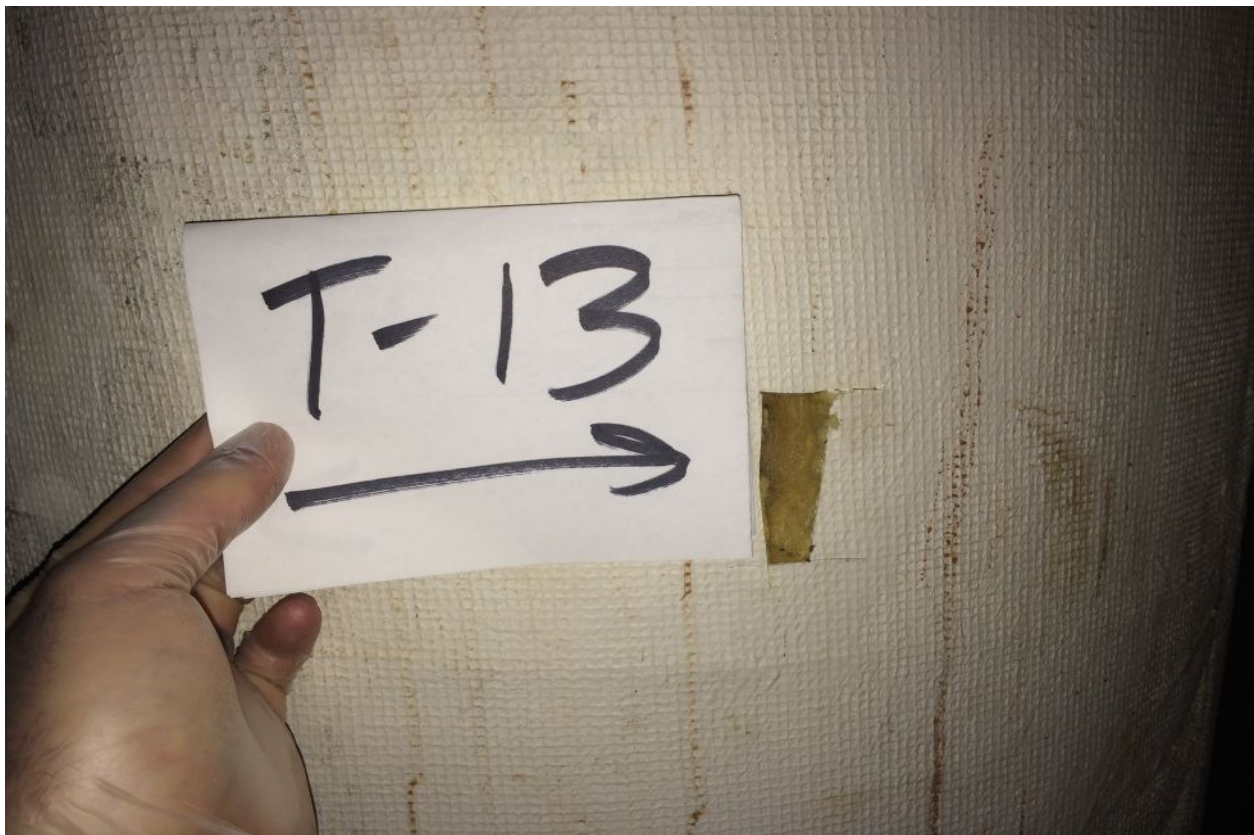
Plate 63: Laboratory analyses did not detect asbestos minerals within plumbing insulation sample TS-12 collected from the Theatre Building basement boiler room.

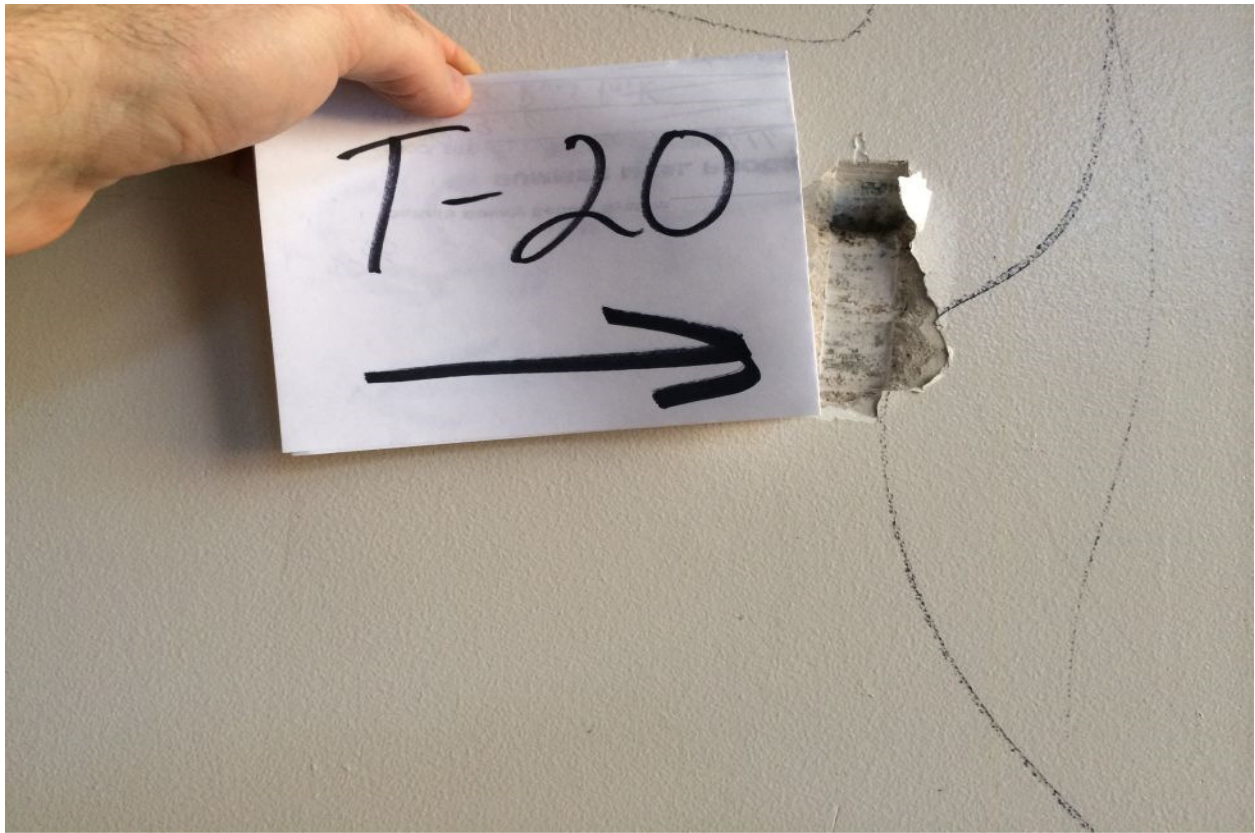
Plate 68: Laboratory analyses did not detect asbestos minerals within troweled on surfacing material within sample TS-19 collected from the Theatre Building basement hall wall.

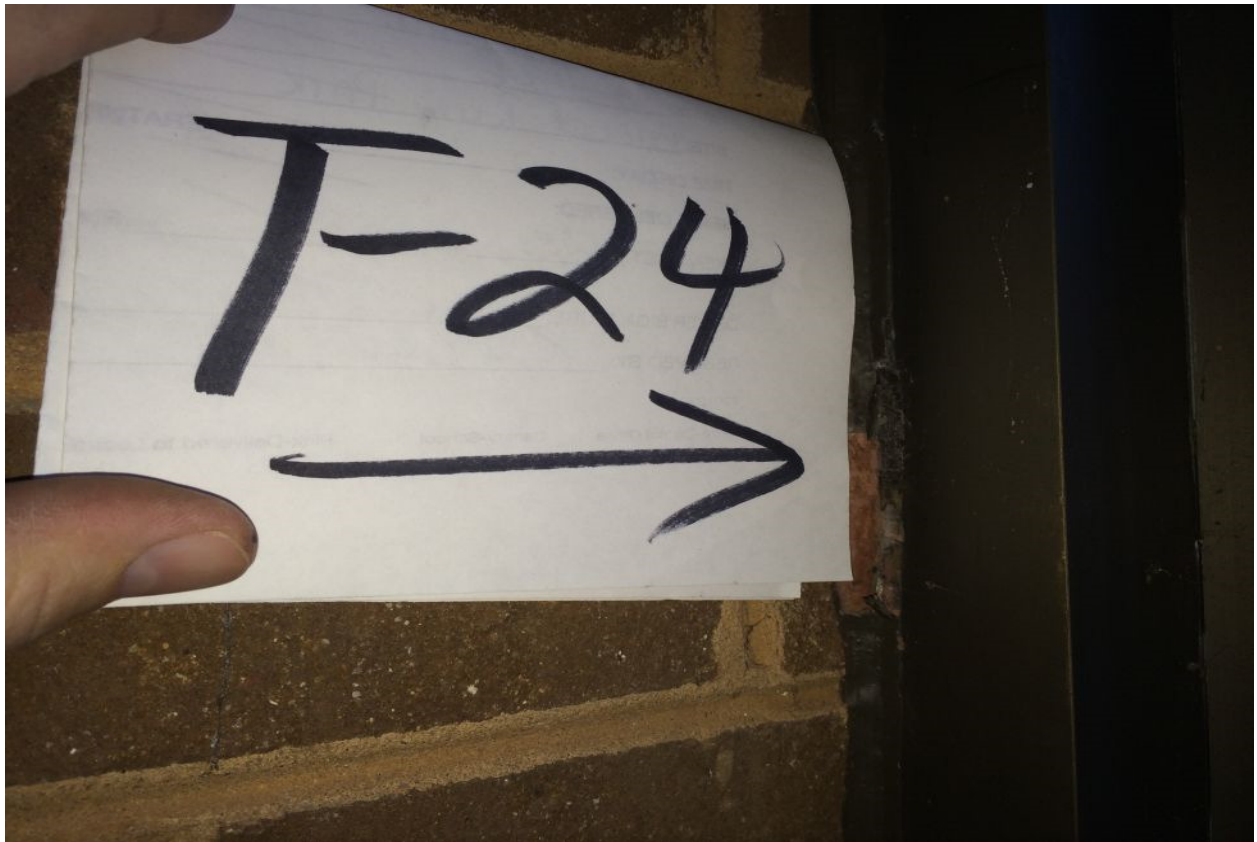
Plate 72: Laboratory analyses did not detect asbestos minerals within the window caulk sample TS-23 collected from the Theatre Building windows.
