Re: Dunwoody Cultural Arts Center HVAC Roof Top Unit System Replacement

# Cultural Arts Center – RTU Assessment

**City of Dunwoody**

Date: 4/18/2025

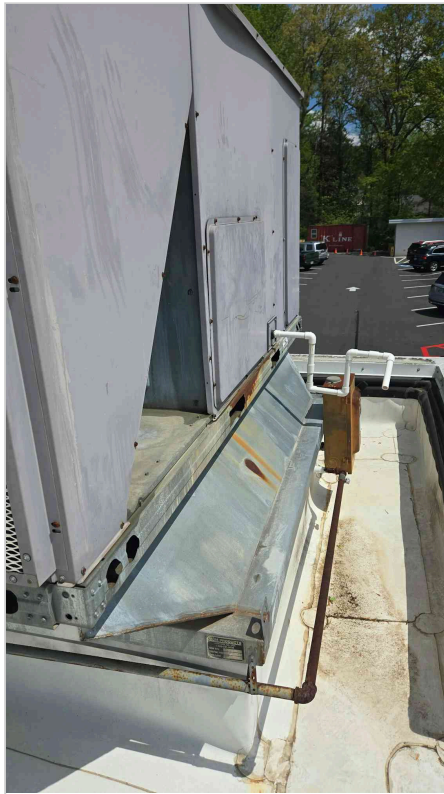
Unit Overview.jpeg

The unit was manufactured, and likely installed, in 2011. A typical lifecycle for well-maintained packaged RTU equipment is 15-20 years. Although the unit is approaching 15 years old, it is in good mechanical condition for its age.
