Re: Contract Award to Advanced Sports Group for Brook Run Park Artificial Turf Repairs

Brook Run Park Artificial Turf Repairs

Inspection Report Synthetic Turf Field

Dunwoody Brook Run Park Synthetic Turf Fields

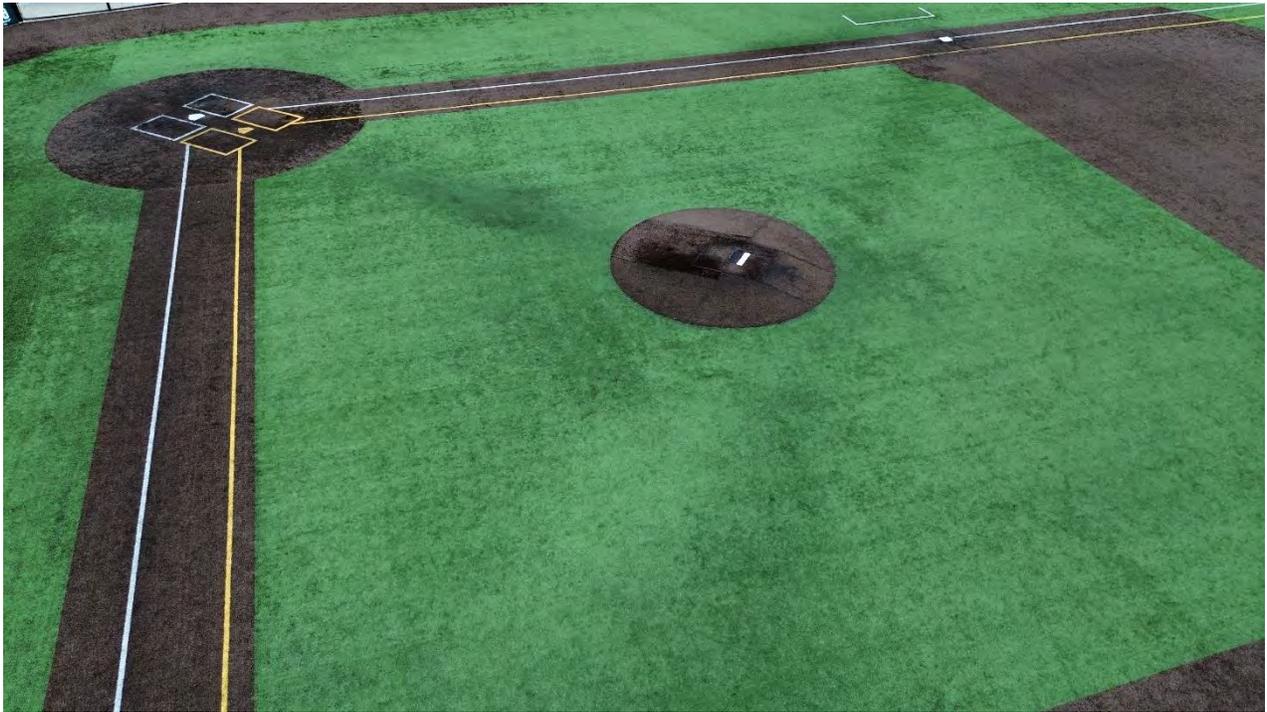
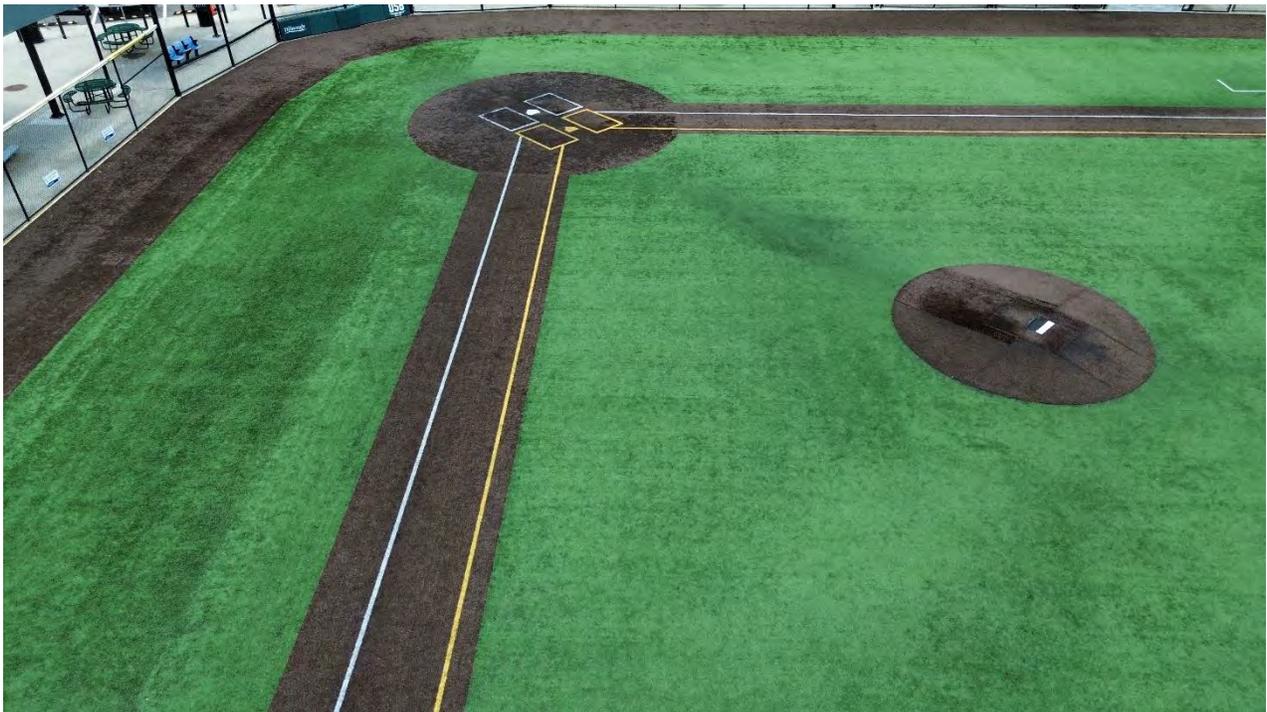
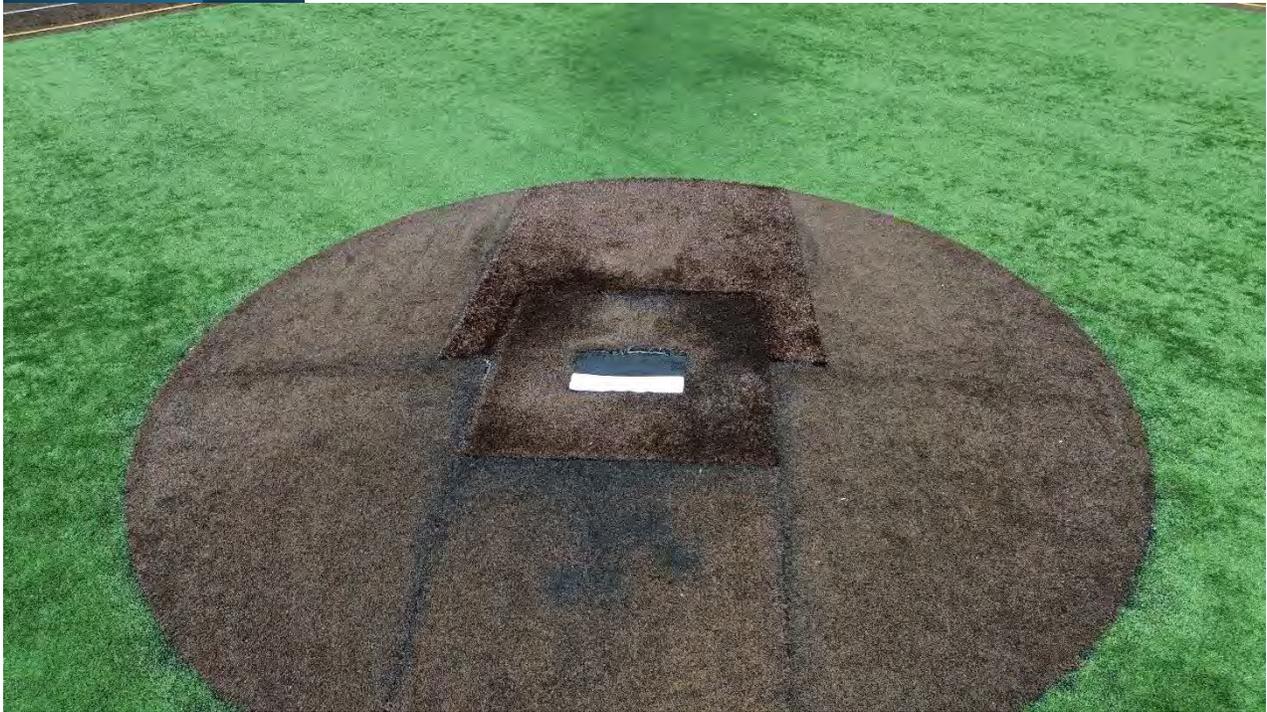
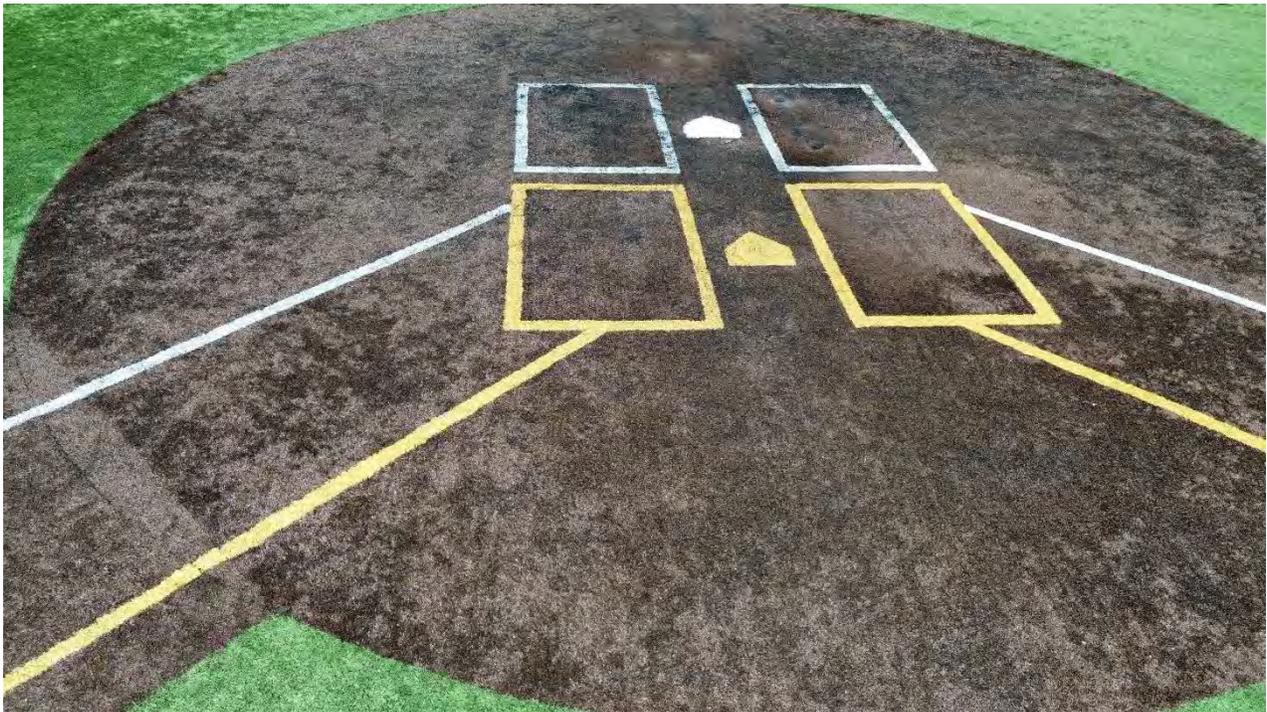
Fiber Wear Patterns

Fiber wear patterns were normal for turf fields at this age. High Wear areas were as expected for both baseball and soccer fields. Baseball Fields need attention in home plates areas and slide areas to extend the life of the field and maintain safe play. Soccer Goal mouths, circles and corners were matted due to low infill levels. Most of the turf outside of high wear is holding up very well.

High wear areas indicate normal use, and the fibers are in good condition.
